## **Asbestos Building Materials Assessment**

House  
10 Bisley Crescent  
Brockville ON

Project No.: 122150275  
February 15, 2017

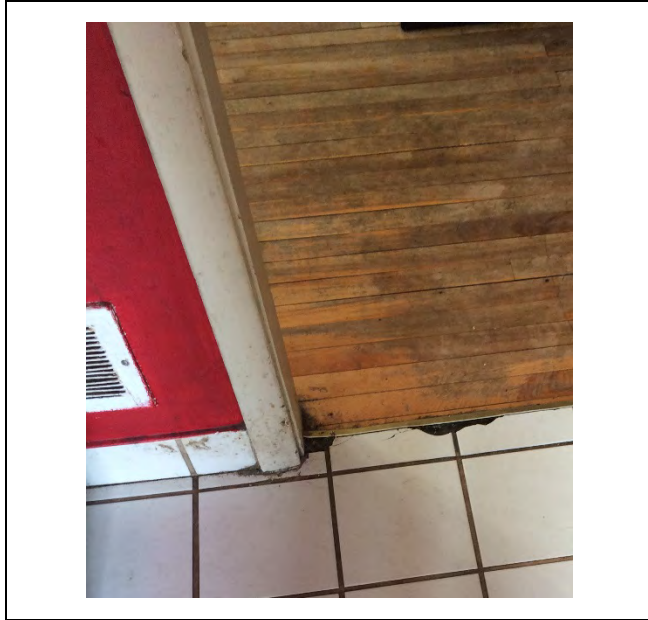
This material was observed to be in good condition. It should be noted that drywall joint-fill compound is considered non-friable in its undisturbed state but can release fibers when damaged.

Photo 1: Asbestos-containing drywall joint-fill compound on the kitchen walls and presumed asbestos-containing ceramic tile grout and mortar / adhesive on the kitchen floor.

- Asbestos-containing materials that may be impacted during renovation and/or demolition activities should be removed prior to the renovation and/or demolition activities;
