## **Asbestos Building Materials Assessment**

Multi-Residential Building  
105 Lewis Street East  
Merrickville ON

Project No.: 122150275

February 15, 2017

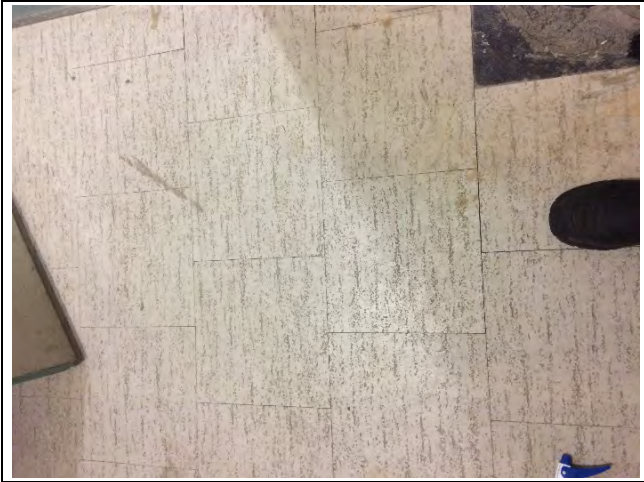
The 12"x12" vinyl floor tile – beige with black spots was observed to be in poor condition (one (1) loose tile) in the communal storage room. The remaining materials were observed to be in good condition.

Photo 1: Asbestos-containing 12" x 12" vinyl floor tiles – beige with black spots (3.89% Chrysotile) in the communal storage room.

- Damaged asbestos-containing 12"x12" vinyl floor tile – beige with black spots should be removed and disposed of following Type 1 abatement procedures;

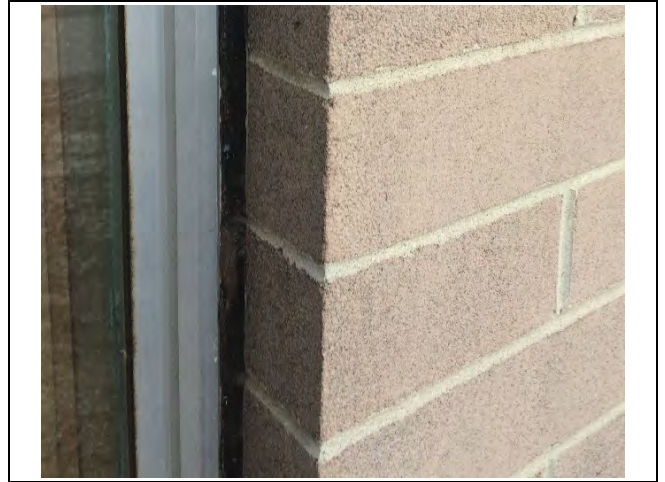
Photo 2: Asbestos-containing exterior window caulking – black (0.85% Chrysotile) near the main entrance.

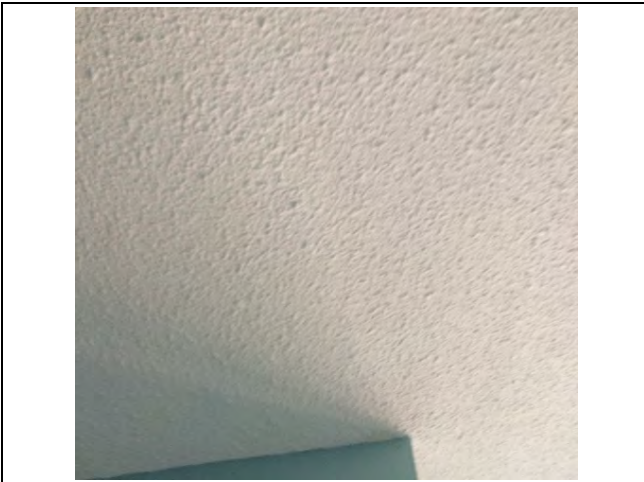
Photo 3: Asbestos-containing stucco (2% Chrysotile) observed to be in good condition on the ceiling in the 1<sup>st</sup> floor stairwell.

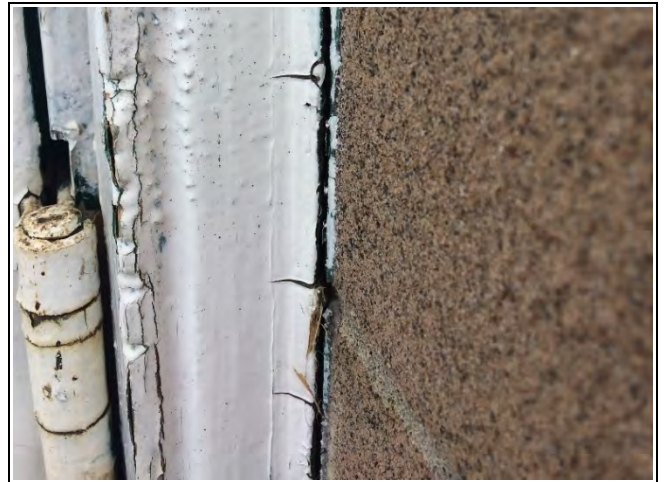
Photo 4: Asbestos-containing exterior caulking – dark brown (0.53% Chrysotile) at the back entrance door.

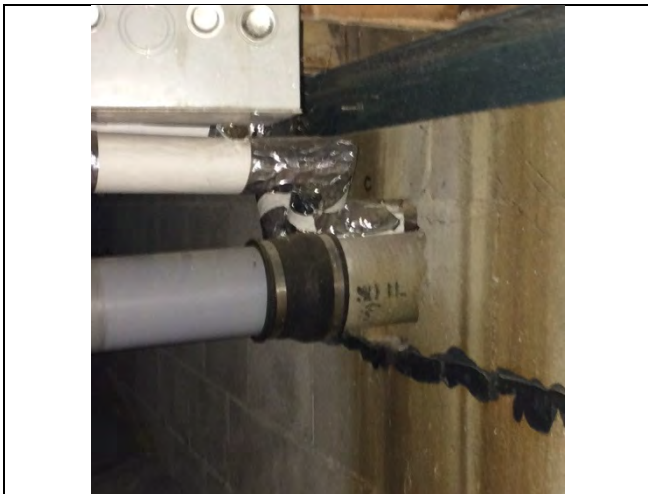
Photo 7: Presumed asbestos-containing cement pipe observed in the crawlspace.
