Asbestos Building Materials Assessment

150 Stone Street
Gananoque ON

Project No.: 122150275

February 14, 2017

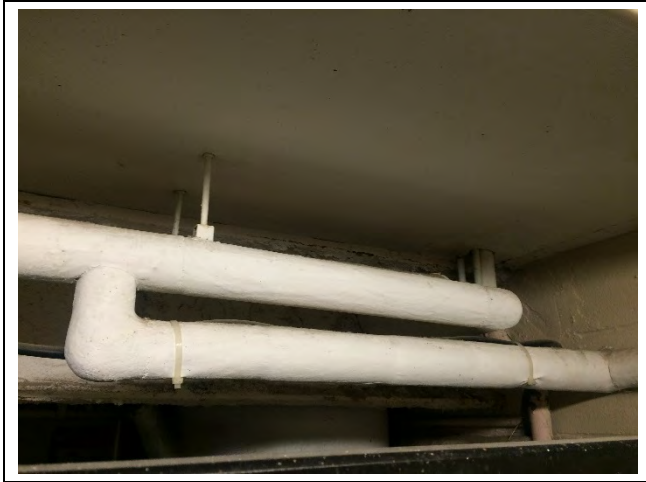
These materials were observed to be in good condition.

Photo 1: Insulating cement on pipe fittings identified to be asbestos-containing in the first floor garbage room (50% Chrysotile).

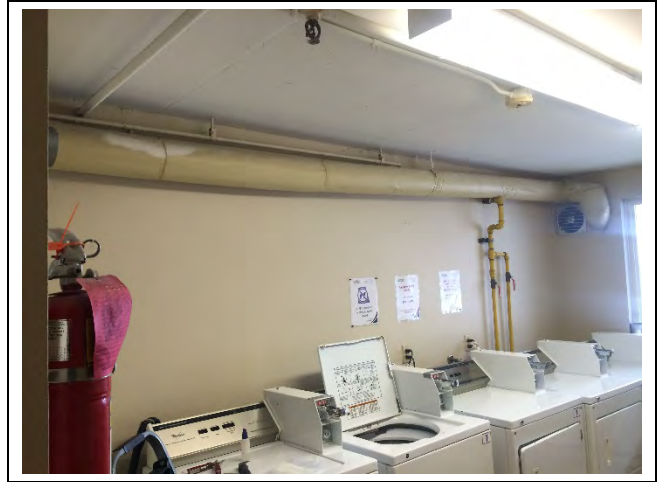
Photo 2: Corrugated paper-like straight pipe insulation identified to be asbestos-containing in the first floor laundry room (65% Chrysotile).
