Asbestos Building Materials Assessment

Multi-Residential Building
200 Bridge Street
Kemptville ON

Project No.: 122150275

February 16, 2017

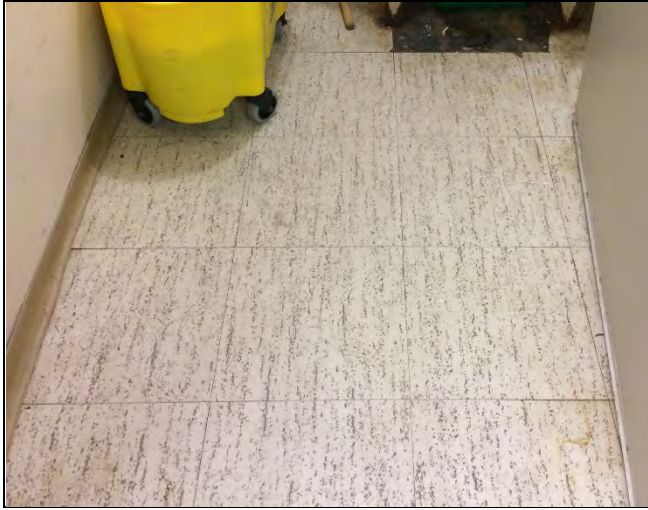
Mastic associated with 12"x12" vinyl floor tiles – beige with black dots was observed to be in poor condition in the custodian closet. The remaining materials were observed to be in good condition. It should be noted that drywall joint-fill compound is considered non-friable in its undisturbed state but can release fibers when damaged.

Photo 1: Asbestos-containing 12" x 12" vinyl floor tiles beige with black dots (2.41% Chrysotile) and associated mastic (0.95% Chrysotile) observed in the custodian's closet. The mastic was exposed at the right corner.

- Exposed asbestos-containing mastic associated with 12" x 12" vinyl floor tiles – beige with black dots should be covered with non-asbestos-containing vinyl floor tiles (recommended corrective action);

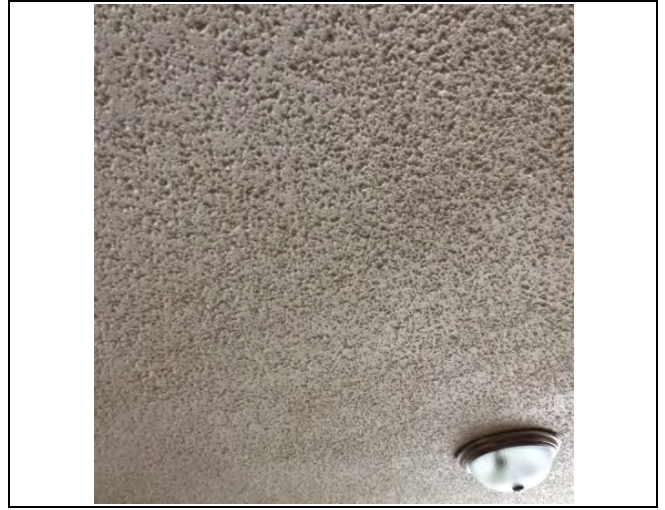
Photo 2: Asbestos-containing stucco - rough pattern (1% Chrysotile) on ceiling in the living room of unit 212.

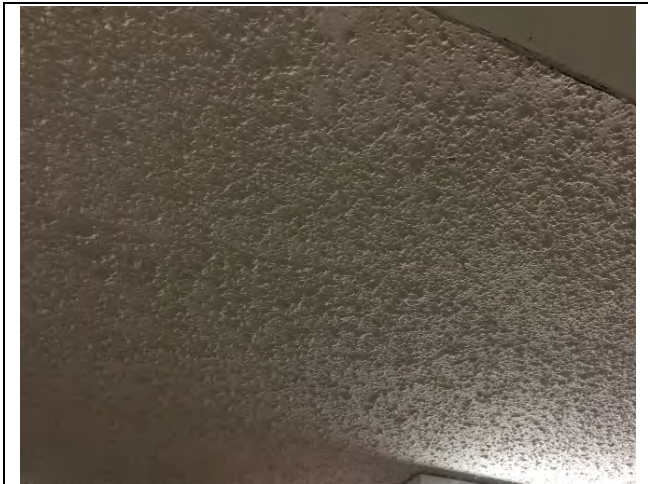
Photo 3: Asbestos-containing stucco - medium rough pattern (1% Chrysotile) on the ceiling in the 1st floor south stairwell.

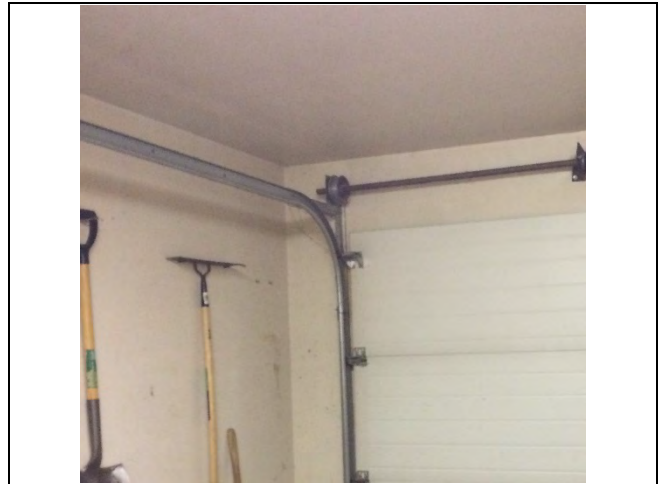
Photo 4: Asbestos-containing drywall joint-fill compound (1% Chrysotile) on the walls and ceiling in the garage.

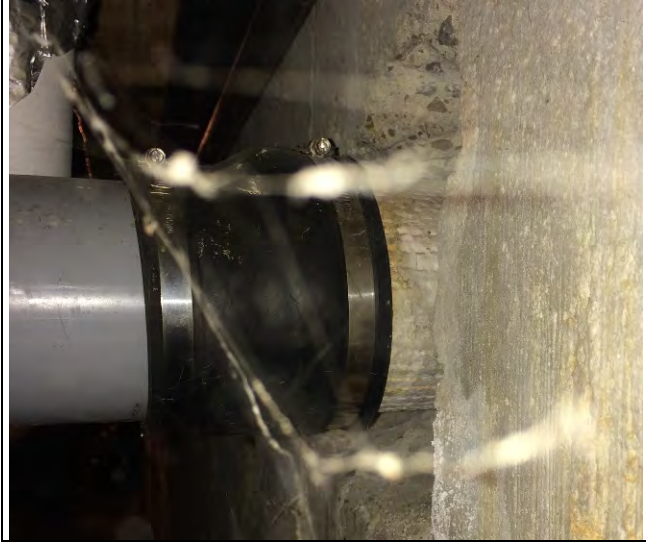
Photo 5: Presumed asbestos-containing cement pipe in the crawlspace.

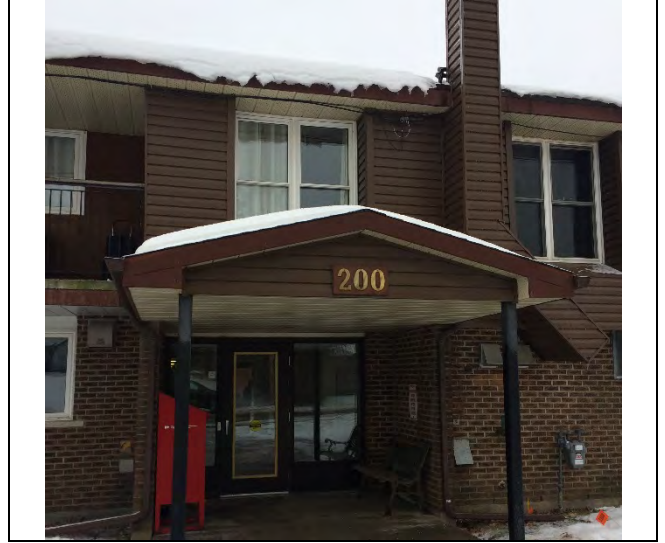
Photo 6: Presumed asbestos-containing brick mortar on exterior walls.

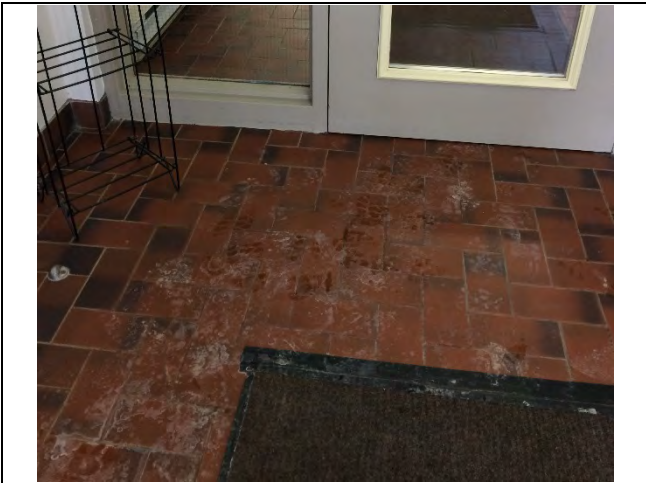
Photo 7: Presumed asbestos-containing ceramic tile grout and mortar/adhesive at the lobby and main entrance.

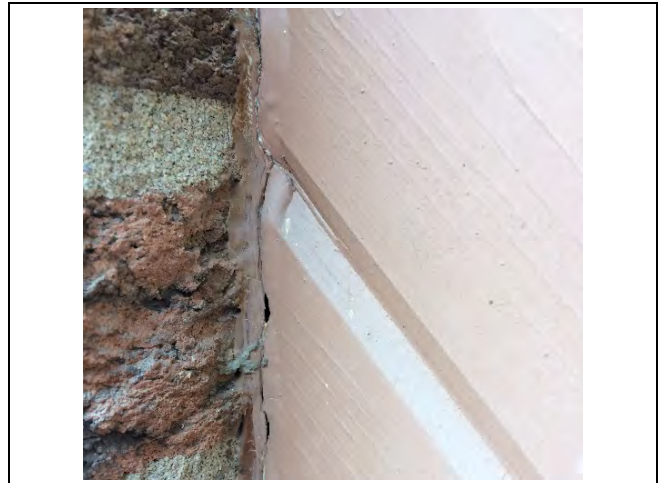
Photo 8: Presumed asbestos-containing exterior caulking – brown on the joint of the walls around the window of the lounge room.
