Asbestos Building Materials Assessment

Multi-Unit Residential Building
201-203 Prescott Street
Kemptville ON

Project No.: 122150275

February 17, 2017

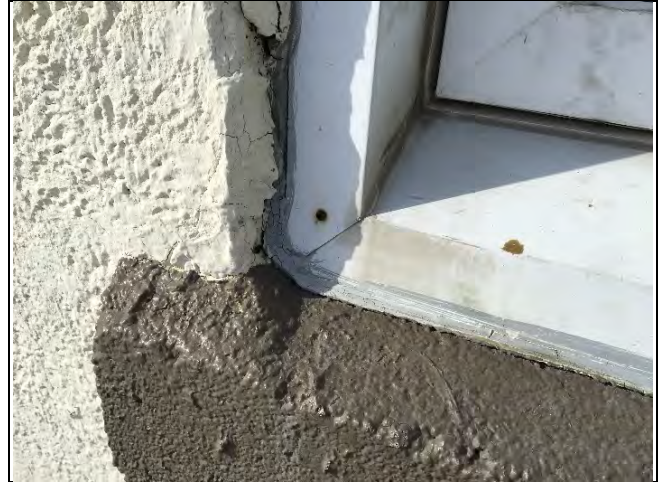
Photo 2: Presumed asbestos-containing exterior window caulking – grey observed at 203 Prescott Street.

- Prior to renovation and/or demolition activities that would disturb them, undertake testing of PACMs that may be impacted to determine their asbestos content. Confirmed asbestos materials should be handled accordingly;

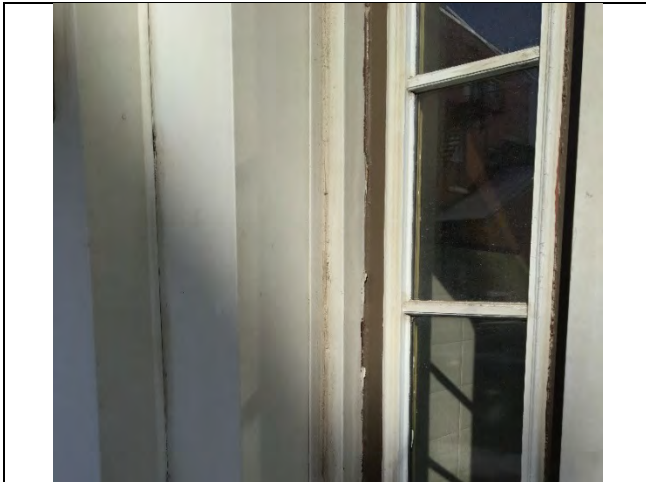
Photo 3: Presumed asbestos-containing exterior door caulking – white observed at 201 Prescott Street.

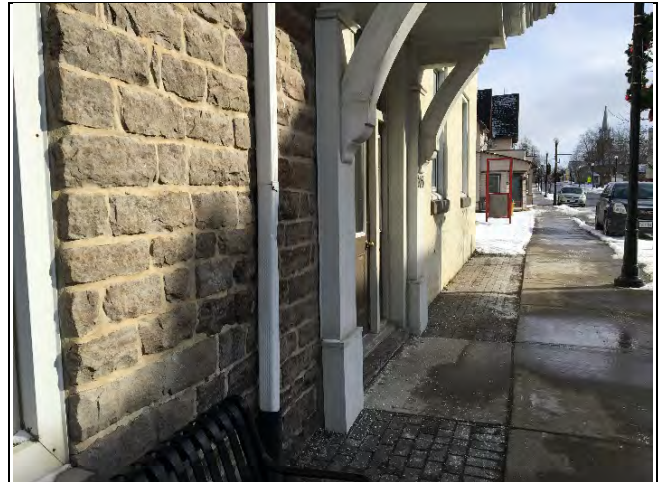
Photo 4: Presumed asbestos-containing brick mortar observed at the exterior of 201 Prescott Street.
