Asbestos Building Materials Assessment

Residential House
209 Victor Crescent
Prescott ON

Project No.: 122150275

February 14, 2017

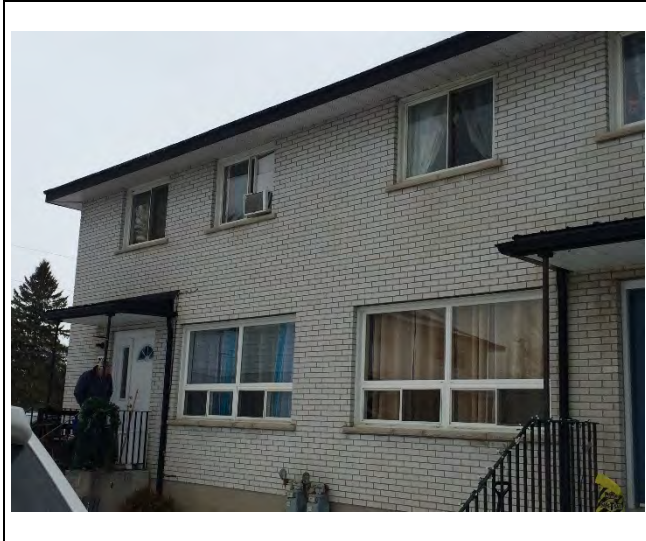
- Brick mortar;
- Roof caulking; and,
- Roofing materials.

These materials were observed to be in good condition. These materials were not sampled to preserve their integrity. As these materials are known to have been manufactured with asbestos,

Photo 1: Presumed asbestos-containing brick mortar, roofing materials and roof caulking was observed to be present on the exterior of the house.

- Prior to renovation and/or demolition activities that would disturb them, undertake testing of PACMs that may be impacted to determine their asbestos content. Confirmed asbestos materials should be handled accordingly;

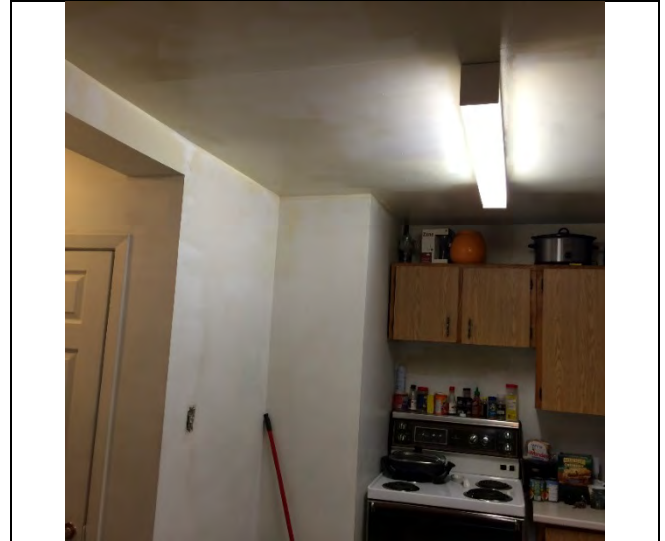
- Drywall joint-fill compound (non-friable).

This material was observed to be in good condition.

It should be noted that drywall joint-fill compound is considered non-friable in its undisturbed state but can release fibers when damaged.

Photo 2: Asbestos-containing drywall joint-fill compound was observed on walls and ceiling.

- Asbestos-containing materials that may be impacted during renovation and/or demolition activities should be removed prior to the renovation and/or demolition activities;
