Asbestos Building Materials Assessment

Multi-Residential Building
240 Helen Street
Cardinal ON

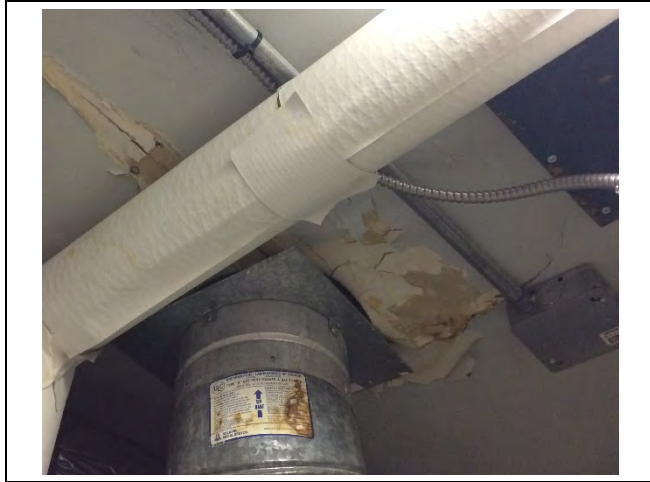
Photo 1: Asbestos-containing drywall joint-fill compound observed to be in poor condition on the ceiling in the hot water tank room located in the laundry room.

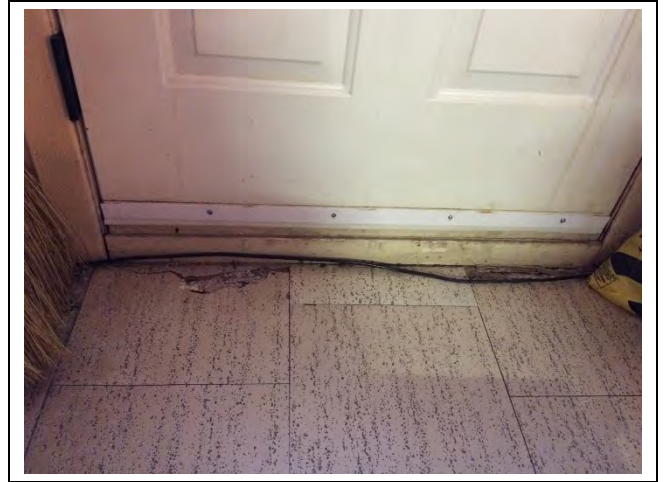
Photo 2: Asbestos-containing 12"x12" vinyl floor tile – beige with black dots observed to be in poor condition (cracked tiles) in the living room of Unit 108.

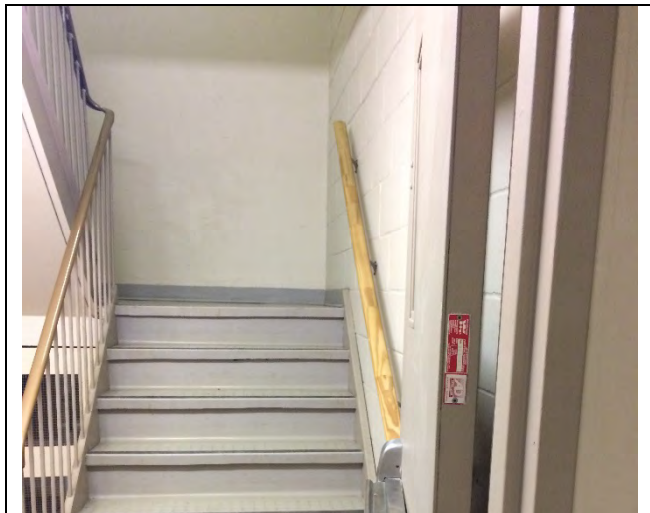
Photo 3: Presumed asbestos-containing fire rated door.

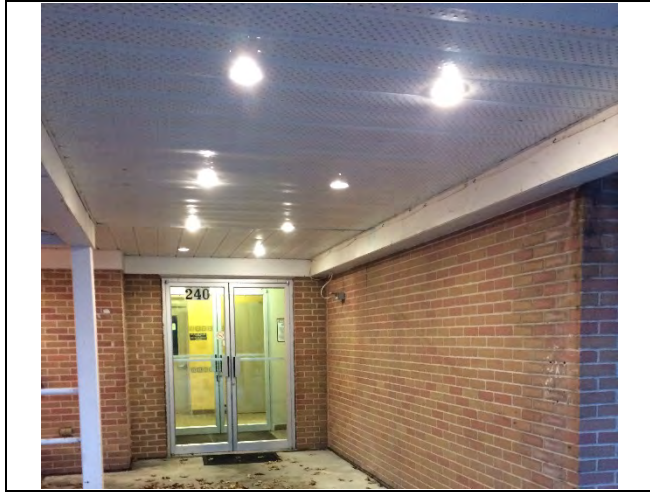
Photo 5: Presumed asbestos-containing brick mortar observed to be in good condition on the exterior walls
