## **Asbestos Building Materials Assessment**

Residential House  
256 Victor Road  
Prescott ON

Project No.: 122150275

February 16, 2017

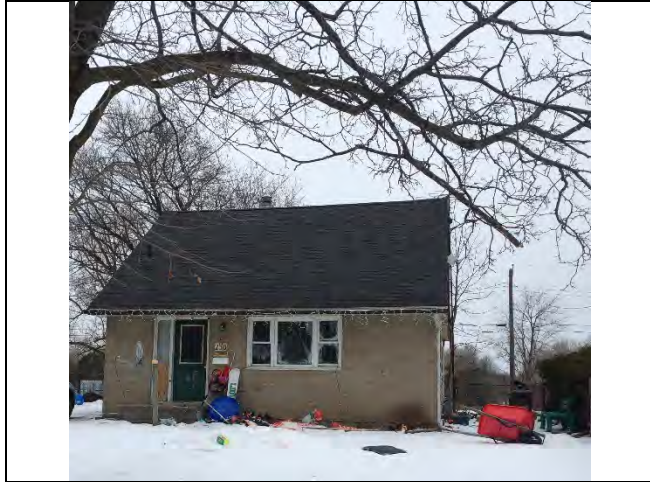
These materials were observed to be in good condition. These materials were not sampled to preserve their integrity. As these materials are known to have been manufactured with asbestos, they should be presumed to be asbestos-containing unless proven otherwise by laboratory analysis.

Photo 1: Presumed asbestos-containing brick mortar, roofing materials and roof caulking.

- Prior to renovation and/or demolition activities that would disturb them, undertake testing of PACMs that may be impacted to determine their asbestos content. Confirmed asbestos materials should be handled accordingly;

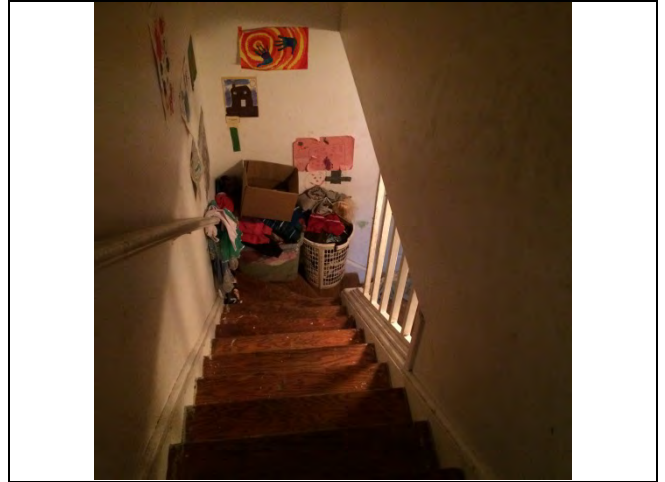
The material was observed to be in good condition. It should be noted that drywall joint-fill compound is considered non-friable in its undisturbed state but can release fibers when damaged.

Photo 2: Asbestos-containing drywall joint-fill compound on the 2<sup>nd</sup> floor stairwell.

- Asbestos-containing materials that may be impacted during renovation and/or demolition activities should be removed prior to the renovation and/or demolition activities;

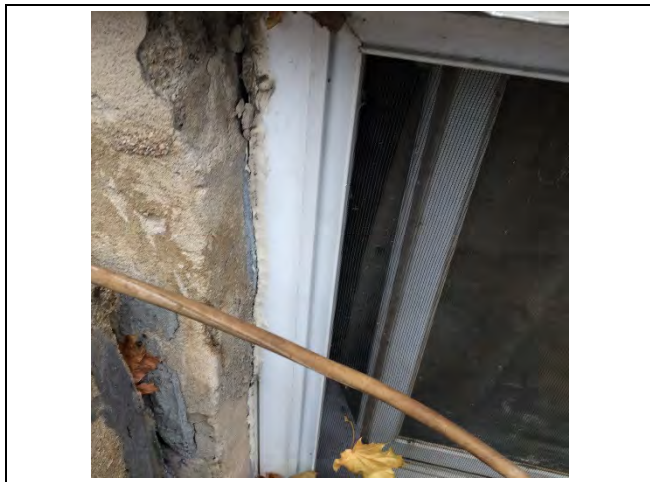
Photo 3: Presumed asbestos-containing exterior window caulking – white observed on exterior windows.
