Asbestos Building Materials Assessment

Residential House
258 Roberta Crescent
Prescott ON

Project No.: 122150275

February 16, 2017

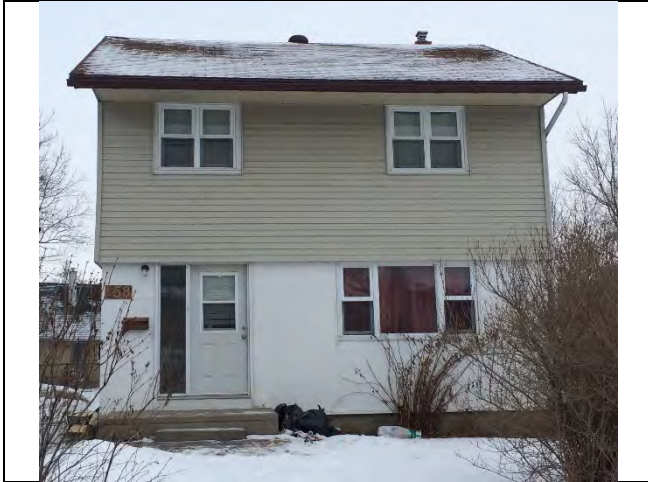
The exterior texture coat was observed to be cracking and chipping (5m²) on the west wall with debris on the ground. The remaining material was observed to be in good condition.

Photo 1: Asbestos-containing exterior texture coat on exterior of house.

- Damaged asbestos-containing exterior texture coat should be repaired and debris cleaned up following type 1 abatement procedures;
- Damaged asbestos-containing textured materials debris (recommended corrective action), should be removed from the exterior;

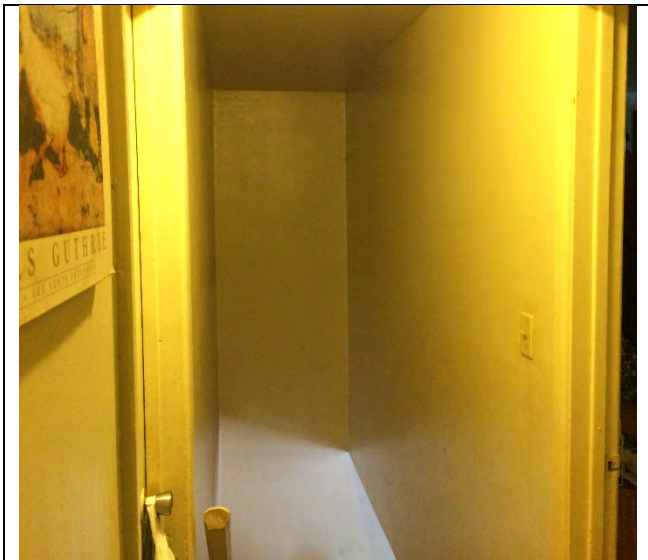
It should be noted that drywall joint-fill compound is considered non-friable in its undisturbed state but can release fibers when damaged.

Photo 3: Asbestos-containing drywall joint-fill compound on the stairwell walls.
