## **Asbestos Building Materials Assessment**

Multi-Unit Residential Building  
275 Water Street  
Prescott ON

Project No.: 122150275

February 16, 2017

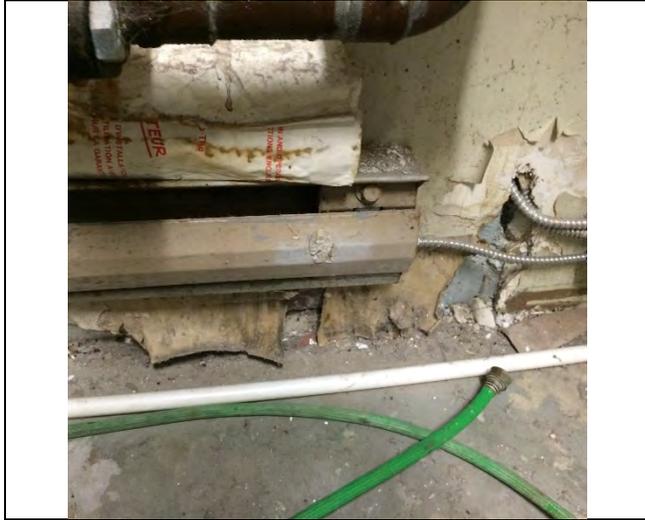
Drywall joint-fill compound was observed to be in damaged in the lounge (<1 sq. m of water damage) and the mechanical room (8 sq. m of water damage). The remaining materials were observed to be in good condition. It should be noted that drywall joint-fill compound is considered non-friable in its undisturbed state but can release fibers when damaged.

Photo 1: Asbestos-containing drywall joint-fill compound (1% Chrysotile) observed to be damaged in the mechanical room.

- Damaged asbestos-containing drywall joint-fill compound, should be removed following Type 2 procedures;
- Asbestos-containing materials that may be impacted during renovation or demolition activities should be removed prior to the renovation or demolition activities;

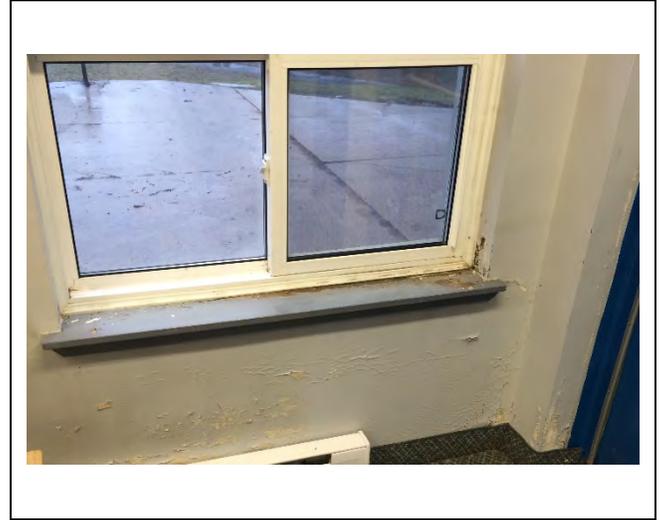
Photo 2: Asbestos-containing drywall joint-fill compound (1% Chrysotile) observed to be damaged in the lounge.

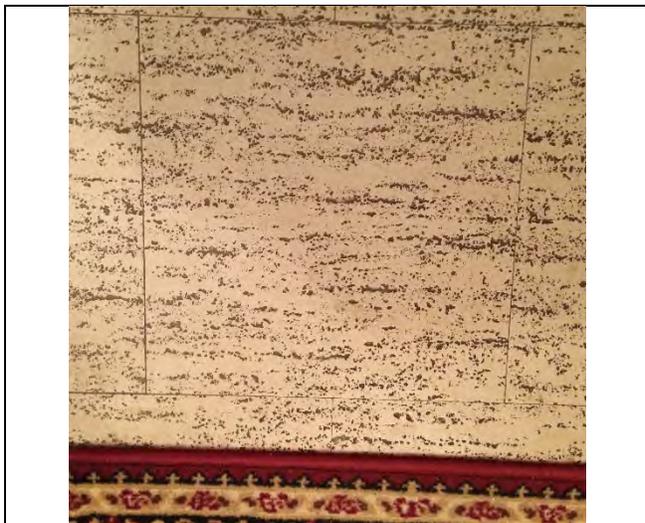
Photo 3: 12"x12" vinyl floor tile – beige with grey specks identified to be asbestos-containing (4.08% Chrysotile).

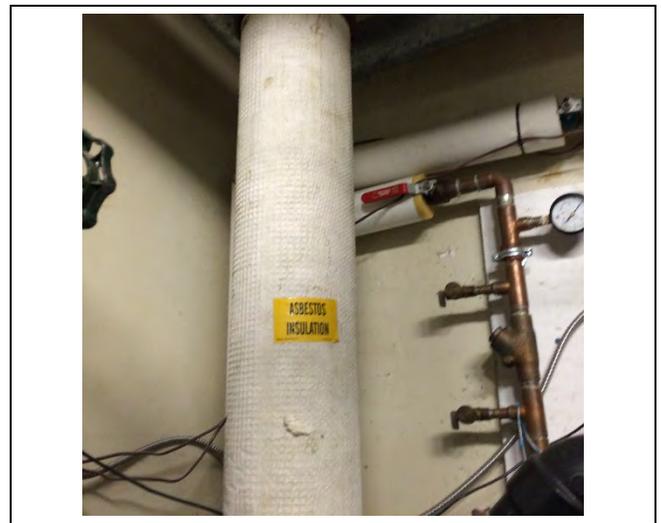
Photo 4: Cement pipe presumed to be asbestos-containing in the mechanical room.

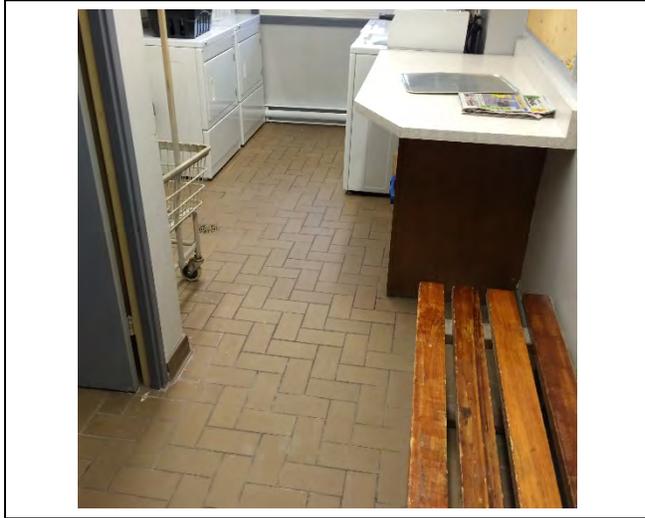
Photo 5: Ceramic tile grout and mortar/adhesive presumed to be asbestos-containing.

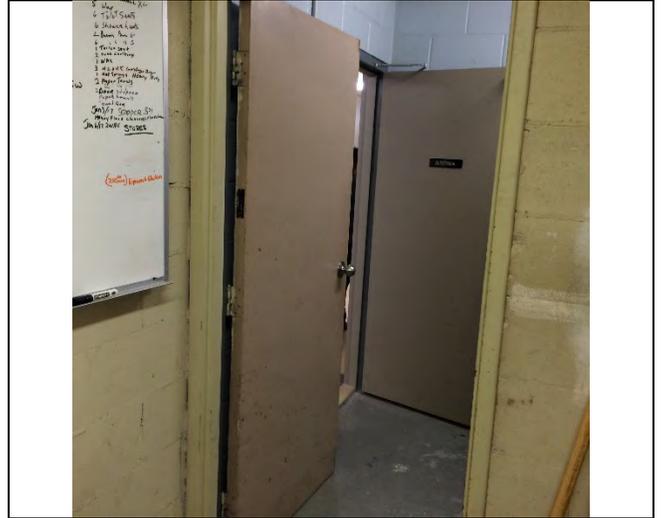
Photo 6: Fire rated doors – metal, presumed to be asbestos-containing.
