Asbestos Building Materials Assessment

Row Houses
280 and 284 Bartholomew Street
Brockville ON

Project No.: 122150275

March 2, 2017

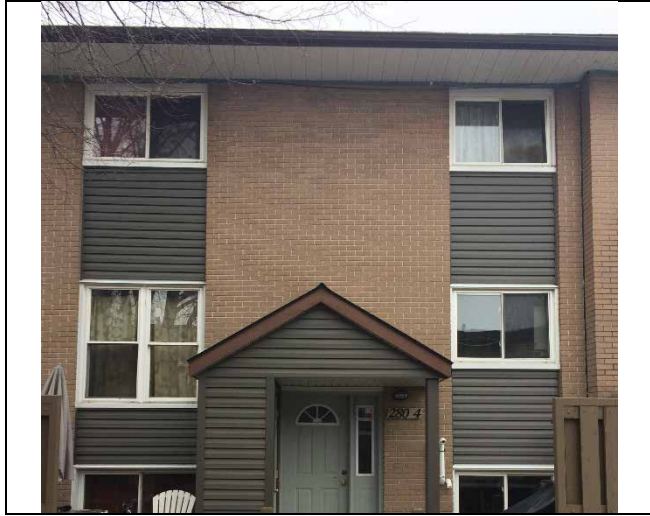
Photo 1: Presumed asbestos-containing brick mortar observed to be in good condition on the exterior walls at 280 Bartholomew Street Unit #4.

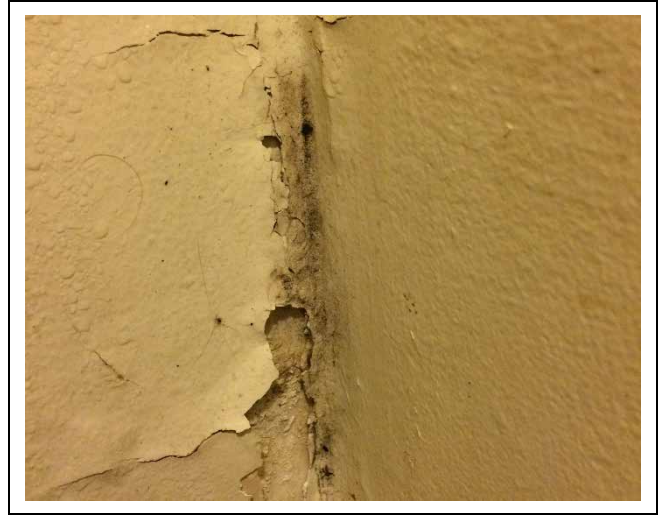
Drywall joint-fill compound at 280 Bartholomew Street Unit#4 was observed to be in poor condition (1 sq. m, suspect mould with drywall joint-fill compound and paper exposed) on the foyer wall.

It should be noted that drywall joint-fill compound is considered non-friable in its undisturbed state but can release fibers when damaged.

Photo 2: Asbestos-containing drywall joint-fill compound observed to be in poor condition on the wall in the foyer at 280 Bartholomew Street Unit #4.

- Damaged asbestos-containing drywall joint-fill compound at 280 Bartholomew Street unit #4 on the foyer wall (recommended corrective action), should be repaired following Type 2 procedures.

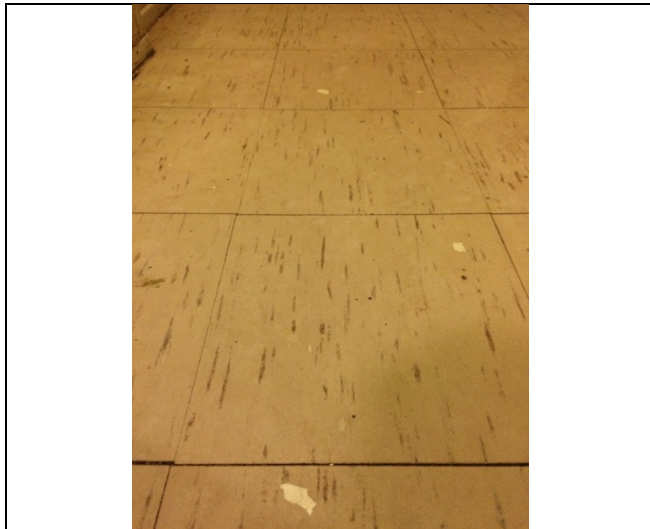
Photo 3: Asbestos-containing 12"x12" vinyl floor tiles – brown with brown streaks observed to be in good condition on the upper level landing at 280 Bartholomew Street Unit #4.

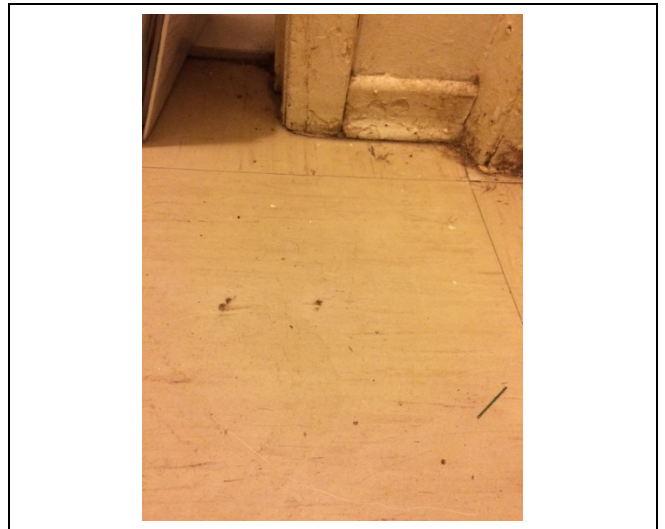
Photo 4: Asbestos-containing 12"x12" vinyl floor tiles – beige with brown streaks observed to be in good condition on the basement landing at 280 Bartholomew Street Unit #4.

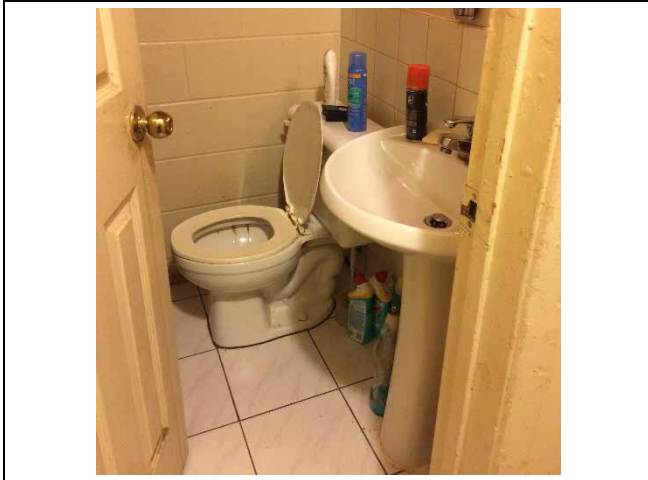
Photo 5: Presumed asbestos-containing ceramic tile grout and mortar/adhesive observed to be in good condition on the walls and floor of the basement level washroom.

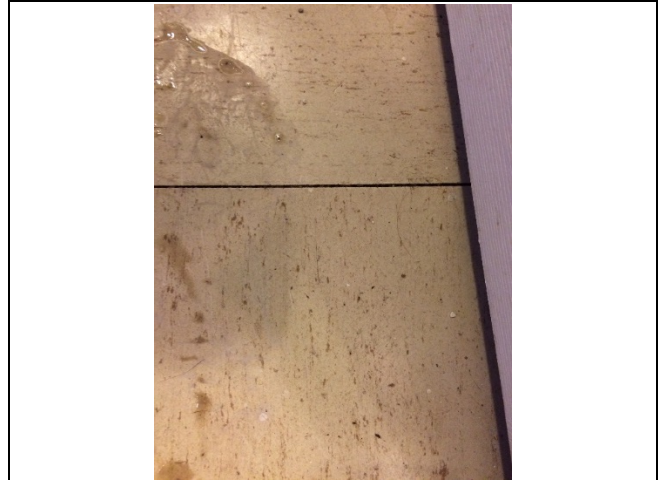
Photo 6: Asbestos-containing 12"x12" vinyl floor tiles – beige with black flecks observed to be in good condition on the basement landing at 280 Bartholomew Street Unit #8.

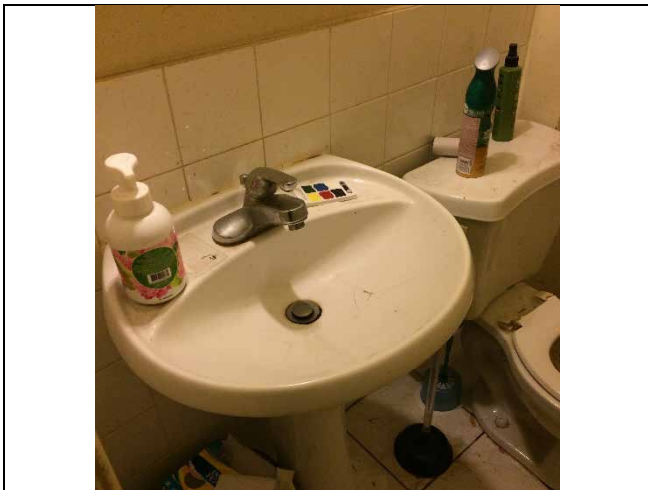
Photo 7: Asbestos-containing drywall joint-fill compound on the walls and presumed asbestos-containing ceramic tile grout and mortar/adhesive on the walls and floor in the washroom, observed to be in good condition at 284 Bartholomew Street Unit #4.
