Asbestos Building Materials Assessment

Multi-Unit Residential Building
3 Miller Drive
Mallorytown ON

Project No.: 122150275

February 15, 2017

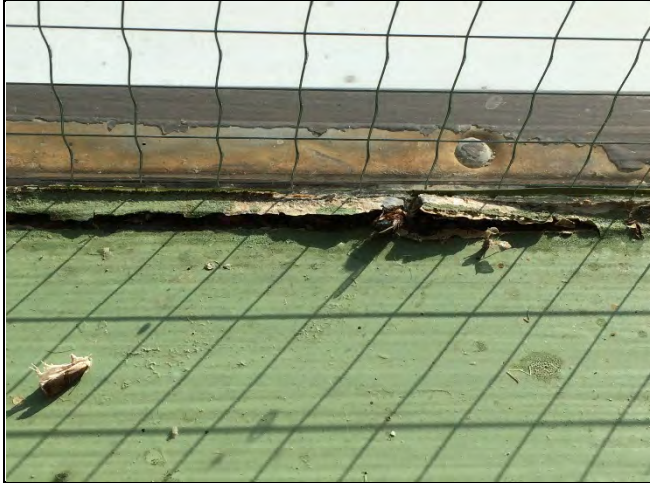
Interior glazing compound – white was observed to be in poor condition (cracking and lifting at the west stairwell). The remaining materials were observed to be in good condition.

Photo 1: Asbestos-containing interior glazing compound – white was observed to be in poor condition at the west stairwell.

- Damaged asbestos-containing interior window glazing compound – white (recommended corrective action), should be removed;
- Asbestos-containing materials that may be impacted during renovation and/or demolition activities should be removed prior to the renovation and/or demolition activities;

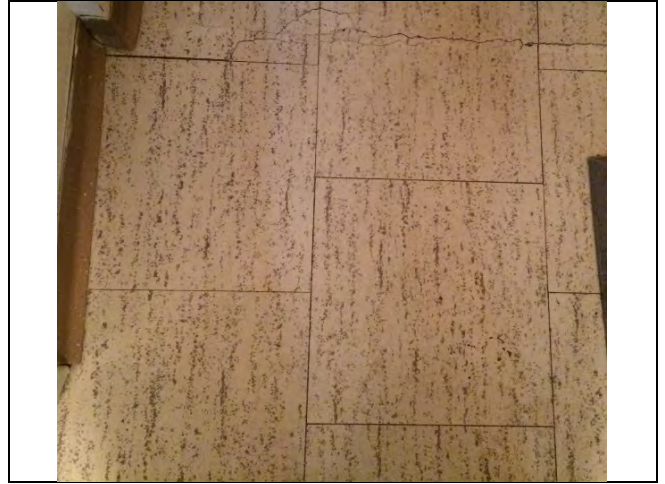
Photo 2: Asbestos-containing 12"x12" vinyl floor tile – beige with grey specks was observed in unit 209 hallway.

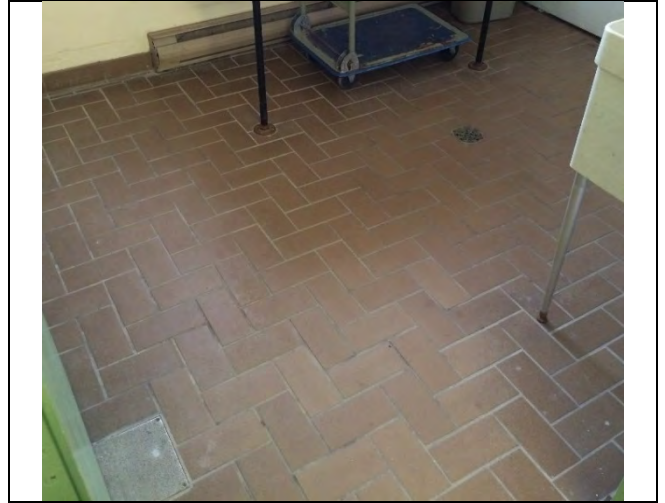
Photo 6: Presumed asbestos-containing ceramic tile grout and mortar / adhesive was observed in the 1st floor laundry room.
