Asbestos Building Materials Assessment

Multi-Residential Building
318 Brock Street
Merrickville ON

Project No.: 122150275

February 16, 2017

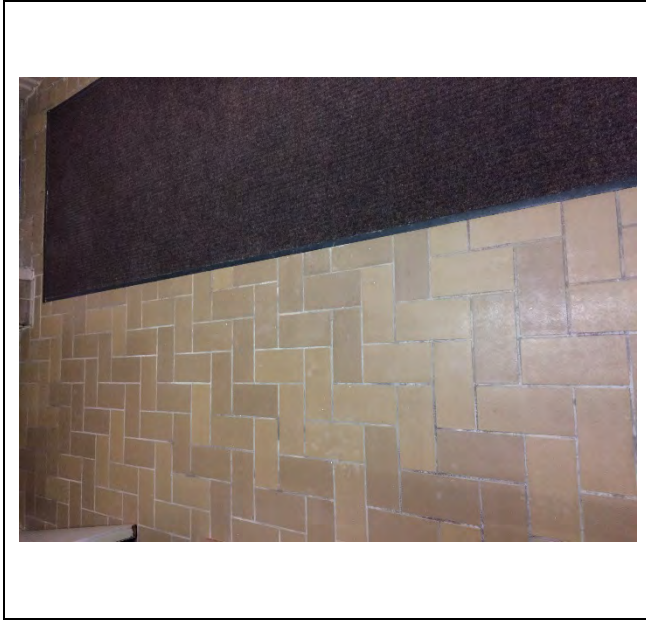
Photo 5: Presumed asbestos-containing ceramic tile grout and mortar/adhesive observed to be in good condition in the lobby.

- Prior to renovation and/or demolition activities that would disturb them, undertake testing of PACMs that may be impacted to determine their asbestos content. Confirmed asbestos materials should be handled accordingly;

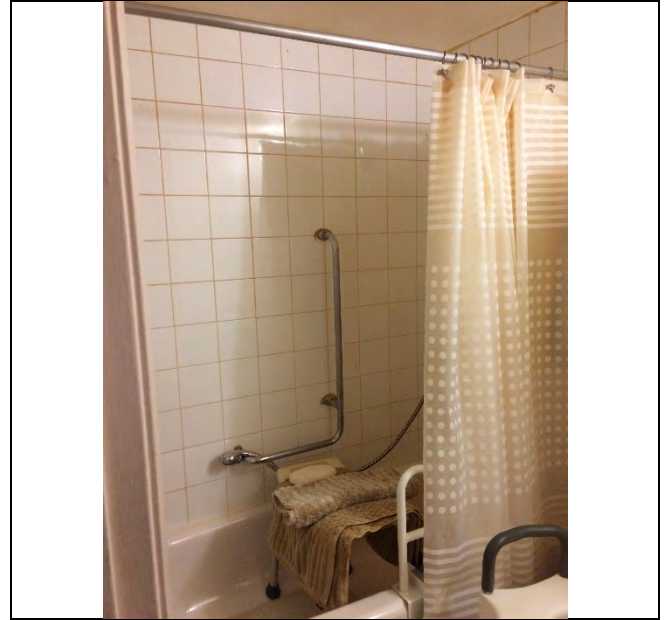
Photo 6: Presumed asbestos-containing ceramic tile grout and mortar/adhesive observed to be in good condition on walls in the washroom at unit 103.
