## **Asbestos Building Materials Assessment**

Multi-Unit Residential Building  
33 Bennett Street  
Brockville ON

Prepared by:  
Stantec Consulting Ltd.  
400-1331 Clyde Avenue  
Ottawa ON K2C 3G4

February 17, 2017

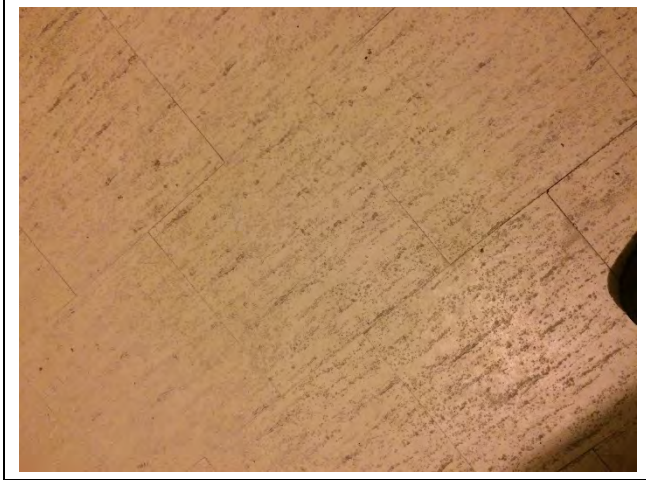
Photo 1: Asbestos-containing 12" x 12" vinyl floor tiles – beige with dots observed to be in good condition in the foyer of unit 107.

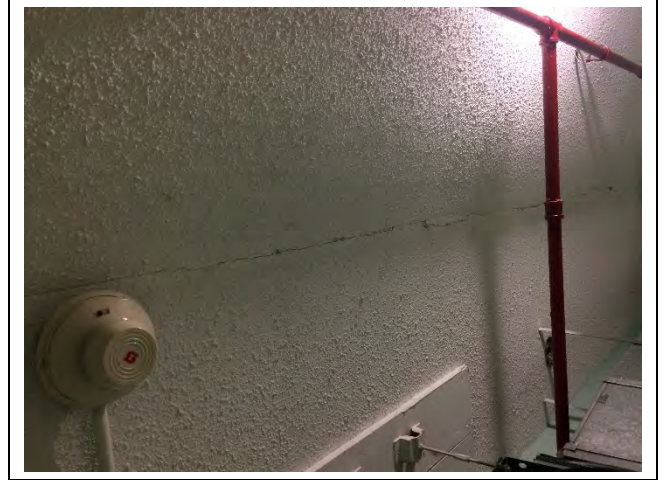
Stucco observed to be in poor condition (cracking, 2 m) in the 2<sup>nd</sup> floor laundry room.

| Level | Room | Specific Location | ACM Location | ACM Type | Estimated Quantity | Sample Number | Original Sample? | Asbestos Content | Friable? | Visible? | Access. | ACM Condition | Comments/ Notes |
|---|---|---|---|--|---|---|---|---|---|---|---|---|---|
| 2 | Laundry Room | Ceiling and Bulkhead | Ceiling and Bulkhead | Stucco | 25 sq.m | Ref: 33-BS-01A | No | 1% Chrysotile | No | Yes | C | good | MINOR CRACKING OBSERVED |

Photo 2: Asbestos-containing texture material observed to be cracking in the 2<sup>nd</sup> floor laundry room ceiling.

- Damaged asbestos-containing stucco should be repaired following Type 2 procedures;
- Loose asbestos-containing exterior caulking – brown should be removed and repaired following Type 1 procedures;

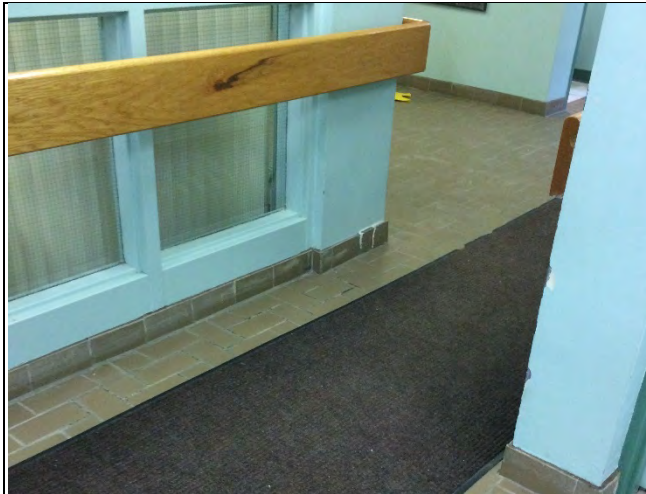
Photo 3: Asbestos-containing drywall joint-fill compound on the walls and presumed asbestos-containing ceramic tile grout and mortar/adhesive on baseboards and floor observed to be in good condition in the 1<sup>st</sup> floor corridor.

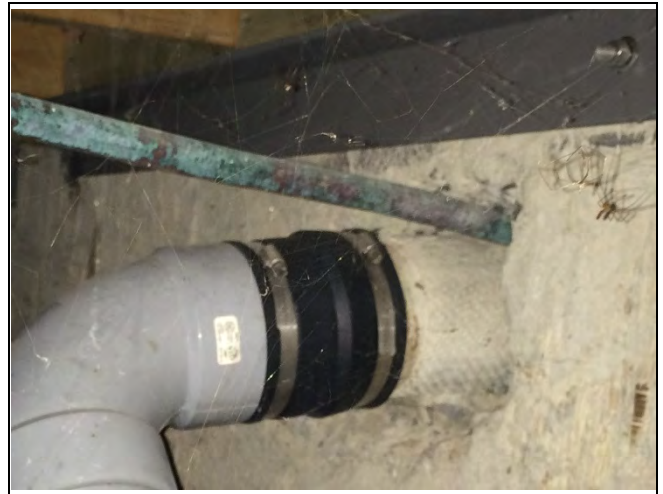
Photo 4: Presumed asbestos-containing cement pipe observed to be in good condition in the crawlspace.
