## **Asbestos Building Materials Assessment**

Multi-Residential Building  
43 Centre Street  
Lansdowne ON

Project No.: 122150275

February 15, 2017

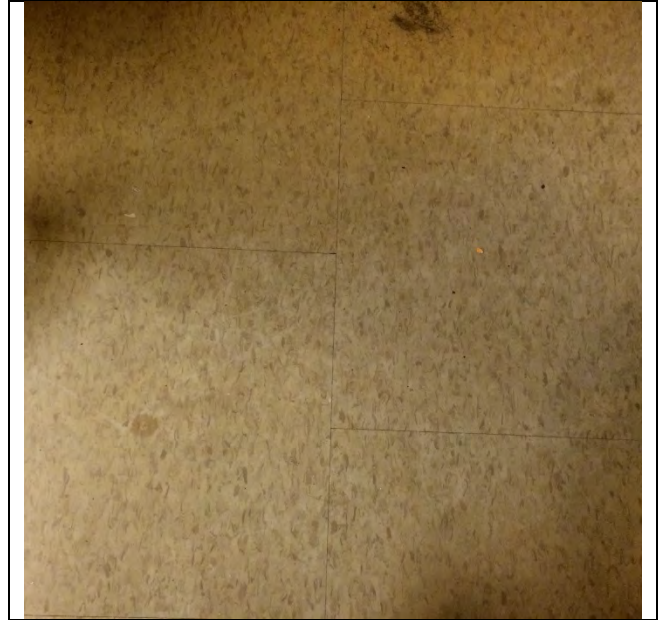
Photo 2: 12"x12" vinyl floor tile – beige with grey specks identified to be asbestos-containing in Unit 207 (2.22% Chrysotile).

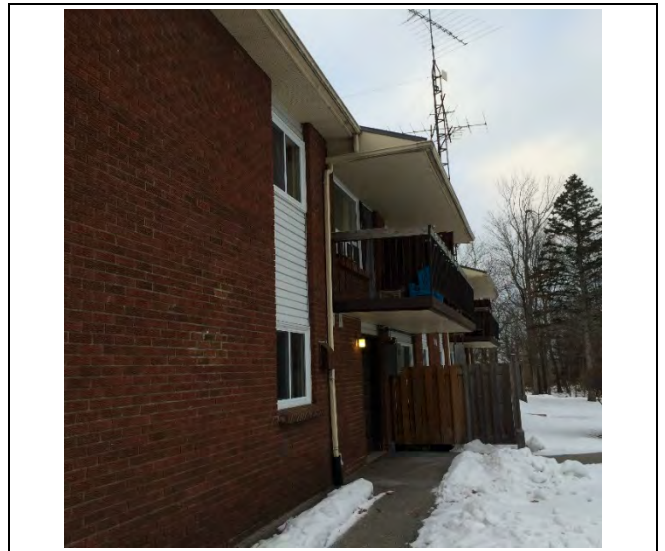
Photo 4: Brick mortar presumed to be asbestos-containing.

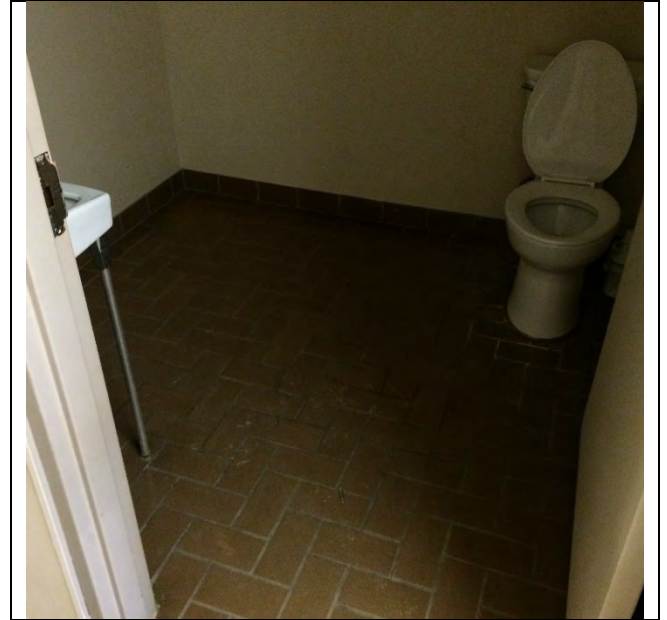
Photo 6: Ceramic tile grout and mortar/adhesive are presumed to be asbestos-containing in the washroom.
