Asbestos Building Materials Assessment

Row Houses
5 ½ Glengarry Road, Units F and L
Brockville ON

Project No.: 122150275

February 15, 2017

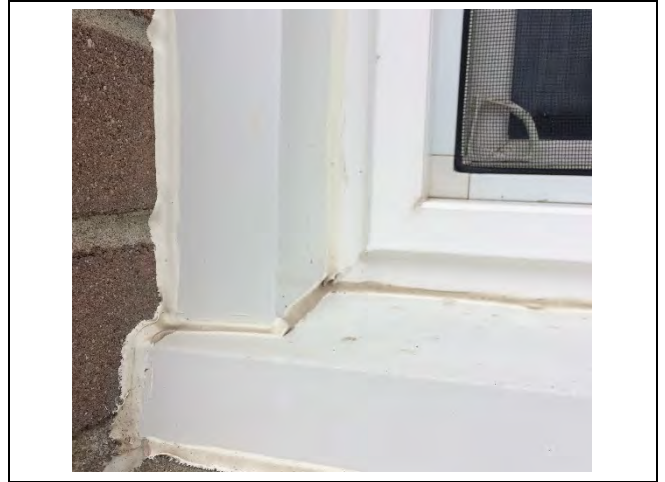
Photo 2: Presumed asbestos-containing exterior window caulking at Unit F.

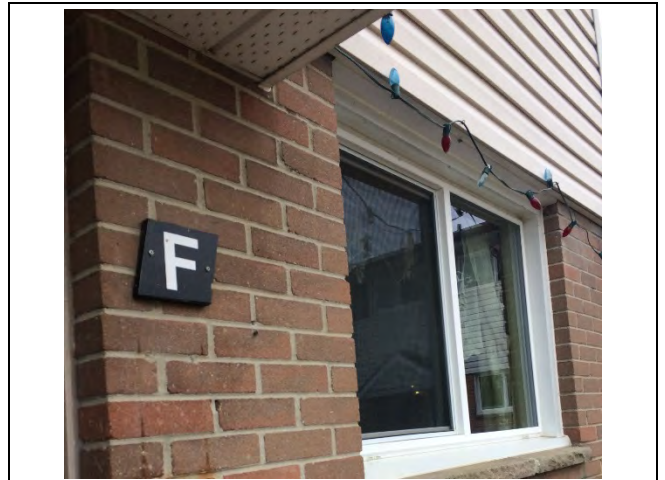
Photo 4: Presumed asbestos-containing brick mortar was observed on exterior walls at Unit F.

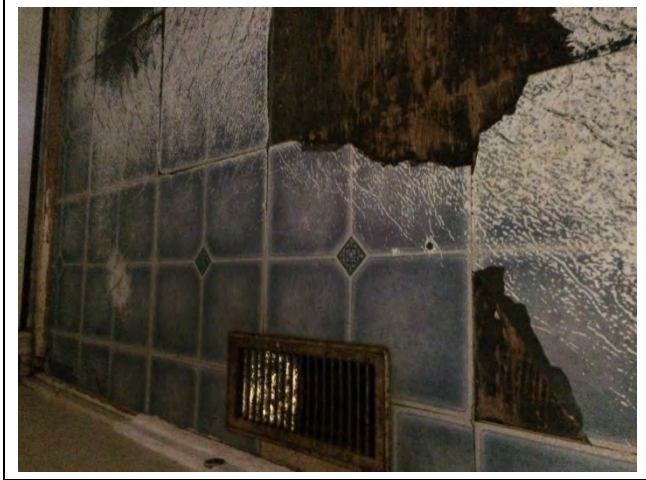
Photo 5: Asbestos-containing 12" x 12" vinyl floor tile – beige with brown streaks was observed to be present under peel and stick tiles in the 1st floor hallway in Unit L.
