Asbestos Building Materials Assessment

Multi-Unit Residential Building
523 Hyde Street
Prescott ON

Project No.: 122150275

February 17, 2017

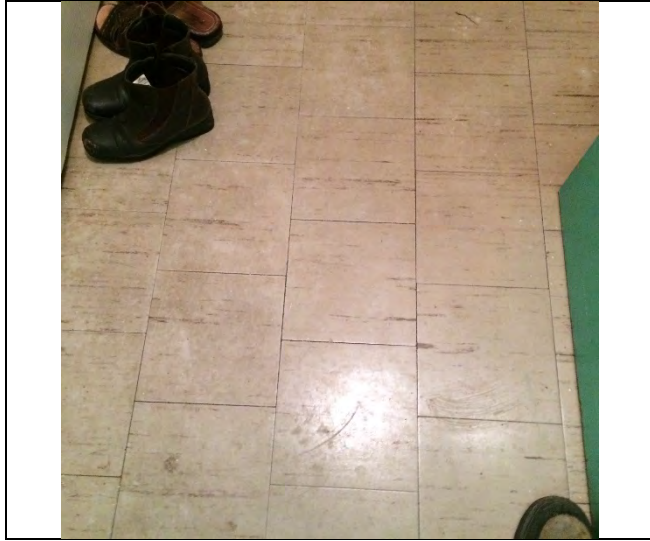
Photo 1: 9"x9" vinyl floor tile – grey with brown streaks is identified to be asbestos-containing (1.52% Chrysotile).

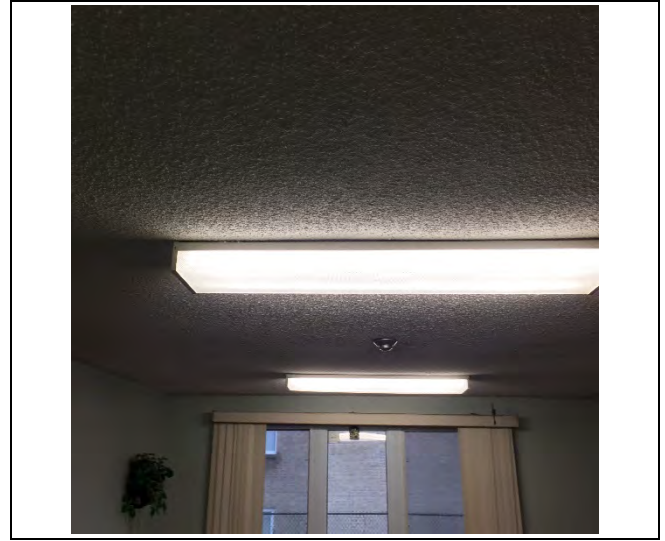
Photo 2: Stucco on ceilings is identified to be asbestos-containing (3% Chrysotile).

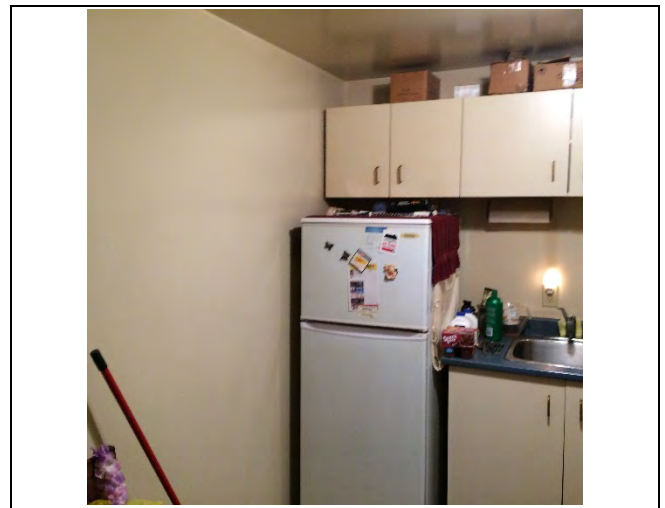
Drywall joint-fill compound was observed to be in poor condition (<1 sq. m chipped) in the front entrance lobby. The remaining materials were observed to be in good condition. It should be noted that drywall joint-fill compound is considered non-friable in its undisturbed state but can release fibers when damaged.

Photo 4: Drywall joint-fill compound is identified to be asbestos-containing (1% Chrysotile).

- Damaged asbestos-containing drywall joint-fill compound should be repaired following type 1 abatement procedures;
- Asbestos-containing materials that may be impacted during renovation or demolition activities should be removed prior to the renovation or demolition activities;

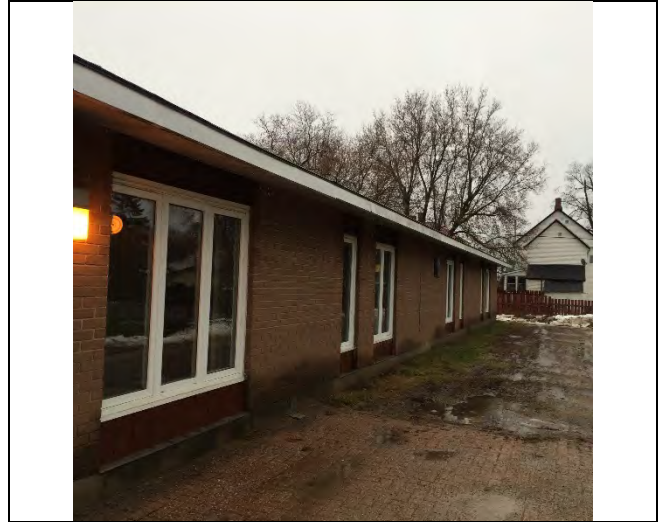
Photo 6: Exterior window caulking – white is presumed to be asbestos-containing.

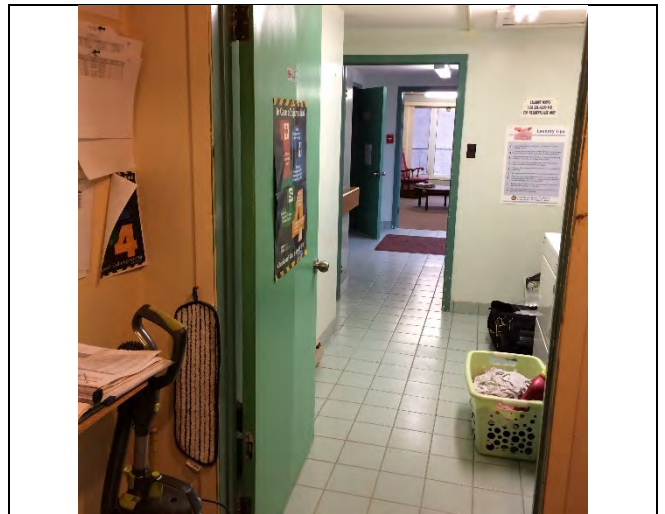
Photo 8: Fire rated door – wood is presumed to be asbestos-containing.
