Asbestos Building Materials Assessment

Residential Dwelling
527 Edward Street
Prescott ON

Project No.: 122150275

February 15, 2017

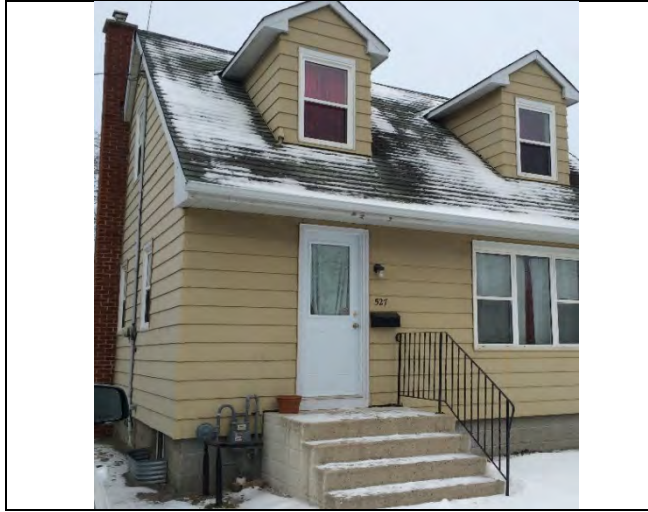
Photo 1: Presumed asbestos-containing roofing materials and roof caulking was observed to be present.

- Prior to renovation and/or demolition activities that would disturb them, undertake testing of PACMs that may be impacted to determine their asbestos content. Confirmed asbestos materials should be handled accordingly;

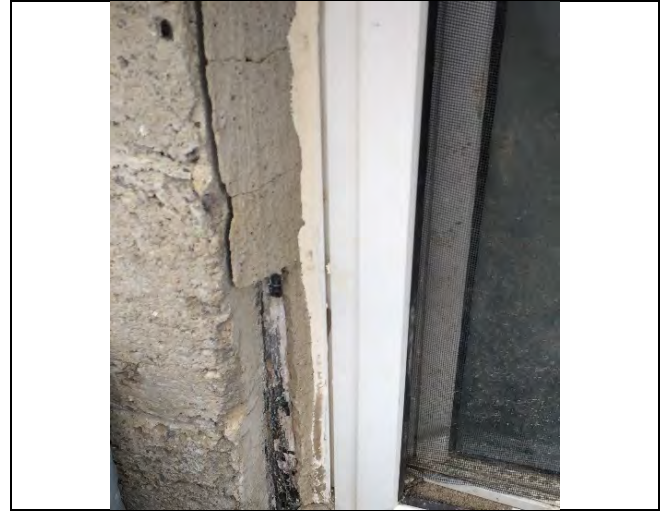
Photo 2: Presumed asbestos-containing exterior window and door caulking – white was observed to be in good condition on the exterior window.
