## **Asbestos Building Materials Assessment**

Residential House  
535 Churchill Road  
Prescott, ON

Project No.: 122150275

February 15, 2017

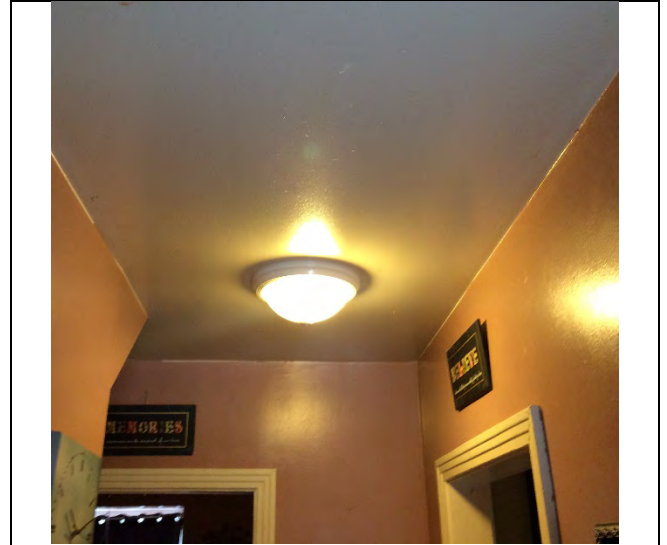
It should be noted that drywall joint-fill compound is considered non-friable in its undisturbed state but can release fibers when damaged.

Photo 2: Asbestos-containing drywall joint-fill compound (1% Chrysotile).

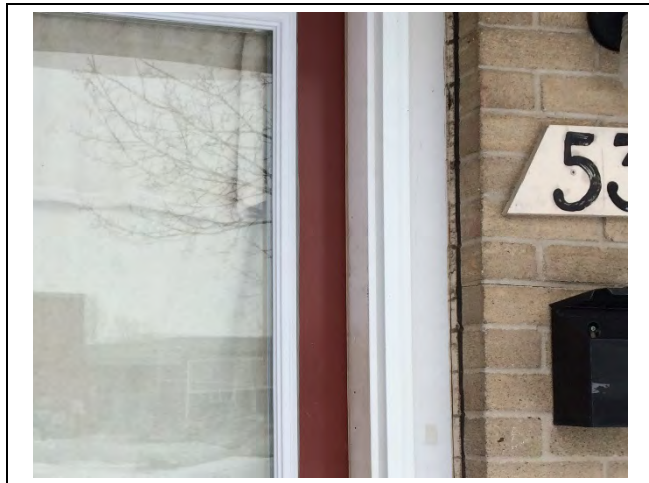
Photo 3: Asbestos-containing exterior door caulking – black (3.1% Chrysotile).

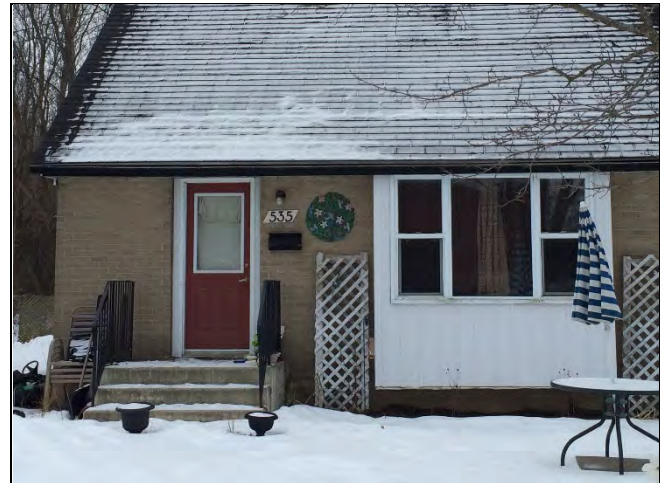
Photo 4: Presumed asbestos-containing brick mortar, roofing materials, and roof caulking.
