## **Asbestos Building Materials Assessment**

Multi-Residential Building  
55 Reynolds Drive  
Brockville ON

Project No.: 122150275

February 15, 2017

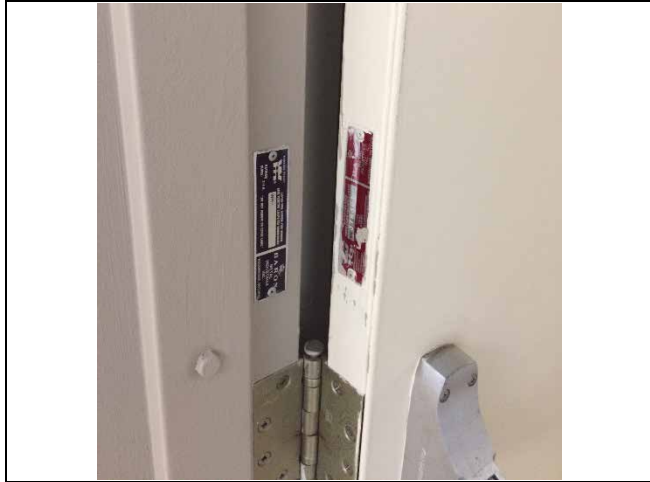
These materials were observed to be in good condition. These materials were not sampled to preserve their integrity. As these materials are known to have been manufactured with asbestos, they should be presumed to be asbestos-containing unless proven otherwise by laboratory analysis.

Photo 1: Presumed asbestos-containing fire rated door.

- Prior to renovation and/or demolition activities that would disturb them, undertake testing of PACMs that may be impacted to determine their asbestos content. Confirmed asbestos materials should be handled accordingly;

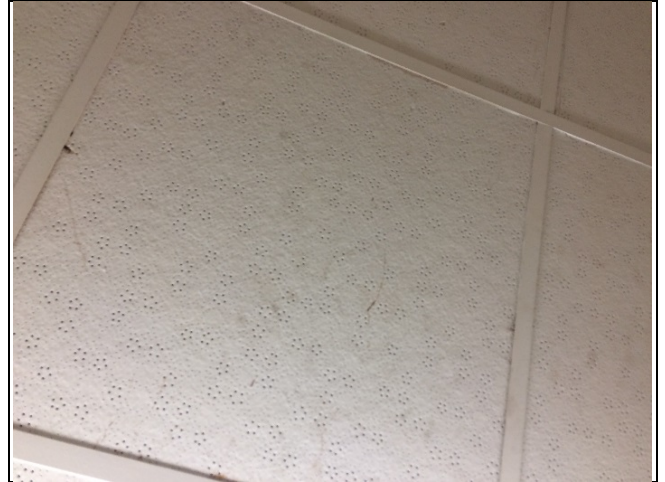
This material was observed to be in good condition.

Photo 2: Asbestos-containing 2'x2' acoustic ceiling tile – large and small pinholes.

- Asbestos-containing materials that may be impacted during renovation and/or demolition activities should be removed prior to the renovation and/or demolition activities;

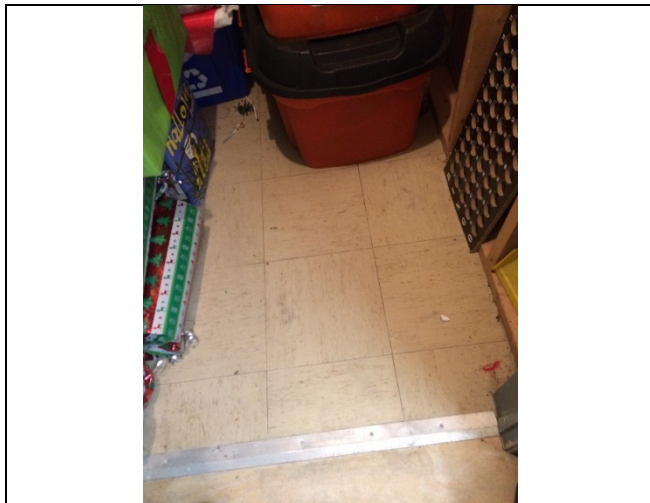
These materials were observed to be in good condition.

Photo 3: Asbestos-containing 12" x12" vinyl floor tiles – beige with brown streaks in the tenant storage under the stairwell.

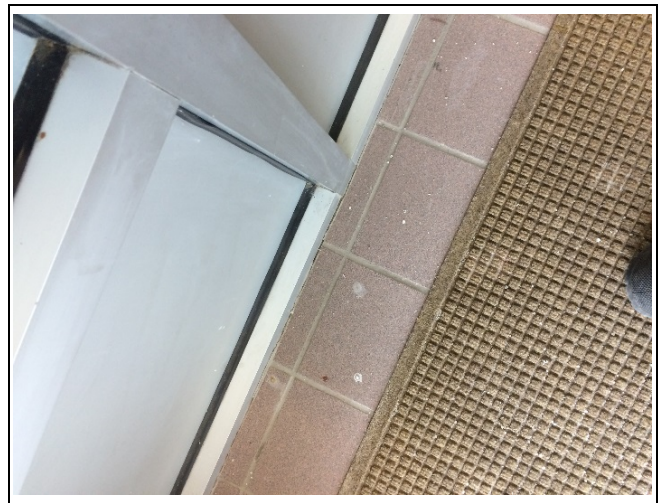
Photo 4: Presumed asbestos-containing ceramic tile grout and mortar/adhesive at the main entrance.
