## **Asbestos Building Materials Assessment**

Multi-Residential Building  
56 Bedford Street  
Westport ON

Project No.: 122150275

February 17, 2017

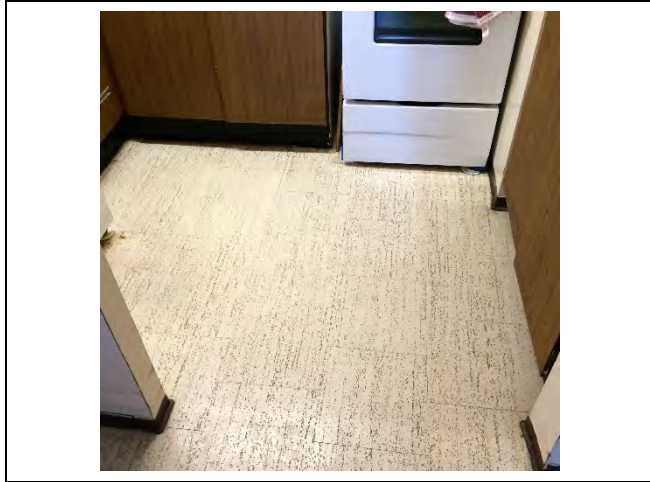
These materials were observed to be in good condition. It should be noted that drywall joint-fill compound is considered non-friable in its undisturbed state but can release fibers when damaged.

Photo 1: 12"x12" vinyl floor tile – beige with grey specks identified to be asbestos-containing in Unit 101 (1.45% Chrysotile).

- Asbestos-containing materials that may be impacted during renovation or demolition activities should be removed prior to the renovation or demolition activities;

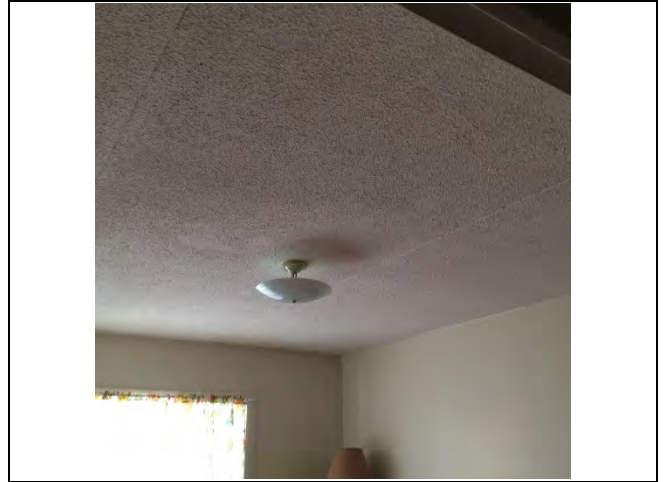
This material was observed to be in good condition.

Photo 2: Stucco identified to be asbestos-containing in Unit 210 (3% Chrysotile).

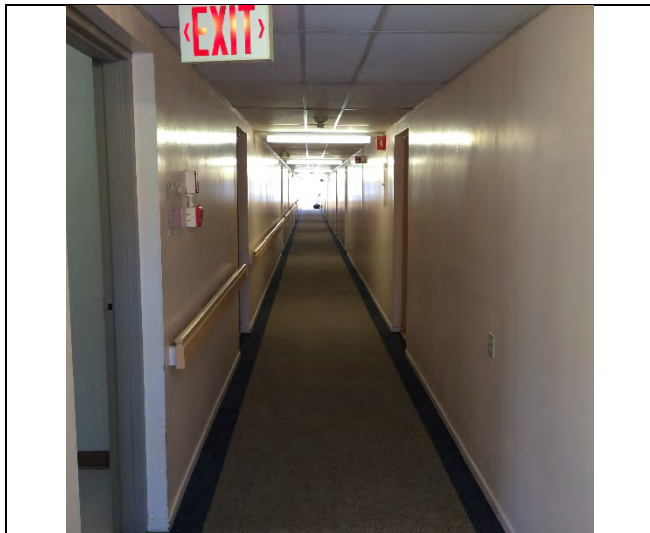
Photo 3: Drywall joint-fill compound identified to be asbestos-containing in the hallways (1% Chrysotile).

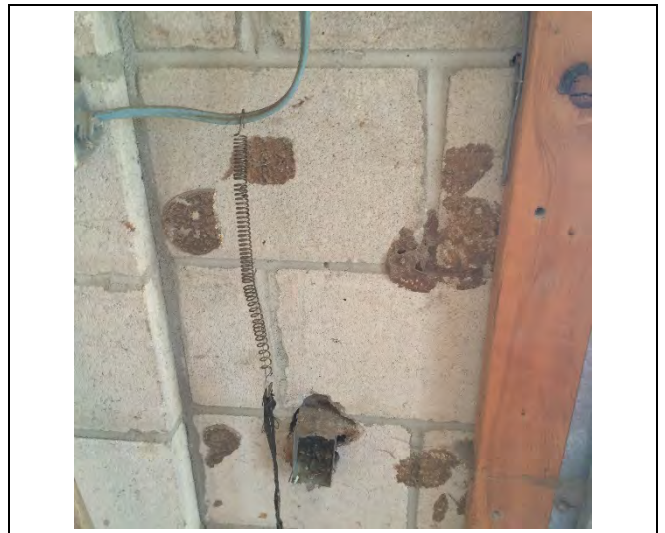
Photo 4: Mastic puck – brown on the block walls in the exterior garage identified to be asbestos-containing (1.2% Chrysotile).

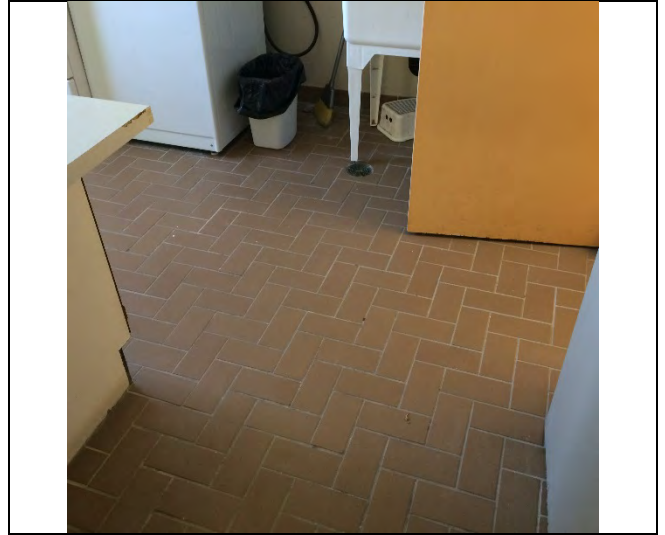
Photo 6: Ceramic tile grout and mortar/adhesive is presumed to be asbestos-containing in the laundry room.

- Prior to renovation and/or demolition activities that would disturb them, undertake testing of PACMs that may be impacted to determine their asbestos content. Confirmed asbestos materials should be handled accordingly;

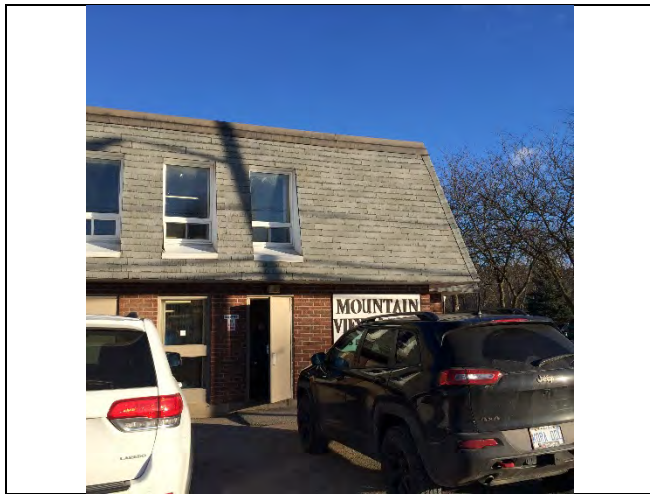
Photo 7: Exterior window and door caulking is presumed to be asbestos-containing.

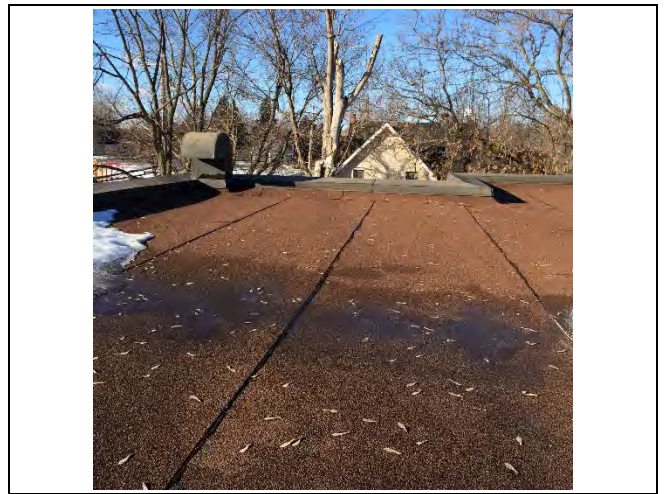
Photo 8: Roof shingles are presumed to be asbestos-containing.
