Asbestos Building Materials Assessment

Multi-Residential Building
80 Water Street
Brockville ON

Prepared for:
United Counties of Leeds & Grenville
100-25 Central Avenue West
Brockville ON K6V 4N6

February 17, 2017

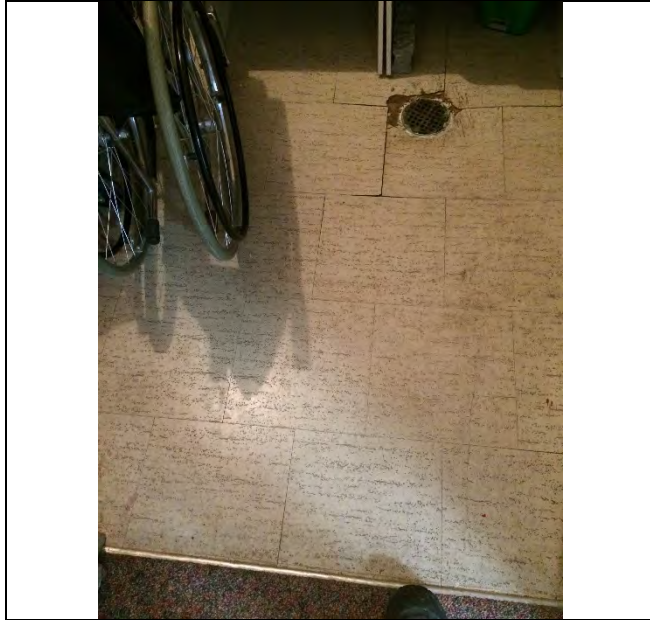
The 12"x12" vinyl floor tile – white with dots was observed to be in poor condition (2-3 loose tiles) in the storage room located inside the common room. The remaining materials were observed to be in good condition.

Photo 1: Asbestos-containing 12"x12" vinyl floor tiles – white with dots was observed to be in poor condition (loose tile) in the storage room in the common room.

- Damaged asbestos-containing 12"x12" vinyl floor tiles – white with dots (recommended corrective action), in the storage room in the common room should be removed and replaced following Type 1 abatement procedures;

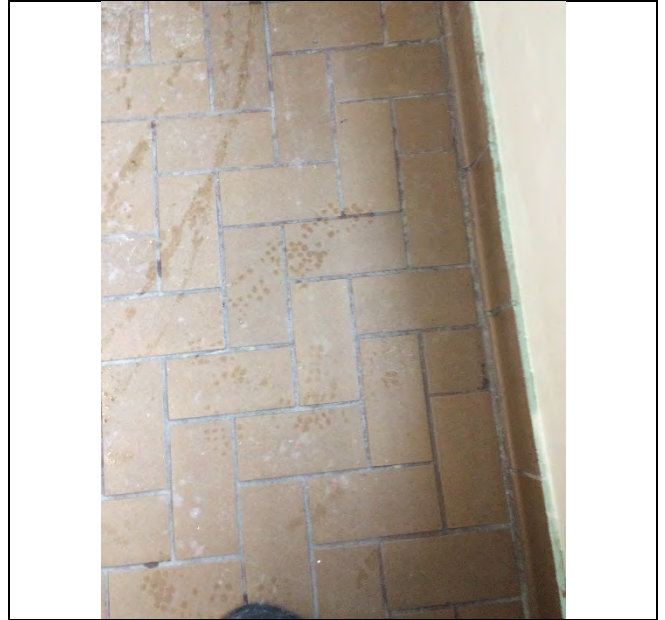
Photo 2: Presumed to be asbestos-containing ceramic tile grout and mortar/adhesive in the lobby.

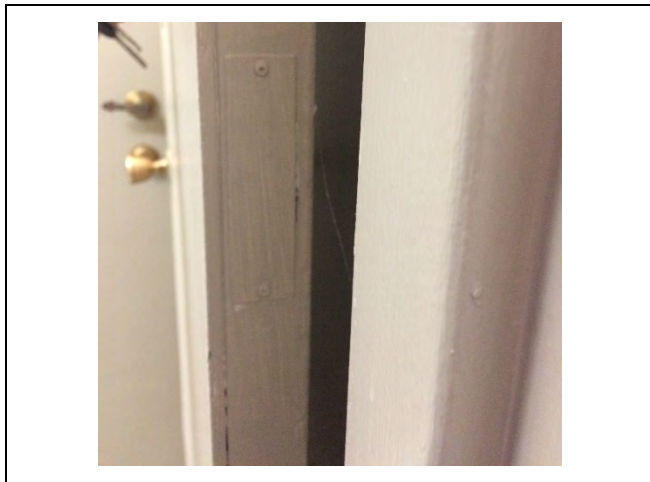
Photo 3: Presumed asbestos-containing fire rated door to the 1st floor stairwell.

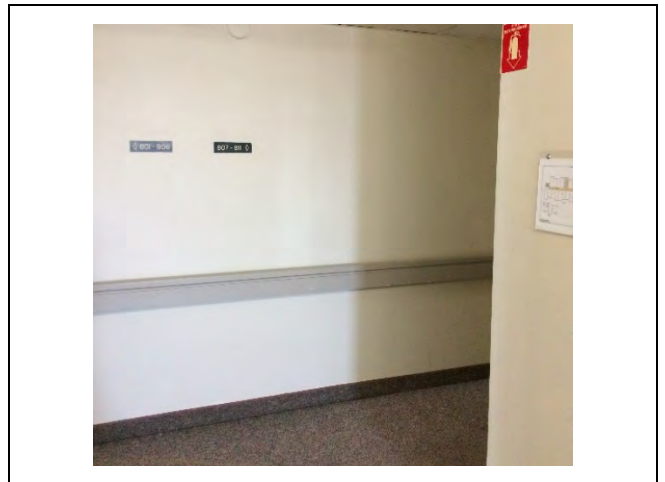
It should be noted that drywall joint-fill compound is considered non-friable in its undisturbed state but can release fibers when damaged.

Photo 4: Asbestos-containing drywall joint-fill compound in the 8th floor corridor near the elevator lobby.

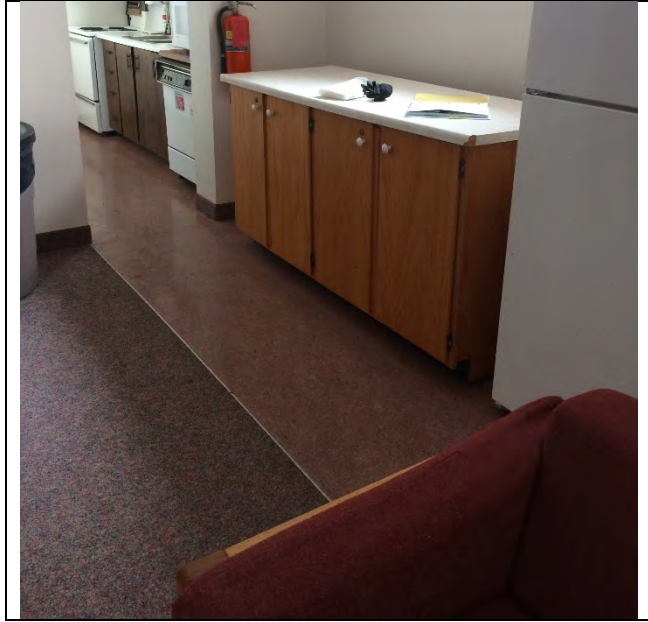
Photo 5: Presumed asbestos-containing mastic associated with 12"x12" vinyl floor tiles – pink mosaic pattern.

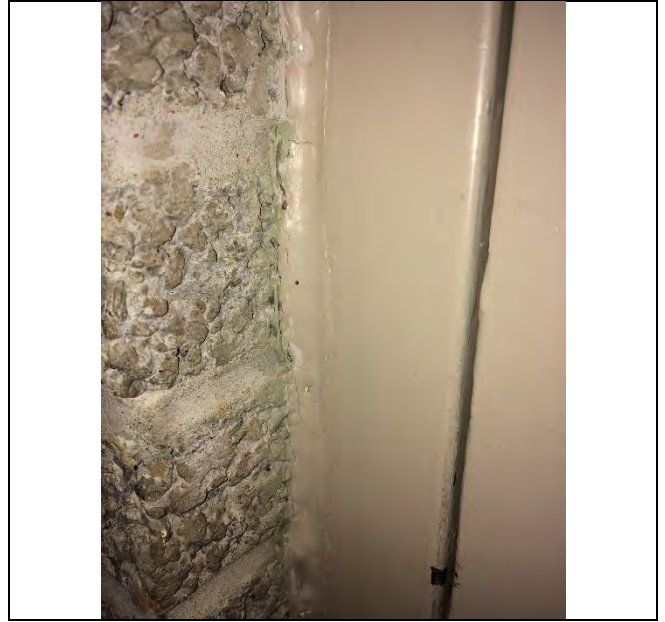
Photo 6: Presumed asbestos-containing brick mortar and exterior door caulking – white (under beige paint) at the back entrance near the elevator door.
