## **Asbestos Building Materials Assessment**

Residential House  
89 Salisbury Crescent  
Brockville ON

Project No.: 122150275

February 15, 2017

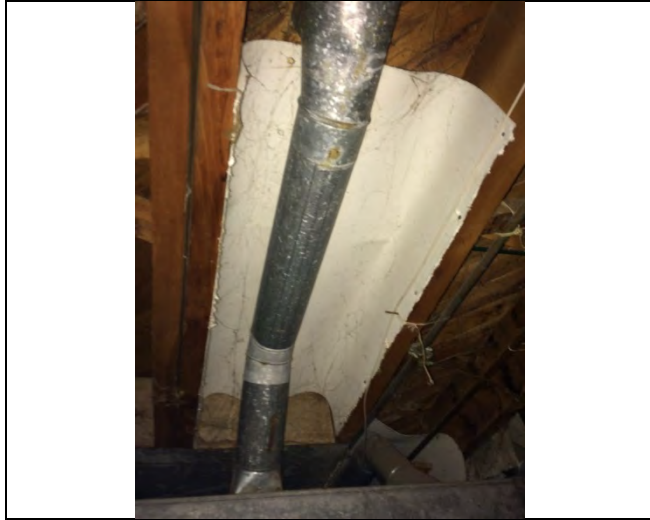
This material was observed to be in good condition.

Photo 1: Asbestos-containing paper-like ducting insulation was observed to be in good condition in the basement.

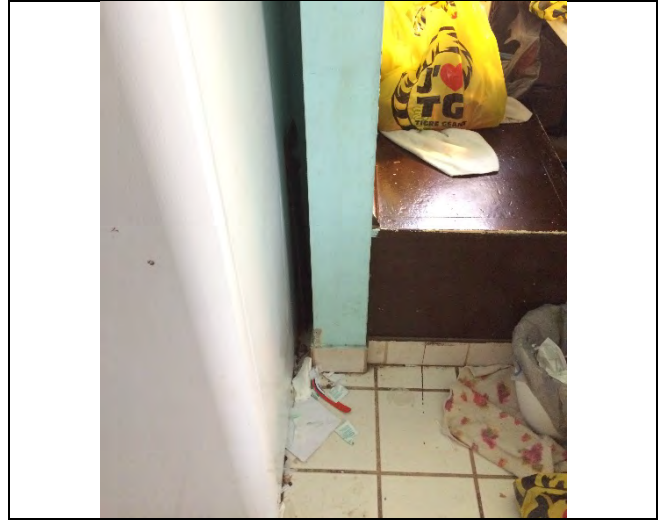
This material was observed to be in good condition.

It should be noted that drywall joint-fill compound is considered non-friable in its undisturbed state but can release fibers when damaged.

Photo 2: Asbestos-containing drywall joint-fill compound was observed in the kitchen.

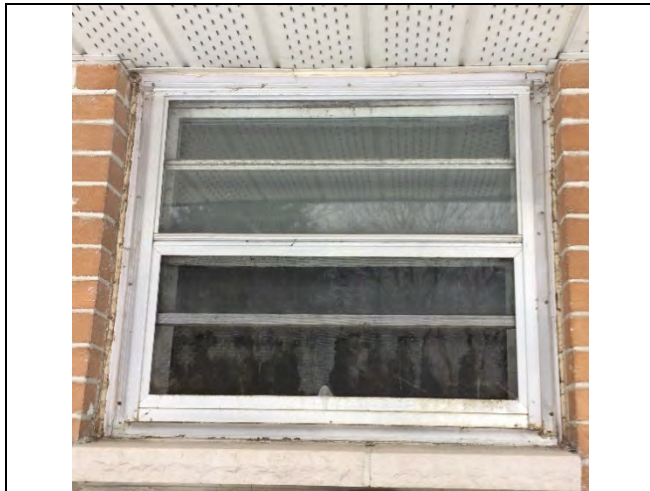
These materials were observed to be in good condition. These materials were not sampled to preserve their integrity. As these materials are known to have been manufactured with asbestos, they should be presumed to be asbestos-containing unless proven otherwise by laboratory analysis.

Photo 3: Presumed asbestos-containing exterior window caulking was observed on washroom window.

- Prior to renovation and/or demolition activities that would disturb them, undertake testing of PACMs that may be impacted to determine their asbestos content. Confirmed asbestos materials should be handled accordingly;

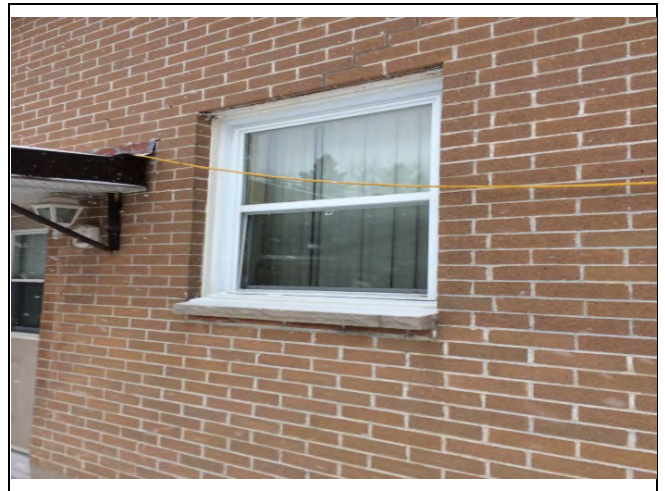
Photo 4: Presumed asbestos-containing brick mortar on exterior walls.
