Asbestos Building Materials Assessment

House
891 Boundary Street
Prescott ON

Project No.: 122150275

February 15, 2017

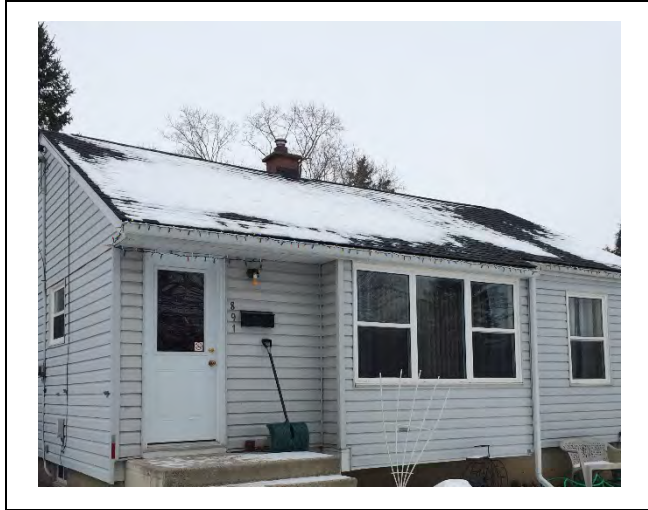
These materials were observed to be in good condition. These materials were not sampled to preserve their integrity. As these materials are known to have been manufactured with asbestos, they should be presumed to be asbestos-containing unless proven otherwise by laboratory analysis.

Photo 1: Presumed asbestos-containing brick mortar, roofing materials and roof caulking.

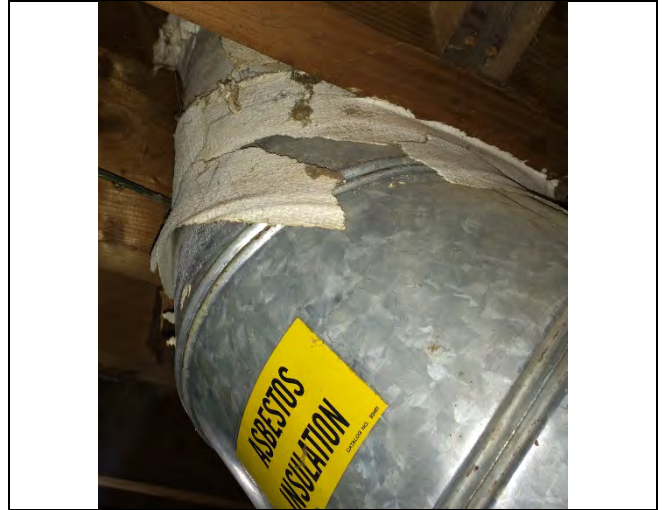
The duct insulation paper wrap was observed to be in poor condition (torn and frayed on 3 ducts) in the basement. The remaining materials were observed to be in good condition.

Photo 2: Asbestos-containing duct insulation tape observed to be in poor condition in the basement.

- Damaged asbestos-containing duct insulation paper wrap, should be repaired following Type 2 procedures;
- Asbestos-containing materials that may be impacted during renovation and/or demolition activities should be removed prior to the renovation and/or demolition activities;
- Prior to renovation and/or demolition activities that would disturb them, undertake testing of PACMs that may be impacted to determine their asbestos content. Confirmed asbestos materials should be handled accordingly;

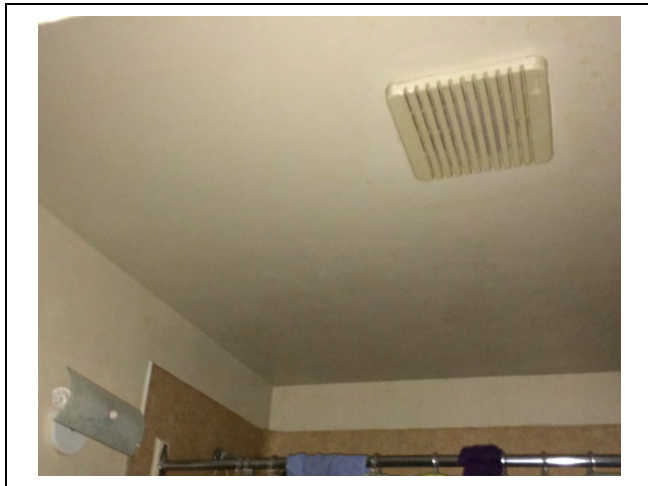
This material was observed to be in good condition. It should be noted that drywall joint-fill compound is considered non-friable in its undisturbed state but can release fibers when damaged.

Photo 3: Asbestos-containing drywall joint-fill compound observed on the walls and ceiling.

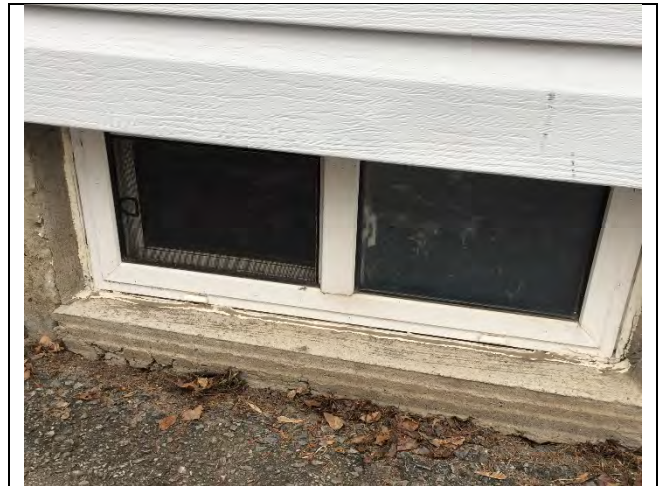
Photo 4: Presumed asbestos-containing exterior caulking – white was observed on the exterior window.
