Asbestos Building Materials Assessment

House
98 Reynolds Drive
Brockville ON

Project No.: 122150275

February 15, 2017

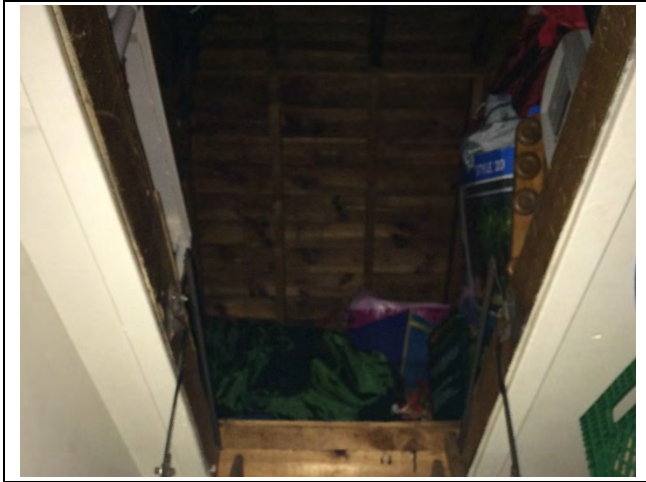
This material was observed to be in good condition.

Photo 1: Asbestos-containing drywall joint-fill compound was observed to be in good condition on the walls and ceiling in the storage room access to the attic.

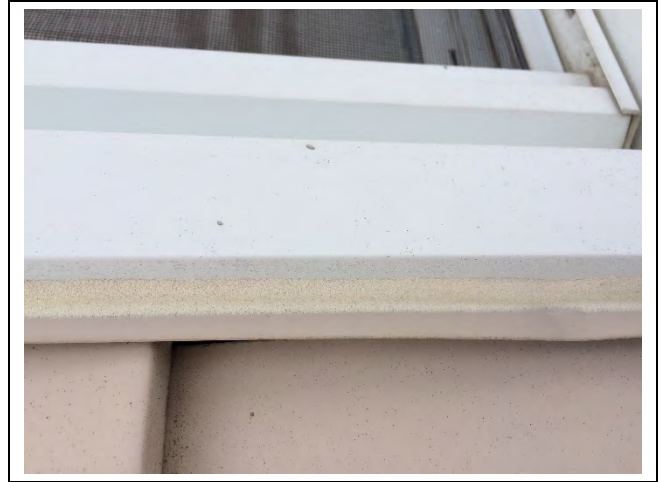
Photo 2: Presumed asbestos-containing exterior caulking – white on the exterior window.

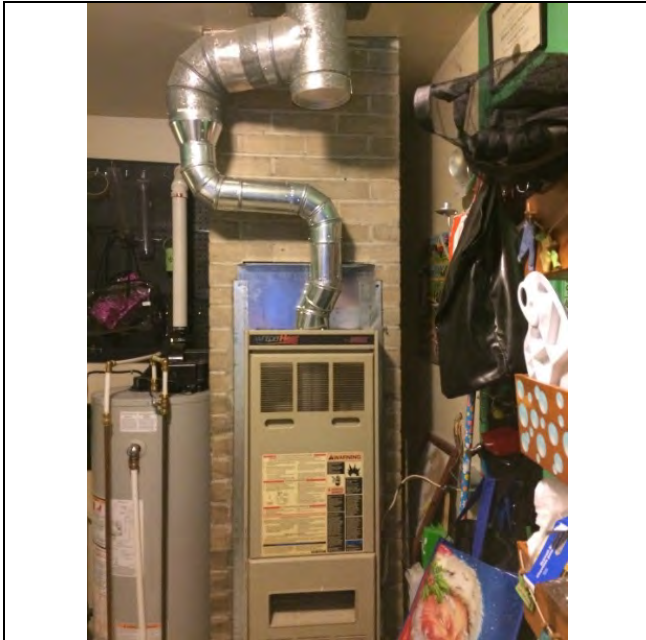
Photo 3: Presumed asbestos-containing brick mortar was observed on a chimney exhaust in the laundry room.

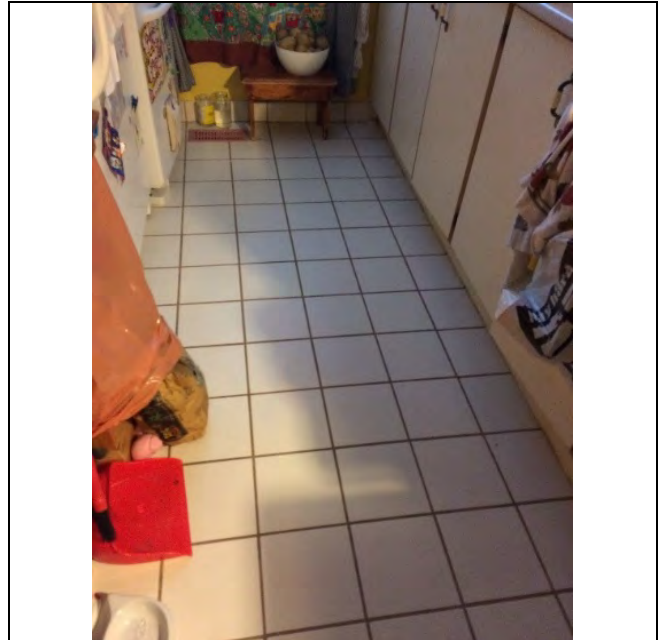
Photo 4: Presumed asbestos-containing ceramic tile grout and mortar / adhesive was observed in the kitchen.
