## **Asbestos Building Materials Assessment**

Multi-Residential Building  
105 Lewis Street East  
Merrickville ON

Prepared by:  
Stantec Consulting Ltd.  
400-1331 Clyde Avenue  
Ottawa ON K2C 3G4

February 15, 2017

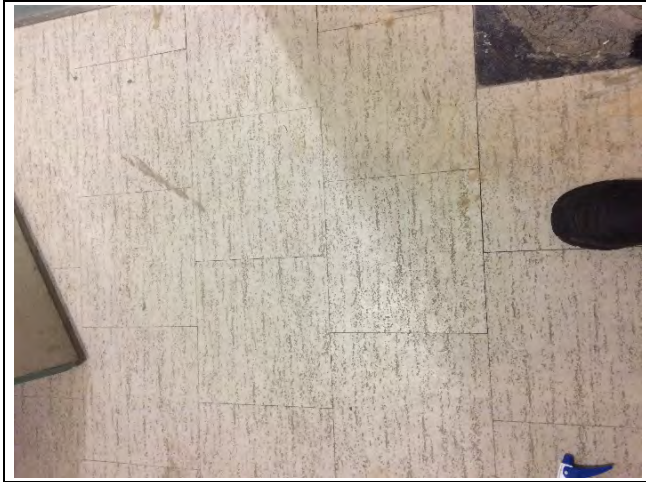
The 12"x12" vinyl floor tile – beige with black spots was observed to be in poor condition (one (1) loose tile) in the communal storage room. The remaining materials were observed to be in good condition.

Photo 1: Asbestos-containing 12"x12" vinyl floor tiles – beige with black spots (3.89% Chrysotile) in the communal storage room.

- Damaged asbestos-containing 12"x12" vinyl floor tile – beige with black spots should be removed and disposed of following Type 1 abatement procedures;

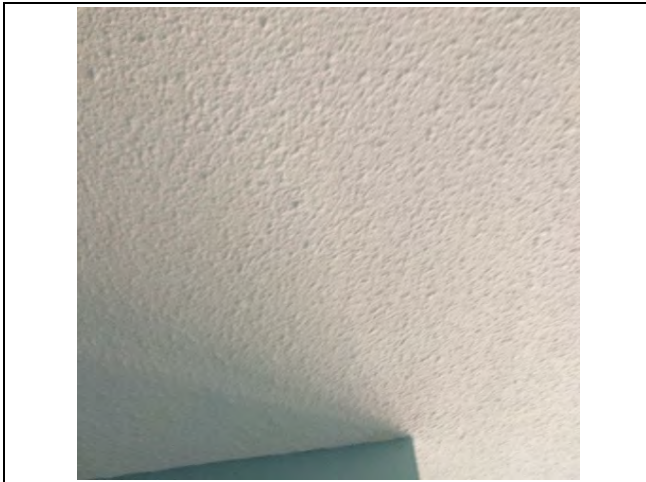
Photo 3: Asbestos-containing stucco (2% Chrysotile) observed to be in good condition on the ceiling in the 1<sup>st</sup> floor stairwell.

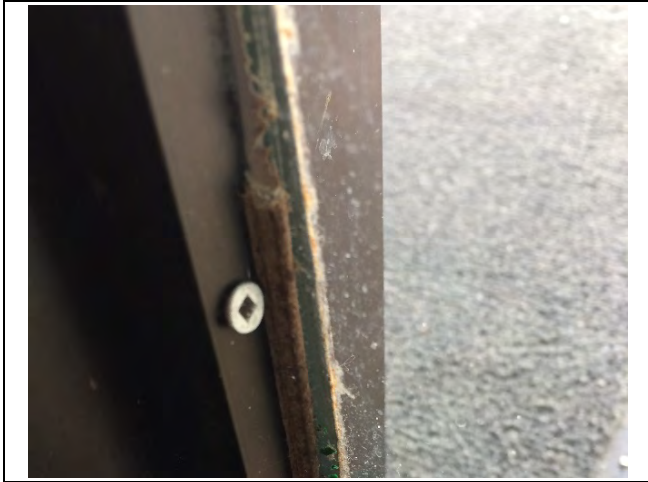
Photo 5: Asbestos-containing interior / exterior glazing compound – grey (4.42% Chrysotile) at the main entrance window.

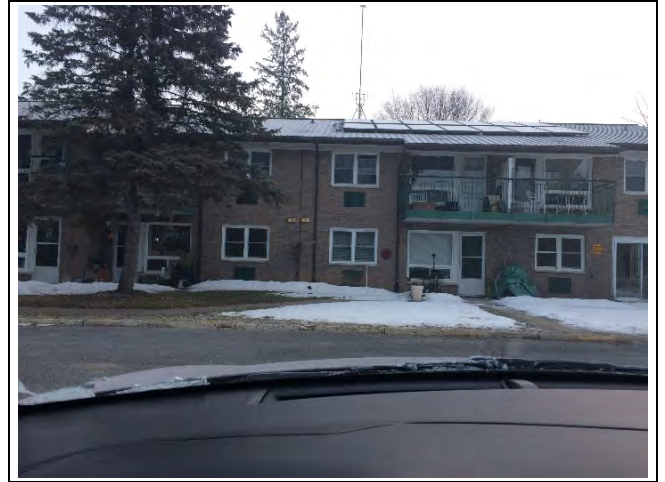
Photo 6: Presumed asbestos-containing roof caulking suspected to be present on the metal roof observed
