## **Asbestos Building Materials Assessment**

Multi-Residential Building  
200 Bridge Street  
Kemptville ON

Project No.: 122150275

February 16, 2017

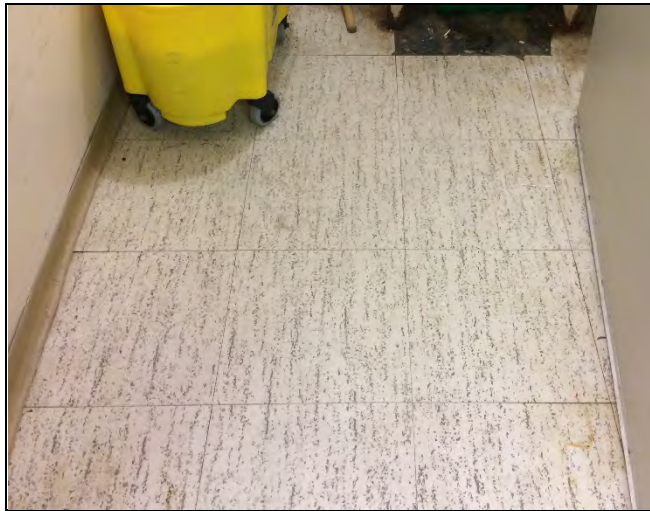
Mastic associated with 12"x12" vinyl floor tiles – beige with black dots was observed to be in poor condition in the custodian closet. The remaining materials were observed to be in good condition. It should be noted that drywall joint-fill compound is considered non-friable in its undisturbed state but can release fibers when damaged.

Photo 1: Asbestos-containing 12"x12" vinyl floor tiles beige with black dots (2.41% Chrysotile) and associated mastic (0.95% Chrysotile) observed in the custodian's closet. The mastic was exposed at the right corner.

- Exposed asbestos-containing mastic associated with 12"x12" vinyl floor tiles – beige with black dots should be covered with non-asbestos-containing vinyl floor tiles (recommended corrective action);

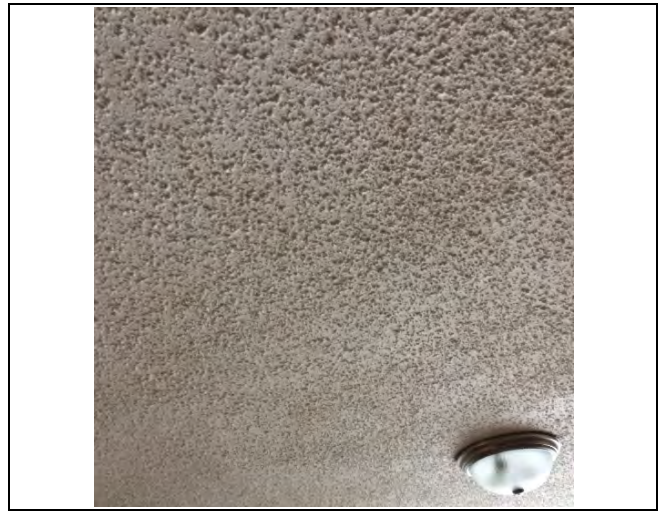
Photo 2: Asbestos-containing stucco – rough pattern (1% Chrysotile) on ceiling in the living room of unit 212.

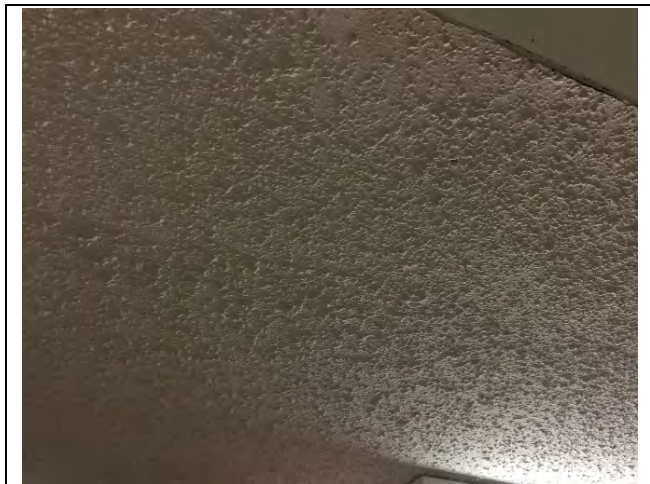
Photo 3: Asbestos-containing stucco – medium rough pattern (1% Chrysotile) on the ceiling in the 1<sup>st</sup> floor south stairwell.

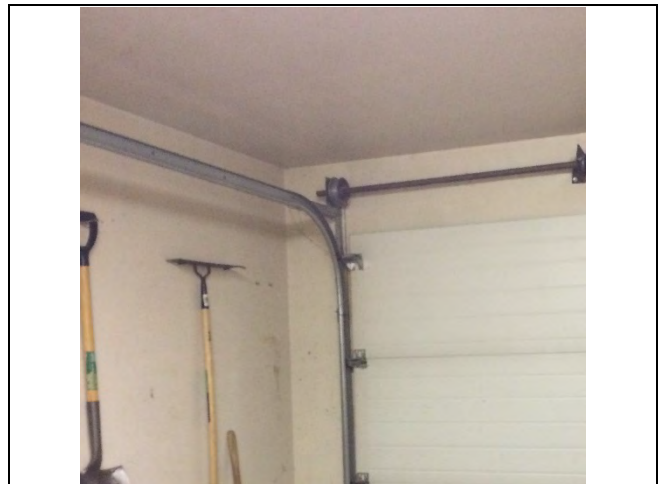
Photo 4: Asbestos-containing drywall joint-fill compound (1% Chrysotile) on the walls and ceiling in the garage.

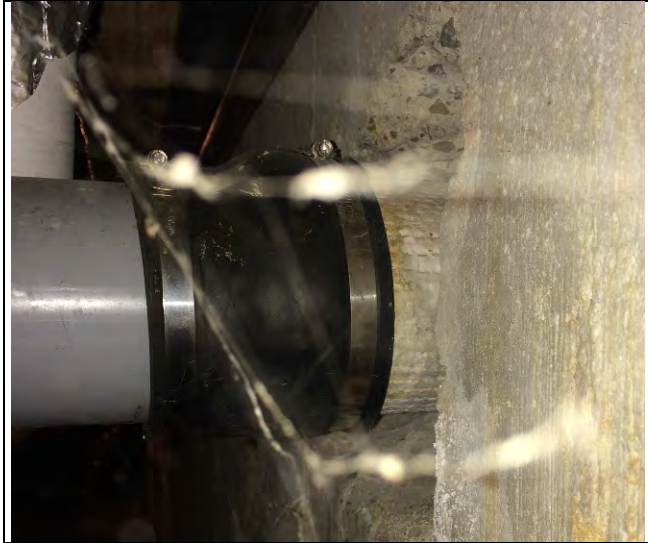
Photo 5: Presumed asbestos-containing cement pipe in the crawlspace.

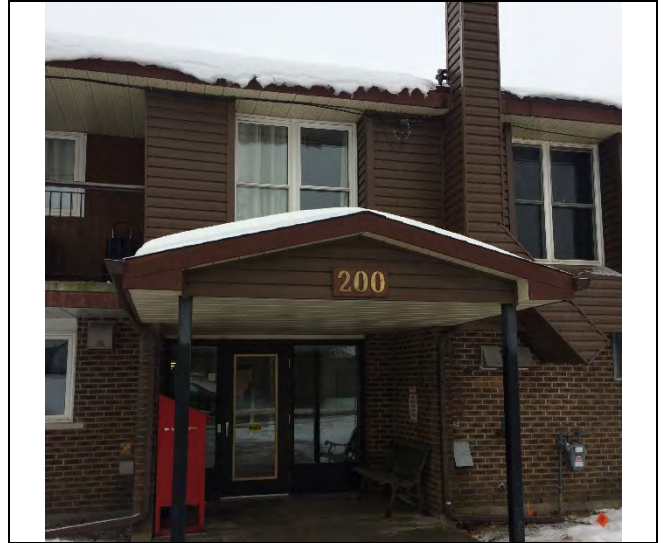
Photo 6: Presumed asbestos-containing brick mortar on exterior walls.

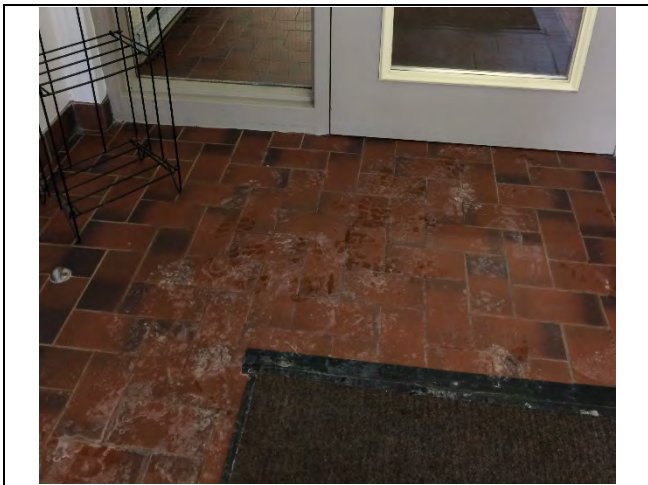
Photo 7: Presumed asbestos-containing ceramic tile grout and mortar/adhesive at the lobby and main entrance.

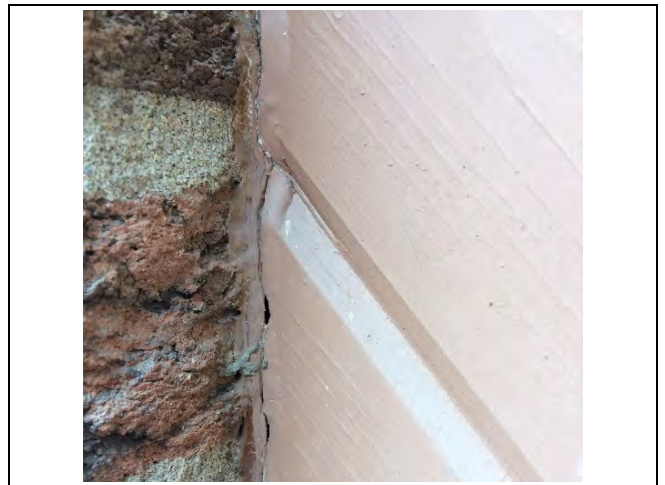
Photo 8: Presumed asbestos-containing exterior caulking – brown on the joint of the walls around the window of the lounge room.
