Asbestos Building Materials Assessment

Multi-Residential Building
80 Water Street
Brockville ON

Prepared for:
United Counties of Leeds & Grenville
100-25 Central Avenue West
Brockville ON K6V 4N6

February 17, 2017

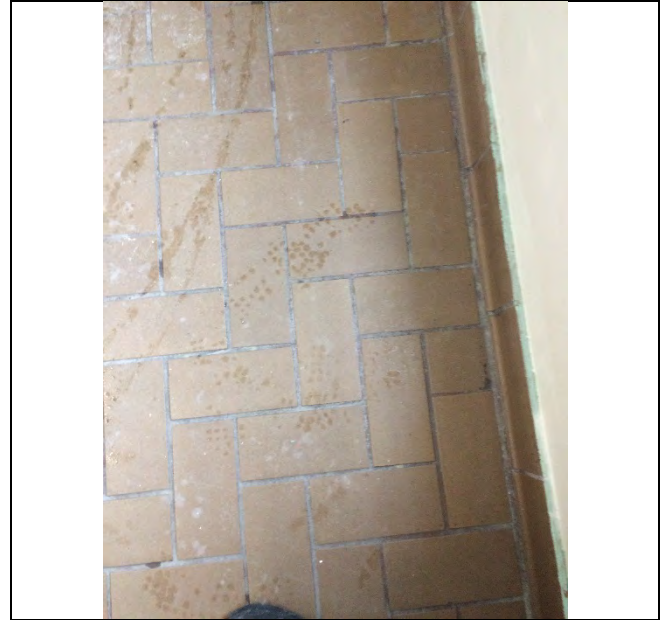
Photo 2: Presumed to be asbestos-containing ceramic tile grout and mortar/adhesive in the lobby.

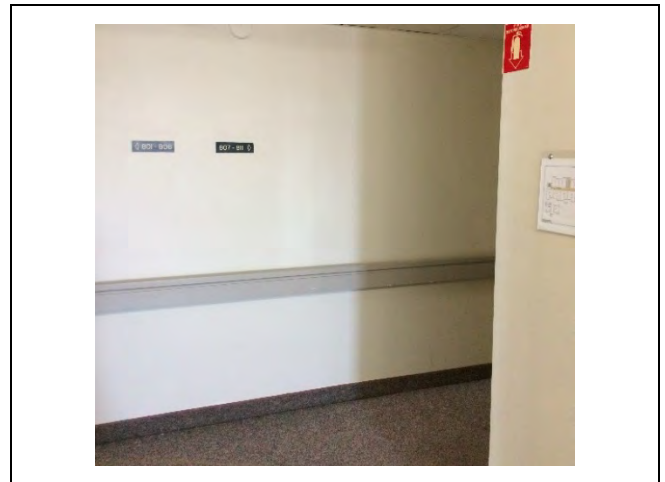
It should be noted that drywall joint-fill compound is considered non-friable in its undisturbed state but can release fibers when damaged.

Photo 4: Asbestos-containing drywall joint-fill compound in the 8th floor corridor near the elevator lobby.

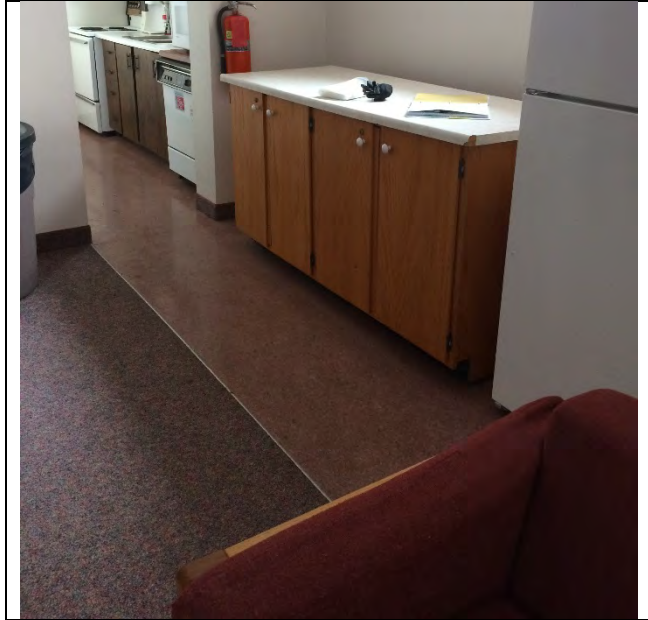
Photo 5: Presumed asbestos-containing mastic associated with 12"x12" vinyl floor tiles – pink mosaic pattern.

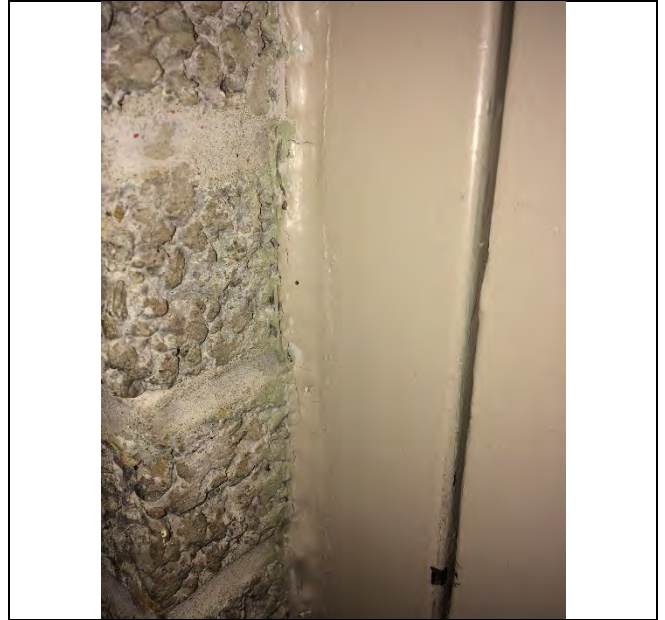
Photo 6: Presumed asbestos-containing brick mortar and exterior door caulking – white (under beige paint) at the back entrance near the elevator door.
