Asbestos Building Materials Assessment

Multi-Unit Residential Building
523 Hyde Street
Prescott ON

Project No.: 122150275

February 17, 2017

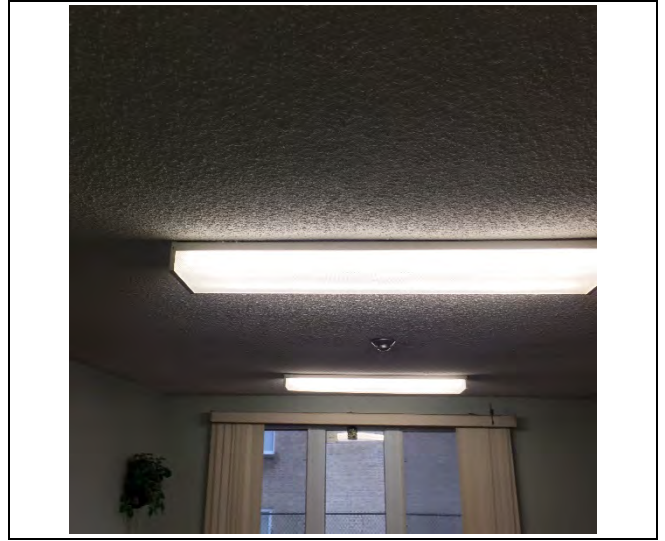
- Stucco.

This material was observed to be in good condition.

Photo 2: Stucco on ceilings is identified to be asbestos-containing (3% Chrysotile).

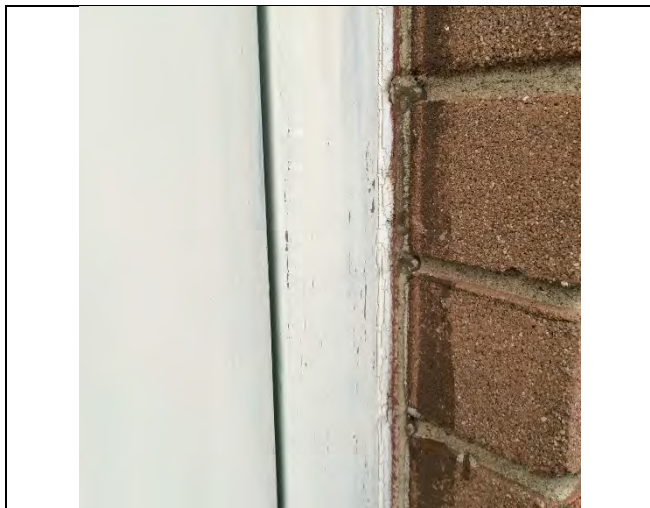
Photo 3: Exterior door caulking – white is identified to be asbestos-containing (6.9% Chrysotile).

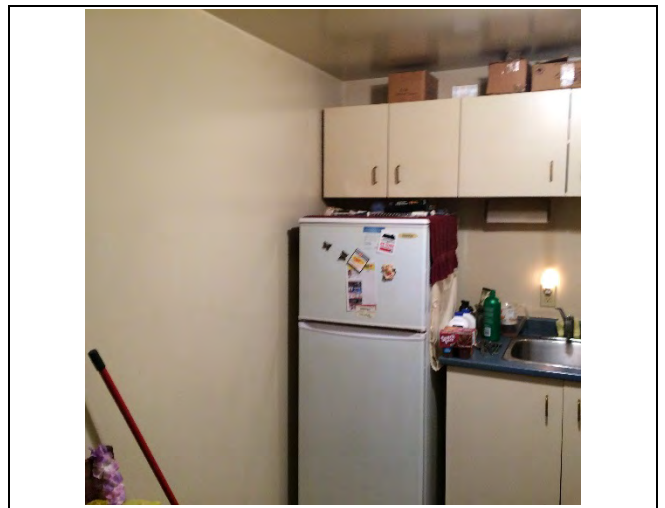
Drywall joint-fill compound was observed to be in poor condition (<1 sq. m chipped) in the front entrance lobby. The remaining materials were observed to be in good condition. It should be noted that drywall joint-fill compound is considered non-friable in its undisturbed state but can release fibers when damaged.

Photo 4: Drywall joint-fill compound is identified to be asbestos-containing (1% Chrysotile).

- Damaged asbestos-containing drywall joint-fill compound should be repaired following type 1 abatement procedures;
- Asbestos-containing materials that may be impacted during renovation or demolition activities should be removed prior to the renovation or demolition activities;

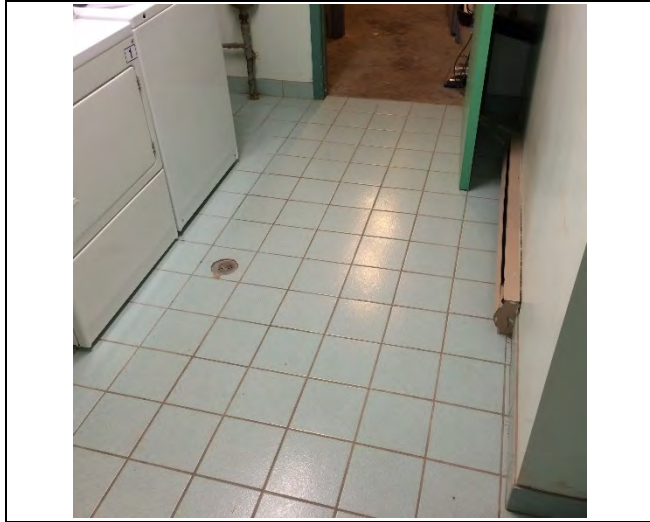
Photo 5: Ceramic tile grout and mortar/adhesive is presumed to be asbestos-containing.

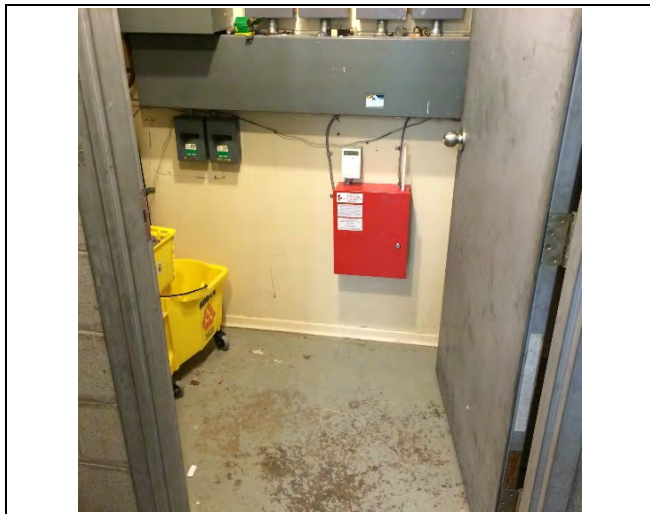
Photo 7: Fire rated door – metal is presumed to be asbestos-containing.
