Asbestos Building Materials Assessment

150 Stone Street
Gananoque ON

Project No.: 122150275

February 14, 2017

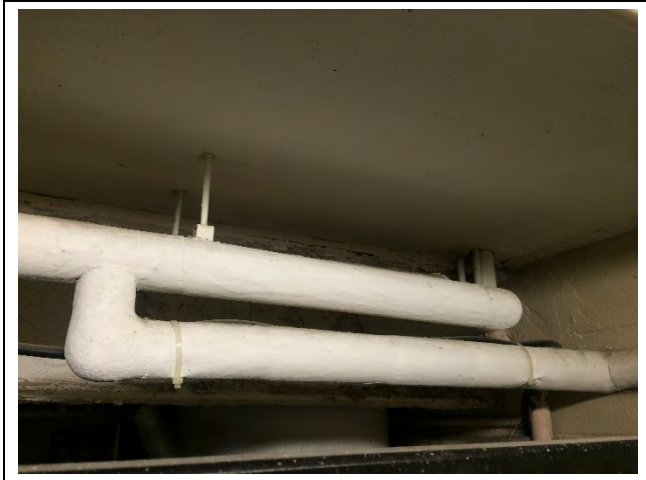
Photo 1: Insulating cement on pipe fittings identified to be asbestos-containing in the first floor garbage room (50% Chrysotile).

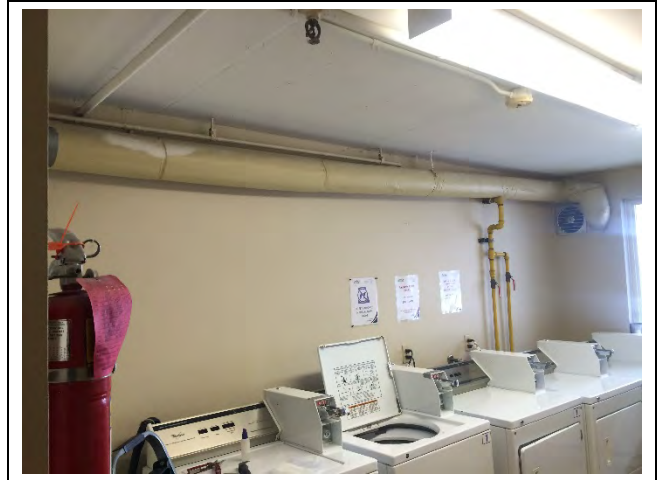
Photo 2: Corrugated paper-like straight pipe insulation identified to be asbestos-containing in the first floor laundry room (65% Chrysotile).

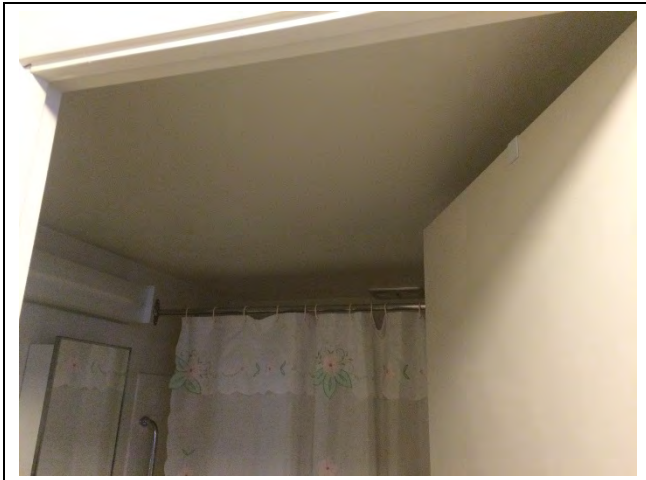
Photo 3: Drywall joint-fill compound identified to be asbestos-containing in Unit 203 (1% Chrysotile).

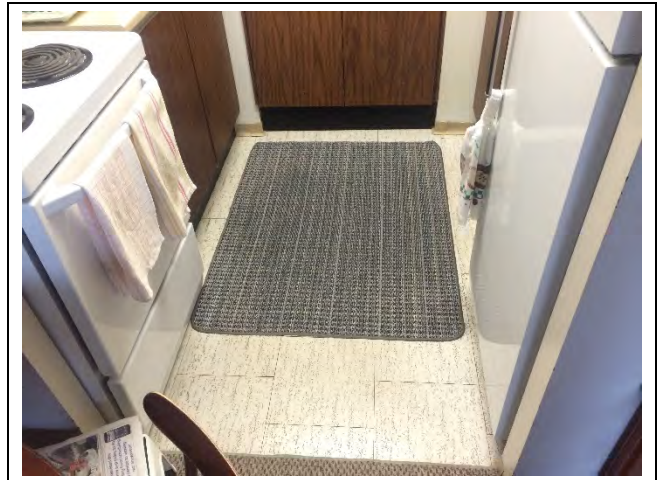
Photo 4: 12"x12" vinyl floor tile – beige with grey specks identified to be asbestos-containing in Unit 203 (2.33% Chrysotile).

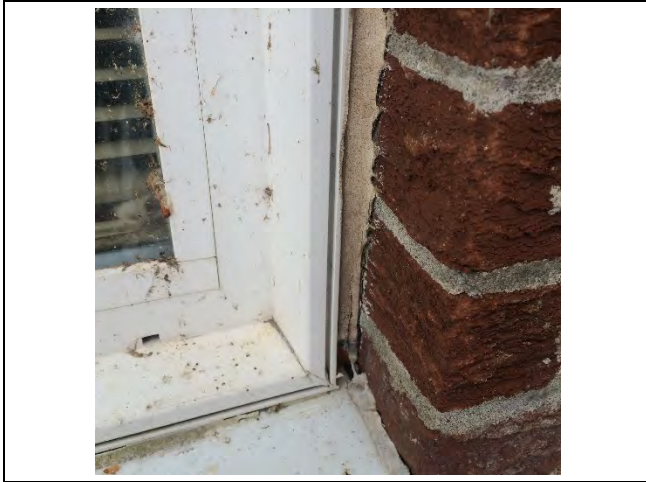
Photo 5: Exterior window caulking – white is presumed to be asbestos-containing.

- Prior to renovation or demolition activities that would disturb them, undertake testing of PACMs that may be impacted to determine their asbestos content. Confirmed asbestos materials should be handled accordingly;
