Asbestos Building Materials Assessment

Multi-Unit Residential Building
3 Miller Drive
Mallorytown ON

Project No.: 122150275

February 15, 2017

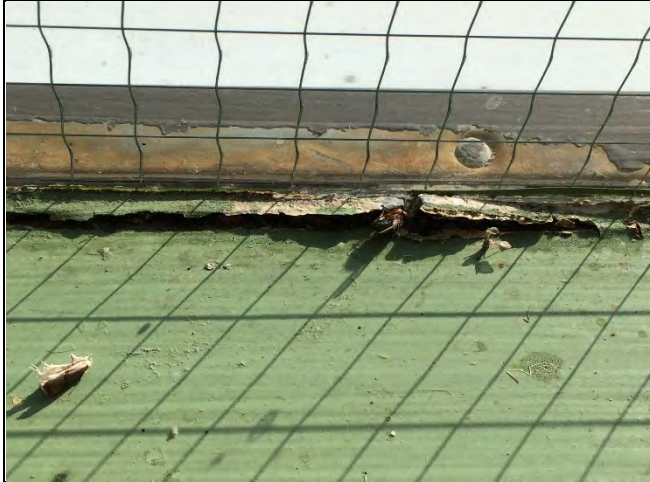
Interior glazing compound – white was observed to be in poor condition (cracking and lifting at the west stairwell). The remaining materials were observed to be in good condition.

1-2	Stairs and Hallways	Doors	Doors	Fire Rated Doors	NQ	NS	No	PACM	No Yes	A	good (PACM)	PACM
1-2	Stairwell	Windows	Windows	Interior Glazing Compound - White	12 m	3-BS-09A	Yes	0.86% Chrysotile	No Yes	A	poor	OBSERVED CRACKING AND LIFTING AT THE WEST STAIRWELL WINDOW
2	Hallway	Ceiling	Ceiling	Stucco	50 sq.m	Ref: 3-BS-02B	No	1% Chrysotile	Yes Yes	C	good	ACM
2	Storage	Stored on Shelf	Stored on Shelf	12"x12" Vinyl Floor Tile - Beige with Grey Specks	5 sq.m	Ref: 3-BS-03A	No	4.06% Chrysotile	No Yes	A	good	ACM

Photo 1: Asbestos-containing interior glazing compound – white was observed to be in poor condition at the west stairwell.

- Damaged asbestos-containing interior window glazing compound – white (recommended corrective action), should be removed;
- Asbestos-containing materials that may be impacted during renovation and/or demolition activities should be removed prior to the renovation and/or demolition activities;

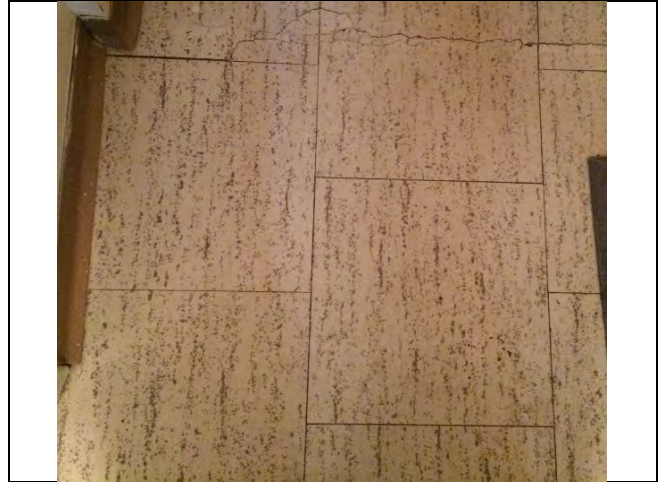
Photo 2: Asbestos-containing 12"x12" vinyl floor tile – beige with grey specks was observed in unit 209 hallway.

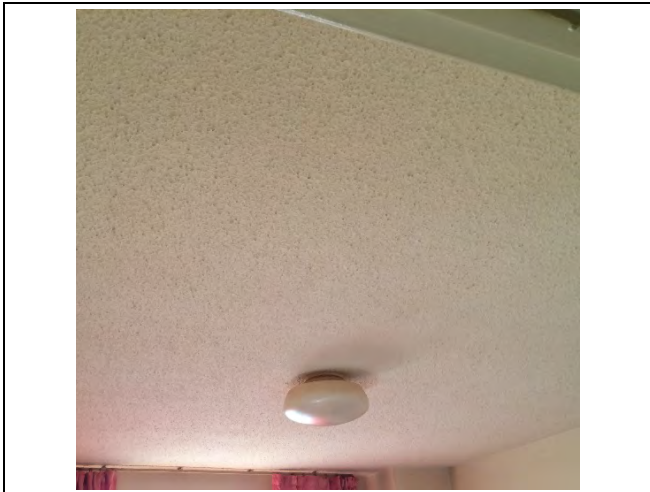
This material was observed to be in good condition.

Photo 3: Asbestos-containing stucco on ceiling was observed in unit 107.

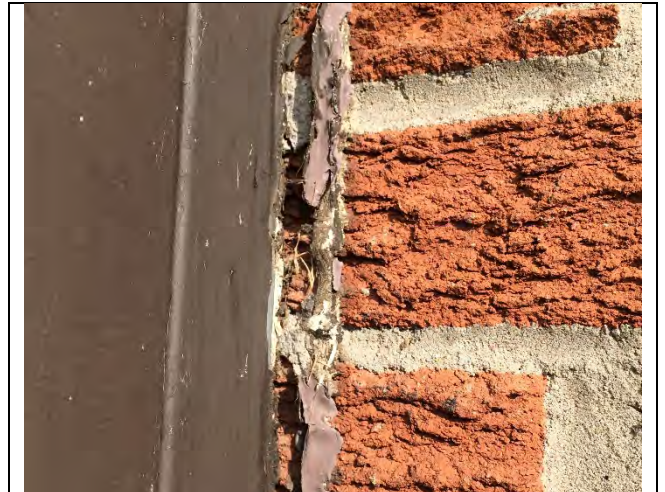
Photo 4: Asbestos-containing exterior door caulking – white was observed beneath brown caulking at the exterior west stairwell.

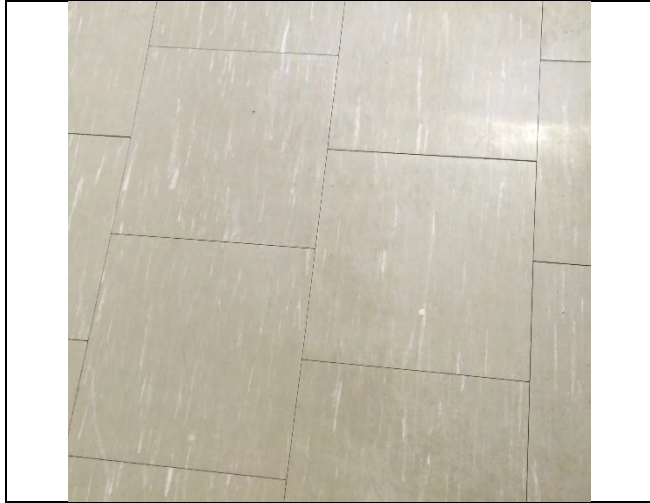
Photo 5: Asbestos-containing 12"x12" vinyl floor tile – olive with white streaks was observed in the east stairwell.

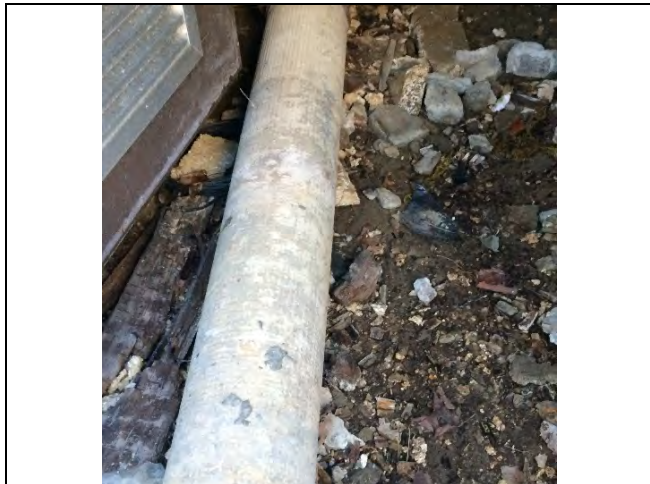
Photo 7: Presumed asbestos-containing cement pipe was observed in the crawlspace.

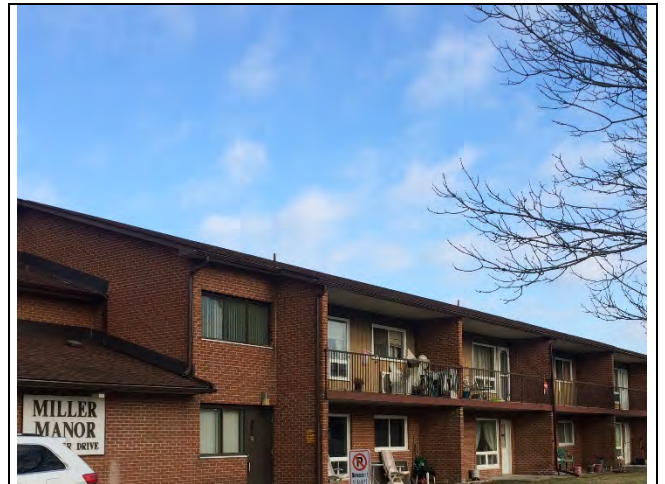
Photo 8: Presumed asbestos-containing brick mortar observed on exterior walls
