## **Asbestos Building Materials Assessment**

House  
1287 Peden Boulevard  
Brockville ON

Project No.: 122150275

February 15, 2017

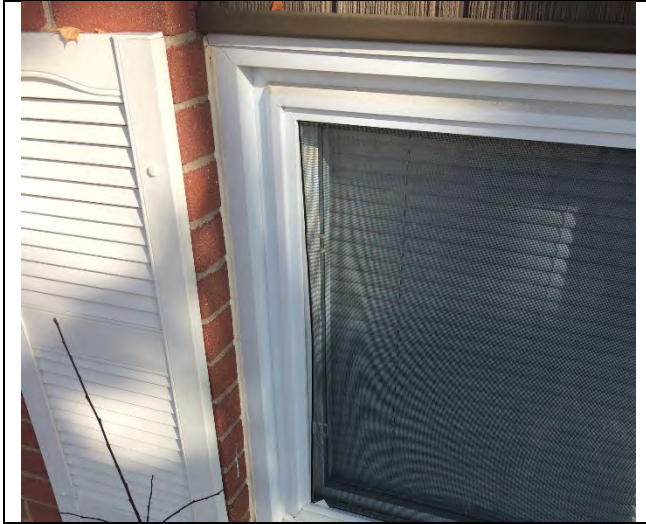
Photo 1: Presumed asbestos-containing exterior caulking – white observed at the front window.

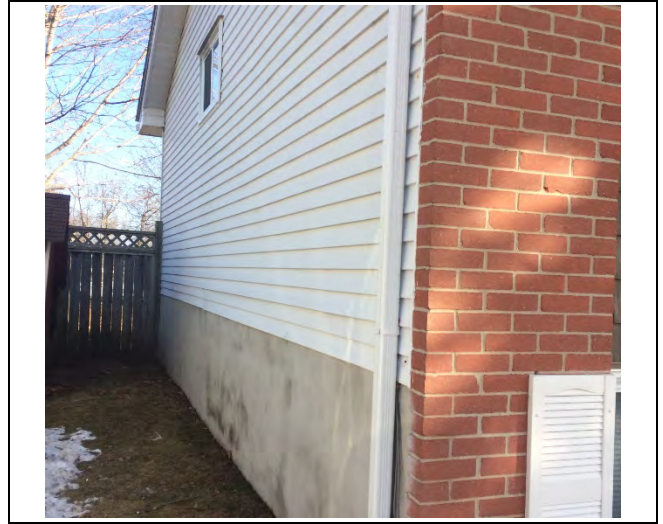
Photo 2: Presumed asbestos-containing brick mortar observed on front exterior wall.

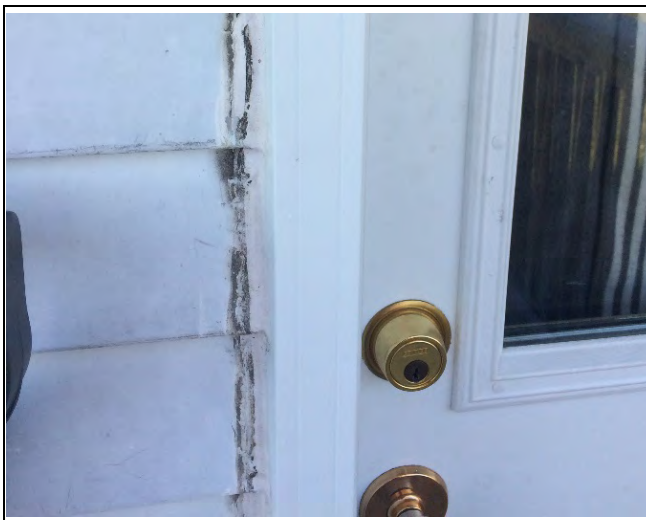
Photo 3: Presumed asbestos-containing exterior caulking – white observed on the back door.

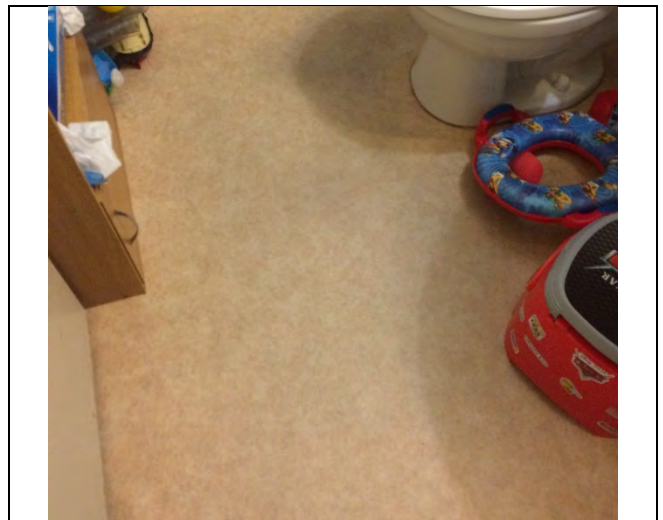
It should be noted that the vinyl floor tiles and vinyl sheet flooring was reported by Leeds Grenville to have been replaced within with last four (4) years.

Photo 4: Vinyl sheet flooring on the washroom floor reported to be new and not suspected to be asbestos-containing.
