Asbestos Building Materials Assessment

Multi-Unit Residential Building
201-203 Prescott Street
Kemptville ON

Project No.: 122150275

February 17, 2017

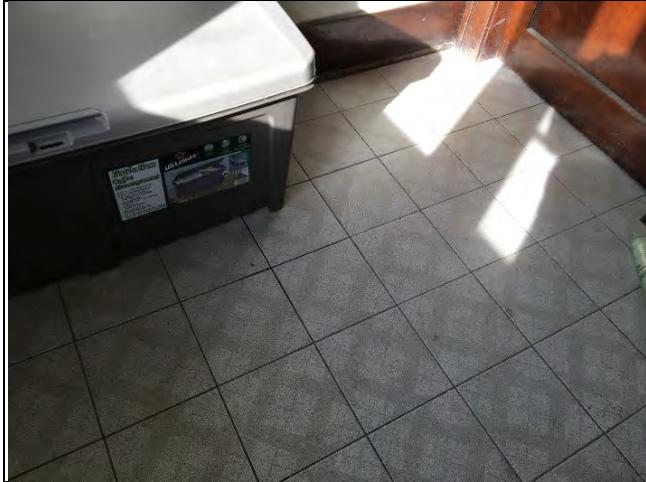
These materials were observed to be in good condition. These materials were not sampled to preserve their integrity. As these materials are known to have been manufactured with asbestos, they should be presumed to be asbestos-containing unless proven otherwise by laboratory analysis.

Photo 1: Presumed asbestos-containing ceramic tile grout and mortar/adhesive observed in unit 6 at 201 Prescott Street.

- Prior to renovation and/or demolition activities that would disturb them, undertake testing of PACMs that may be impacted to determine their asbestos content. Confirmed asbestos materials should be handled accordingly;

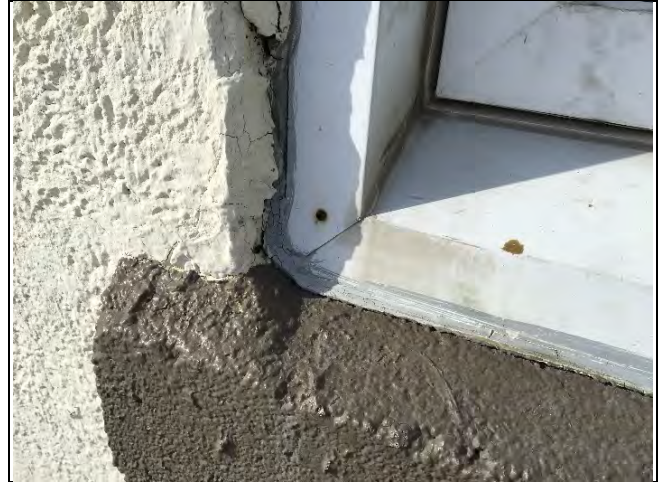
Photo 2: Presumed asbestos-containing exterior window caulking – grey observed at 203 Prescott Street.

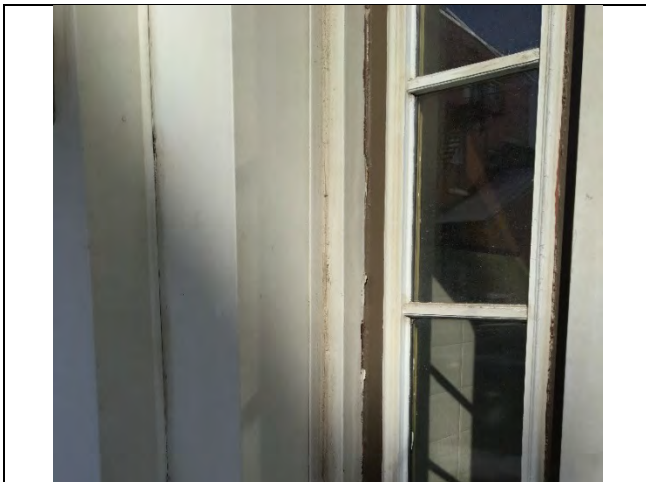
Photo 3: Presumed asbestos-containing exterior door caulking – white observed at 201 Prescott Street.

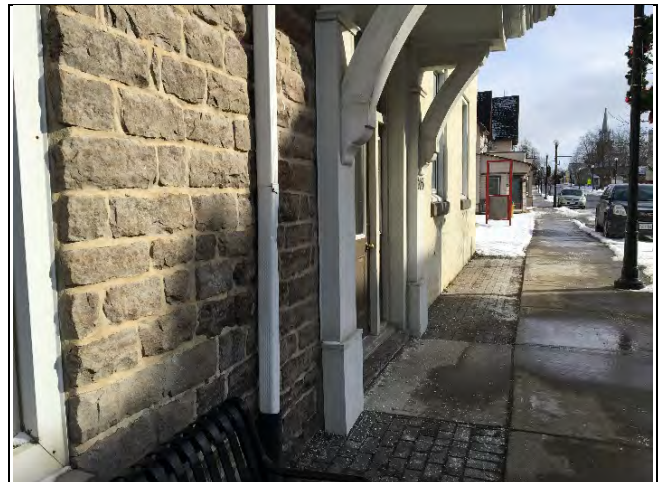
Photo 4: Presumed asbestos-containing brick mortar observed at the exterior of 201 Prescott Street.
