Asbestos Building Materials Assessment

Residential Dwellings
43, 83, 84 and 116 Brighton Crescent
Brockville ON

Prepared by:
Stantec Consulting Ltd.
400-1331 Clyde Avenue
Ottawa ON K2C 3G4

February 17, 2017

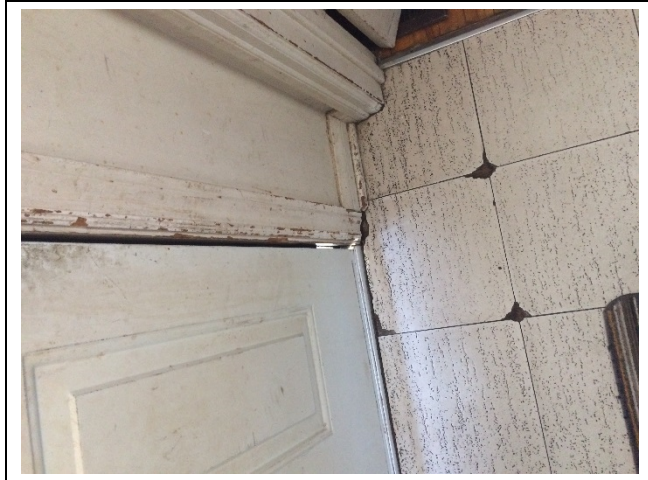
Photo 1: Asbestos-containing 12"x12" vinyl floor tiles – beige with black dots in the foyer of 116 Brighton Crescent.

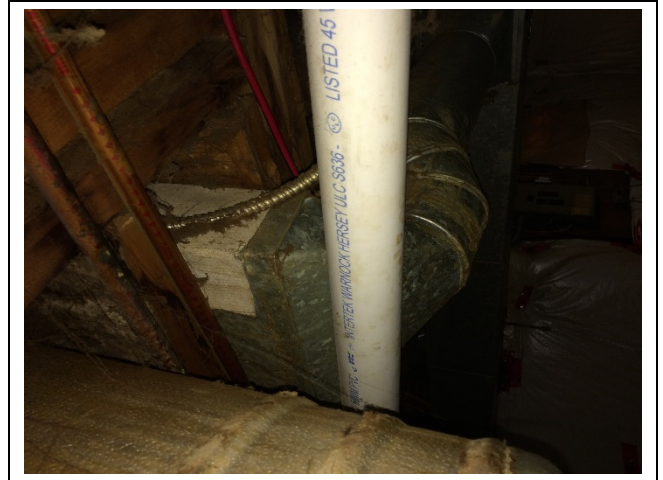
This material was observed to be in good condition.

Photo 2: Asbestos-containing duct insulation paper wrap (70% Chrysotile) in the basement of 116 Brighton Crescent.

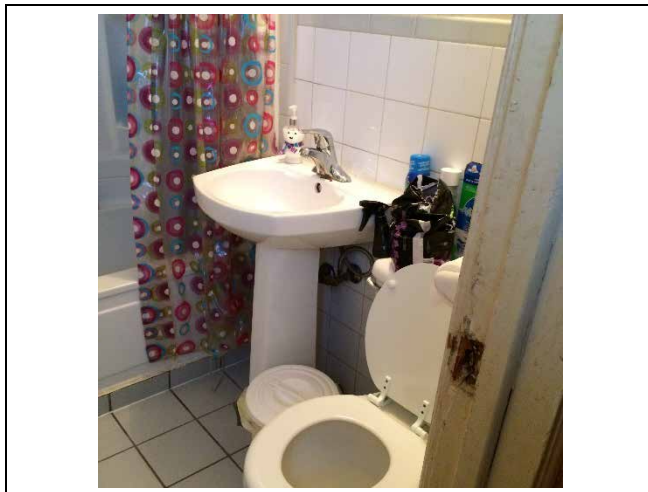
Photo 3: Presumed asbestos-containing ceramic tile grout and mortar/adhesive on walls and floor in the washroom of 116 Brighton Crescent.

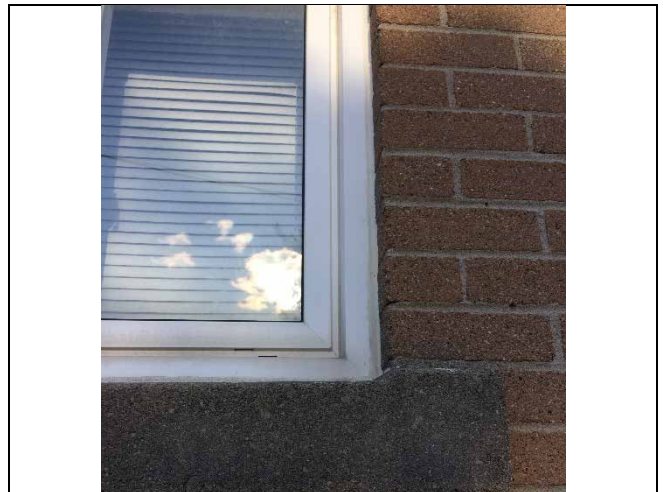
Photo 4: Presumed asbestos-containing exterior window caulking – white and brick mortar of 116 Brighton Crescent.

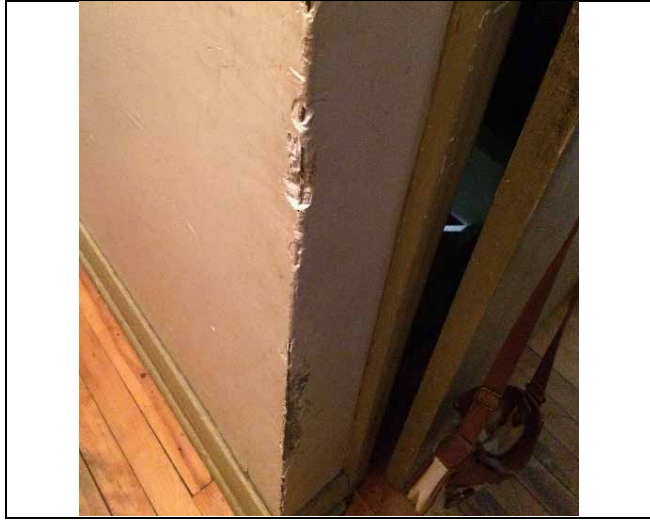
Drywall joint-fill compound as observed to be in poor condition (<1 sq. m) in the corridor of 43 Brighton Crescent. The remaining materials were observed to be in good condition.

It should be noted that drywall joint-fill compound is considered non-friable in its undisturbed state but can release fibers when damaged.

Photo 5: Asbestos-containing drywall joint-fill compound in the corridor of 43 Brighton Crescent.

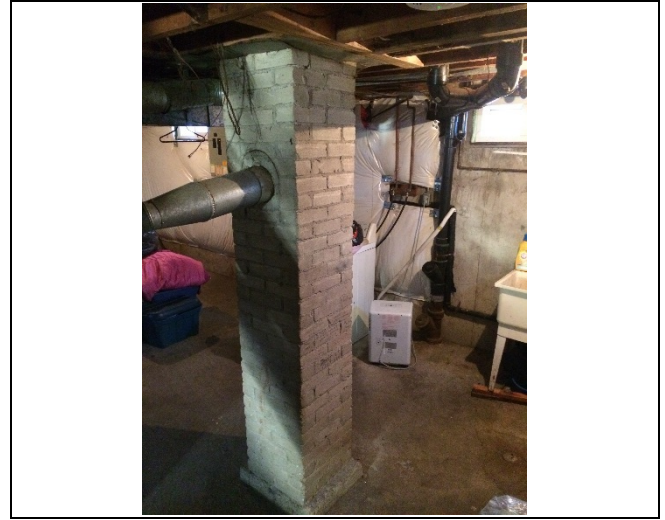
Photo 6: Presumed asbestos-containing brick mortar on a column in the basement of 43 Brighton Crescent.

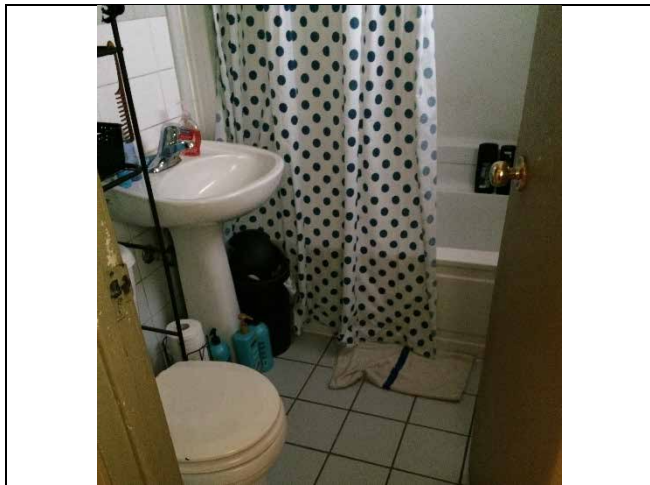
Photo 7: Presumed asbestos-containing ceramic tile grout and mortar/adhesive on the washroom walls and floor of 43 Brighton Crescent.

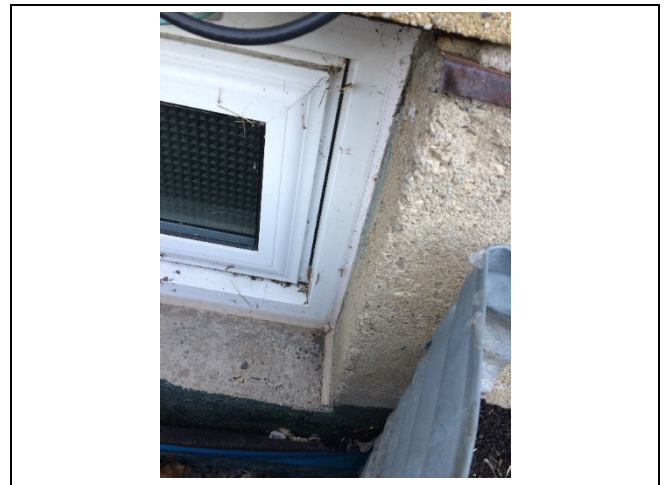
Photo 8: Presumed asbestos-containing exterior caulking – white on a basement window of 43 Brighton Crescent.

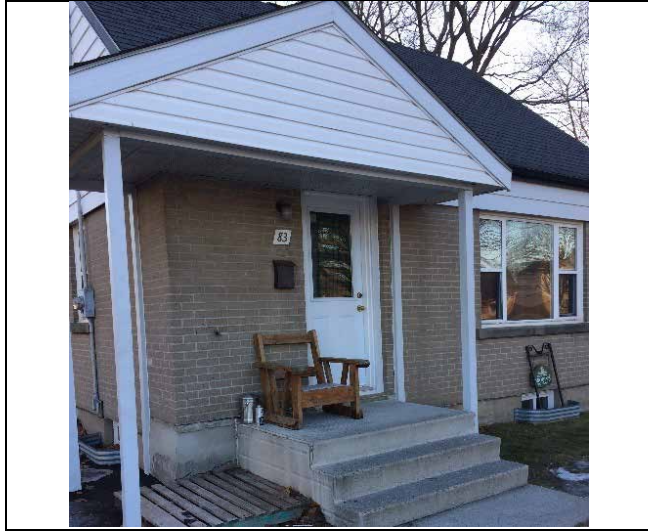
Photo 9: Presumed asbestos-containing exterior window and door caulking – white and brick mortar at the front exterior of 83 Brighton.

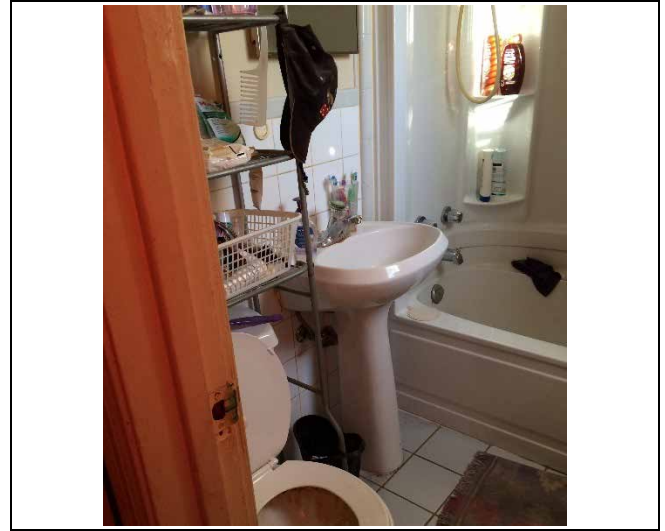
Photo 10: Presumed asbestos-containing ceramic tile grout and mortar / adhesive in the washroom wall and floor at 83 Brighton.

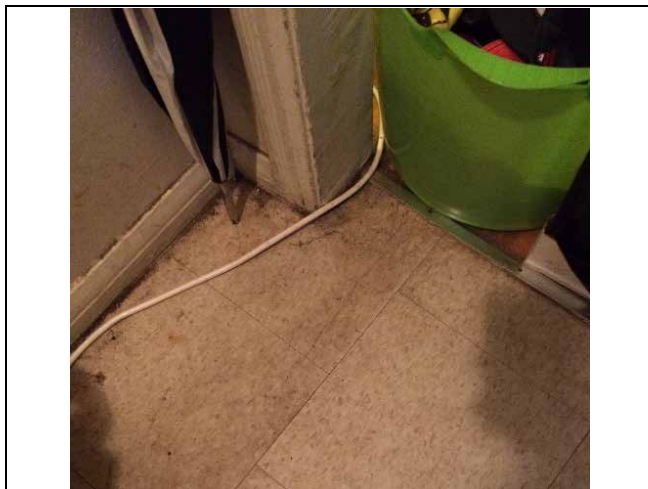
Photo 11: Asbestos-containing drywall joint-fill compound and presumed asbestos-containing mastic associated with 12"x12" vinyl floor tiles – beige and yellow smears in the foyer at 83 Brighton.

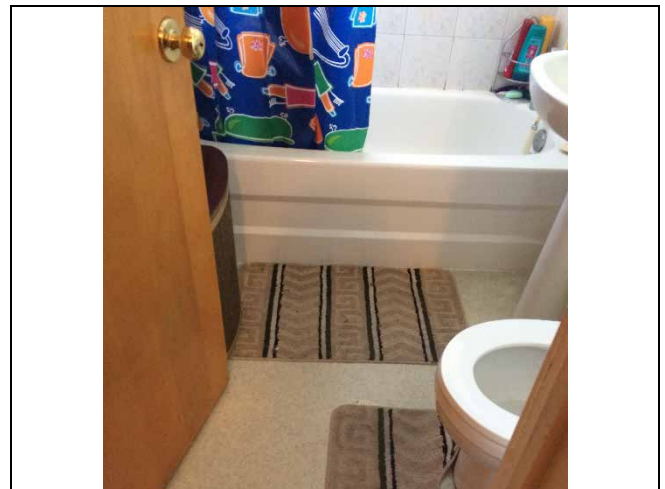
Photo 12: Presumed asbestos-containing ceramic tile grout and mortar / adhesive in the washroom wall at 84 Brighton.

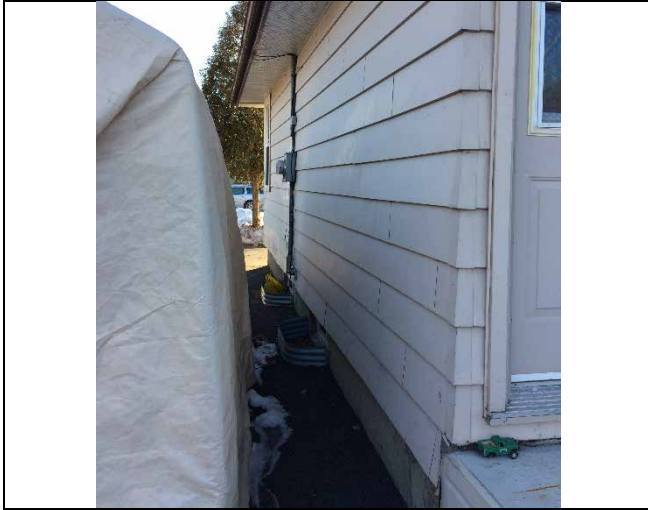
Photo 13: Presumed asbestos-containing exterior door / siding caulking - pink at the back exterior of 84 Brighton.

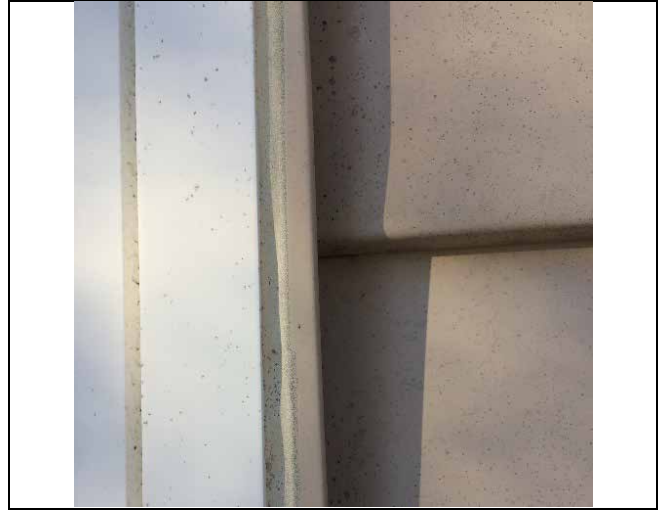
Photo 14: Presumed asbestos-containing exterior window caulking - white at the side window of 84 Brighton.
