Asbestos Building Materials Assessment

Multi-Unit Residential Building
275 Water Street
Prescott ON

Project No.: 122150275

February 16, 2017

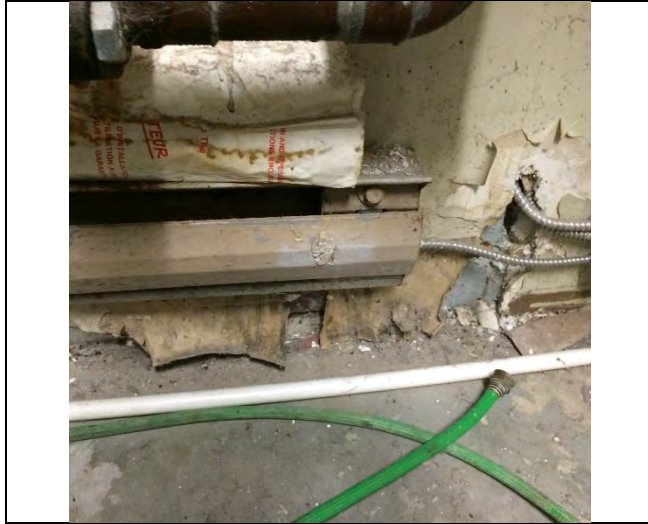
Drywall joint-fill compound was observed to be in damaged in the lounge (<1 sq. m of water damage) and the mechanical room (8 sq. m of water damage). The remaining materials were observed to be in good condition. It should be noted that drywall joint-fill compound is considered non-friable in its undisturbed state but can release fibers when damaged.

Photo 1: Asbestos-containing drywall joint-fill compound (1% Chrysotile) observed to be damaged in the mechanical room.

- Damaged asbestos-containing drywall joint-fill compound, should be removed following Type 2 procedures;
- Asbestos-containing materials that may be impacted during renovation or demolition activities should be removed prior to the renovation or demolition activities;

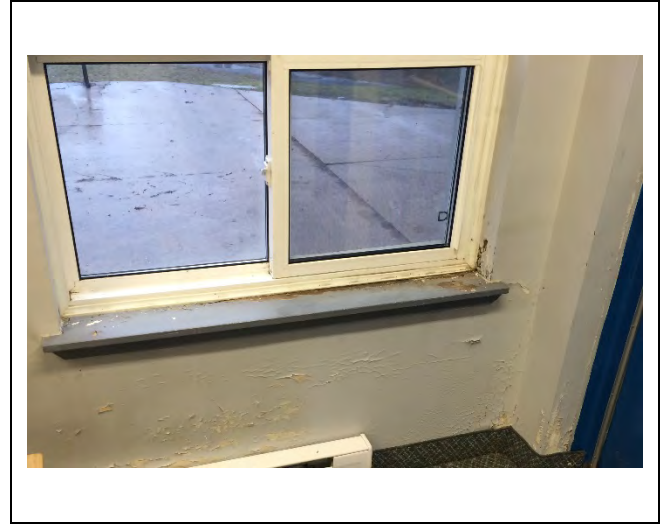
Photo 2: Asbestos-containing drywall joint-fill compound (1% Chrysotile) observed to be damaged in the lounge.

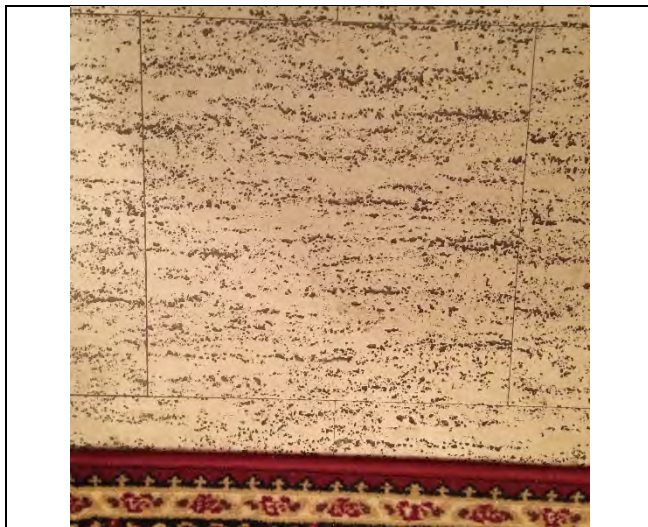
Photo 3: 12"x12" vinyl floor tile – beige with grey specks identified to be asbestos-containing (4.08% Chrysotile).

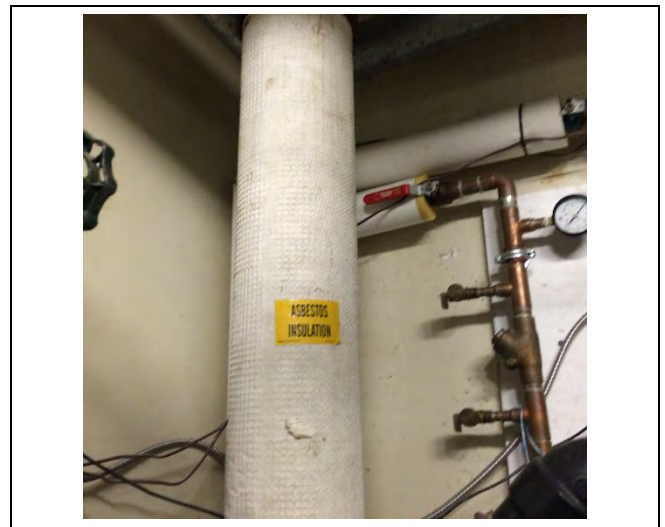
Photo 4: Cement pipe presumed to be asbestos-containing in the mechanical room.

- Prior to renovation or demolition activities that would disturb them, undertake testing of PACMs that may be impacted to determine their asbestos content. Confirmed asbestos materials should be handled accordingly;

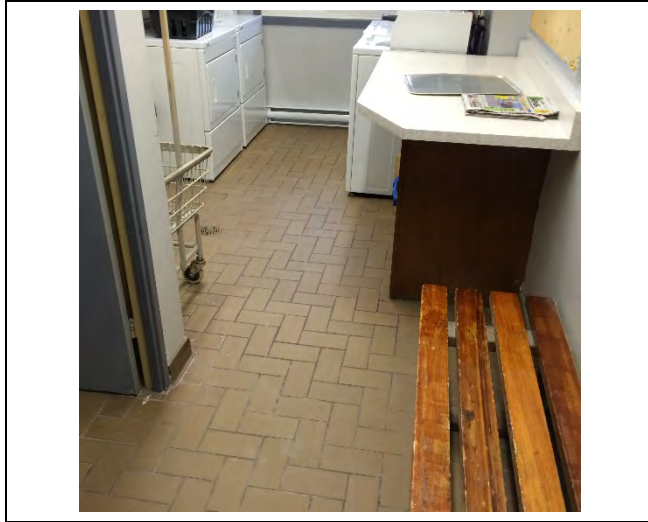
Photo 5: Ceramic tile grout and mortar/adhesive presumed to be asbestos-containing.

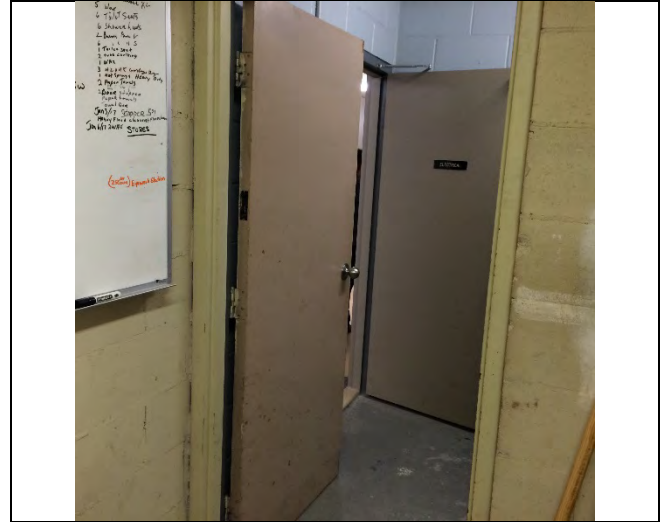
Photo 6: Fire rated doors – metal, presumed to be asbestos-containing.
