Asbestos Building Materials Assessment

Multi-Residential Building
240 Helen Street
Cardinal ON

Project No.: 122150275

February 17, 2017

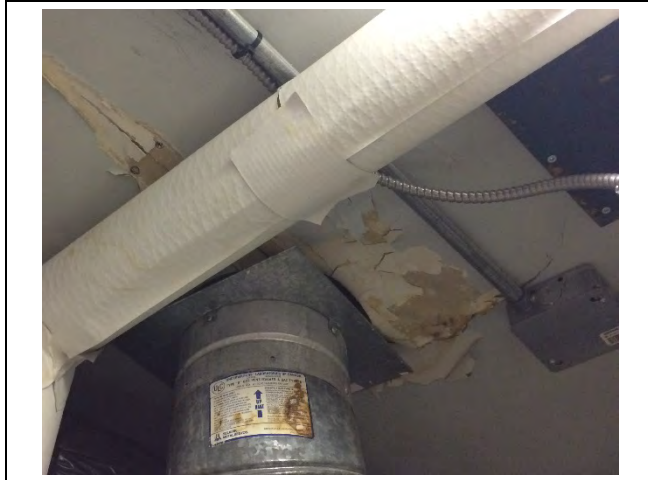
The 12"x12" vinyl floor tiles – beige with black dots were observed to be in poor condition in Unit 108 living room (1 cracked tile) and in Unit 106 hallway (1 cracked tile). Drywall joint-fill compound was observed to be in poor condition in the laundry room's hot water tank room. The remaining materials were observed to be in good condition.

Photo 1: Asbestos-containing drywall joint-fill compound observed to be in poor condition on the ceiling in the hot water tank room located in the laundry room.

- Non-asbestos-containing vinyl floor tiles should be installed over exposed presumed asbestos-containing mastic;
- Damaged asbestos-containing drywall joint-fill compound be removed following Type 2 abatement procedures;

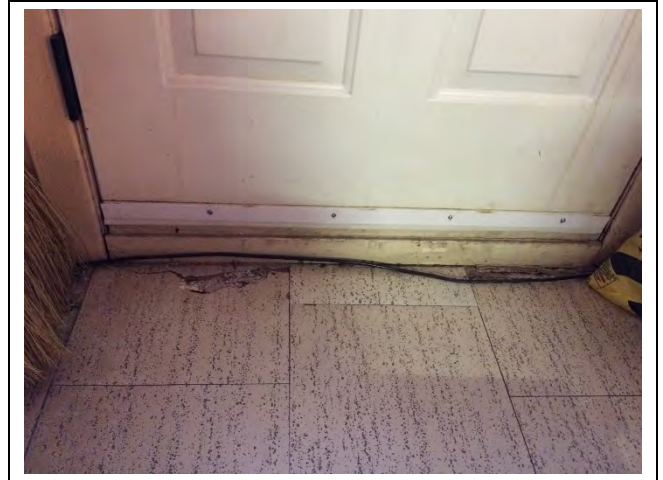
1	Unit 108	Living Room, Hallway, Closets, Washroom and Bedroom	Floor	12"x12" Vinyl Floor Tile - Beige with Black Dots	65 sq.m	Ref: 240-BS-09A	No	2.35% Chrysotile	No Yes	A	poor	CRACKED TILE OBSERVED AT EXTERIOR DOOR IN LIVING ROOM

Photo 2: Asbestos-containing 12"x12" vinyl floor tile – beige with black dots observed to be in poor condition (cracked tiles) in the living room of Unit 108.

- Cracked asbestos-containing 12"x12" vinyl floor tile – beige with black dots should be removed and disposed of following Type 1 abatement procedures;

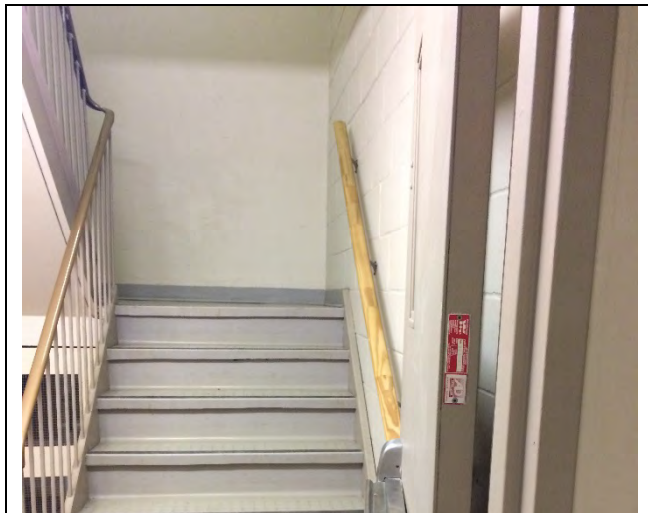
Photo 3: Presumed asbestos-containing fire rated door.

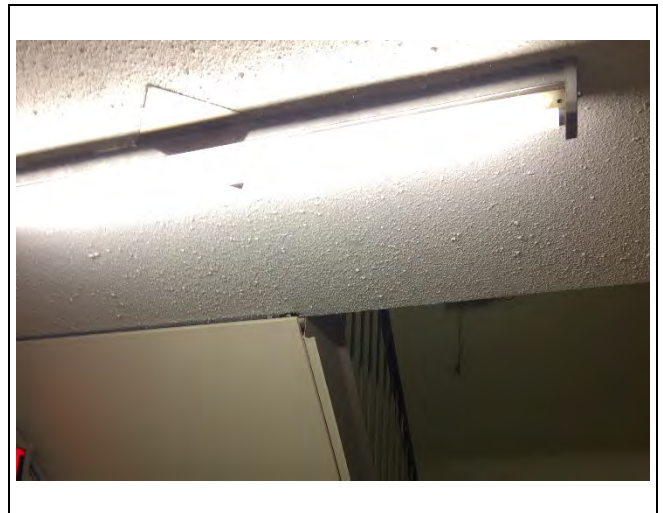
Photo 4: Asbestos-containing texture coat in the 1st floor north stairs.

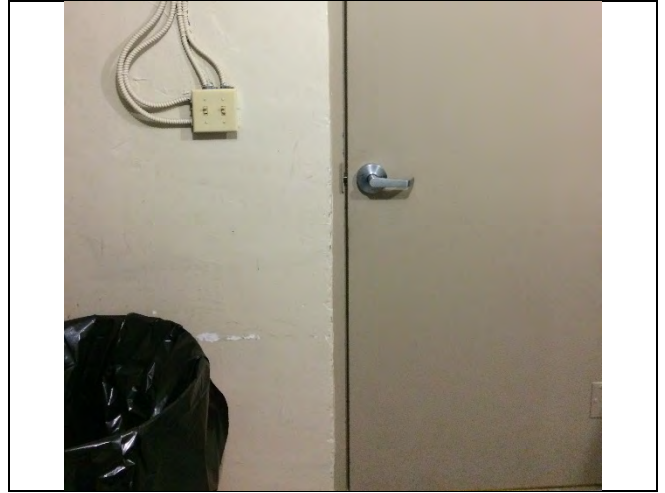
Photo 6: Asbestos-containing plaster observed in the garbage room.

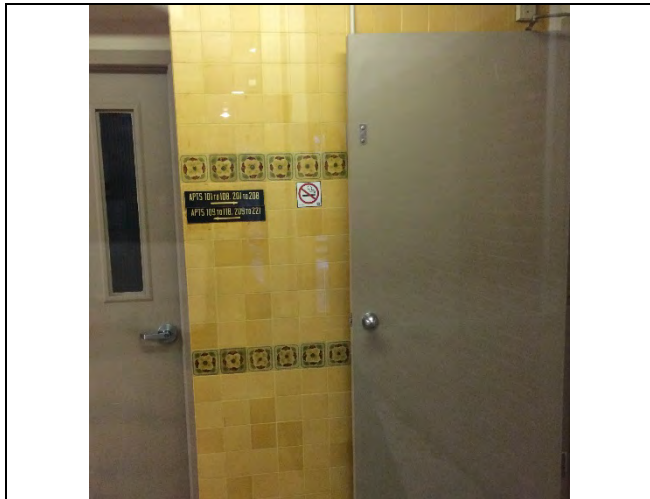
Photo 7: Presumed asbestos-containing ceramic tile grout and mortar/adhesive.

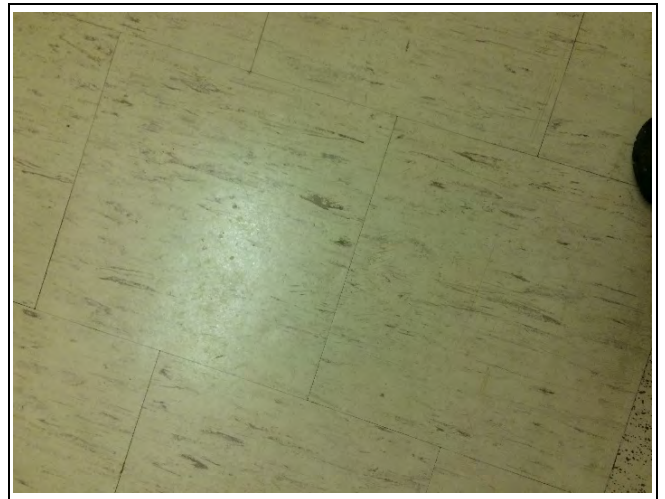
Photo 8: Asbestos-containing 12"x12" vinyl floor tile – beige with brown.
