Asbestos Building Materials Assessment

House
10 Bisley Crescent
Brockville ON

Project No.: 122150275
February 15, 2017

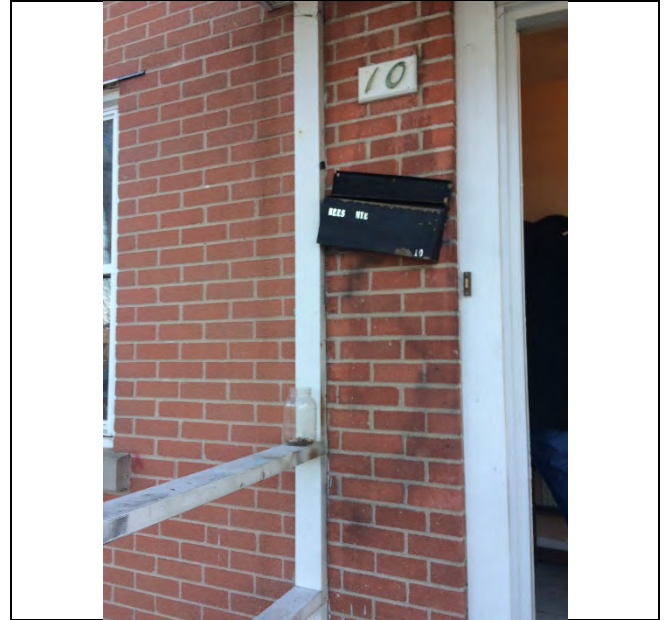
Photo 2: Presumed asbestos-containing brick mortar and exterior door caulking – white observed on the exterior.
