Asbestos Building Materials Assessment

Residential House
535 Churchill Road
Prescott, ON

Project No.: 122150275

February 15, 2017

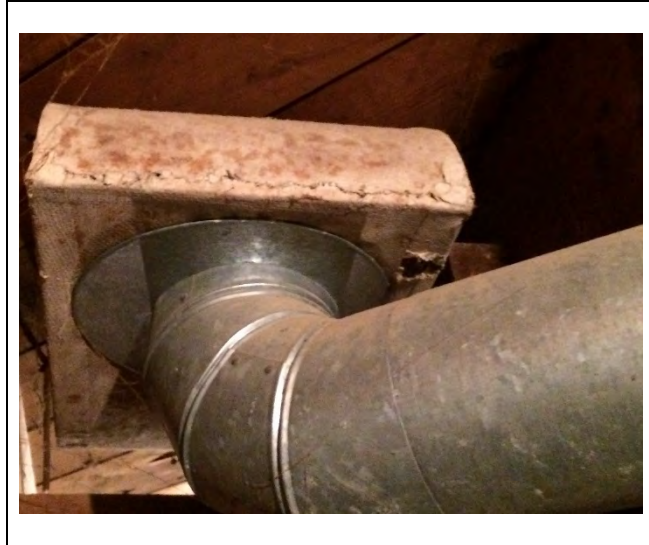
This material was observed to be in poor condition (2 ducts torn) in the basement. The remaining materials were observed to be in good condition

Photo 1: Asbestos-containing duct insulation paper wrap (60% Chrysotile) in poor condition.

- Damaged asbestos-containing duct insulation paper wrap, should be repaired following Type 2 Procedures;
- Asbestos-containing materials that may be impacted during renovation and/or demolition activities should be removed prior to the renovation and/or demolition activities;

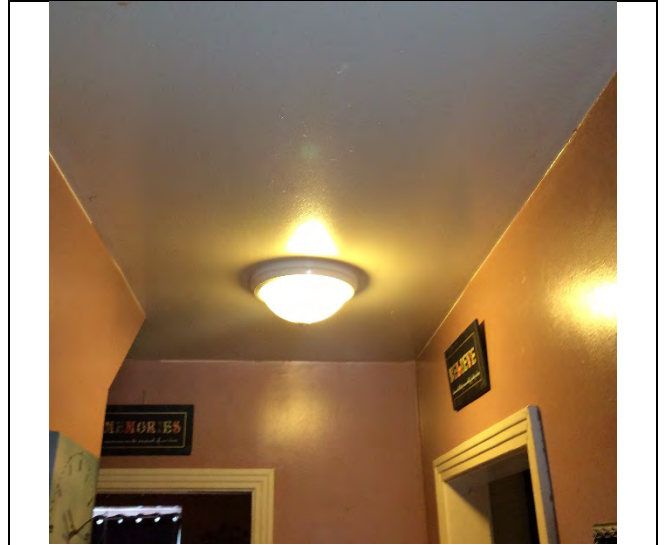
It should be noted that drywall joint-fill compound is considered non-friable in its undisturbed state but can release fibers when damaged.

Photo 2: Asbestos-containing drywall joint-fill compound (1% Chrysotile).

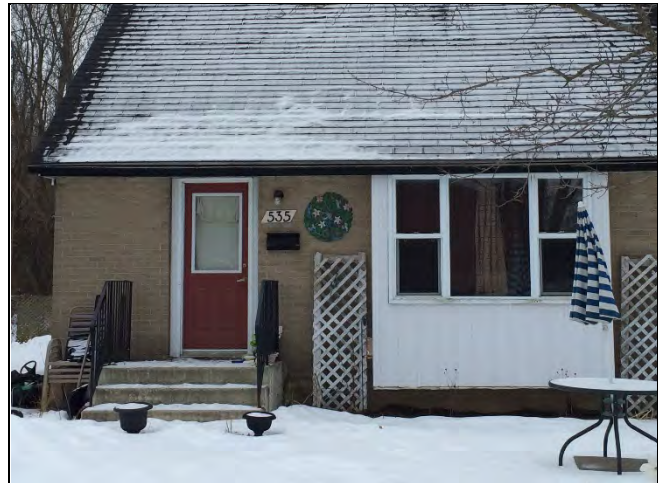
These materials were observed to be in good condition. These materials were not sampled to preserve their integrity. As these materials are known to have been manufactured with asbestos, they should be presumed to be asbestos-containing unless proven otherwise by laboratory analysis.

Photo 4: Presumed asbestos-containing brick mortar, roofing materials, and roof caulking.

- Prior to renovation and/or demolition activities that would disturb them, undertake testing of PACMs that may be impacted to determine their asbestos content. Confirmed asbestos materials should be handled accordingly;
- Should a material suspected to contain asbestos fibres become uncovered during renovation and/or demolition activities, all work in the areas that may disturb the material should be stopped. Samples of the suspect material should be submitted for laboratory analysis to determine if asbestos fibres are present. Confirmed asbestos materials should be handled accordingly; and,
- This report should be added to the Asbestos Management Program and referred to as the current asbestos record.
