## **Asbestos Building Materials Assessment**

Row Houses  
518, 550, 555, 563, and 574 Fort Town  
Drive, Prescott ON

Project No.: 122150275

February 17, 2017

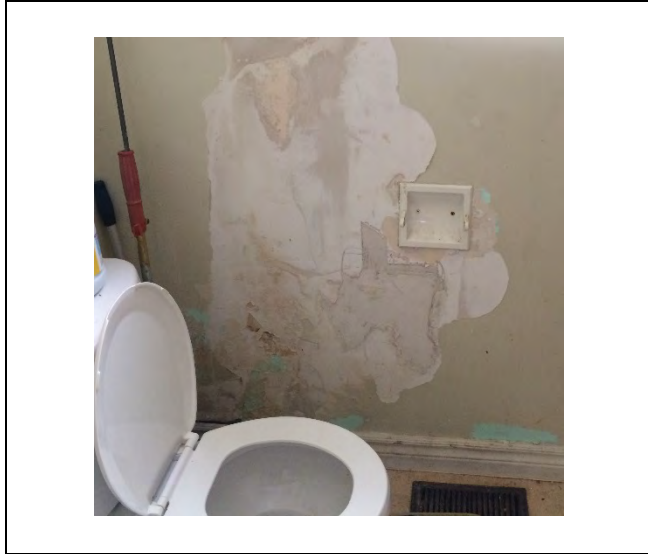
- 555 Fort Town Drive main entrance wall (chipped, (3 sq. m) and washroom wall (water damage, 1 sq. m); and,
- 574 Fort Town Drive kitchen wall (chipped, <1 sq. m).

Photo 1: Asbestos-containing drywall joint-fill compound observed to be in poor condition on wall in the washroom at 555 Fort Town Drive.

- Damaged asbestos-containing drywall joint-fill compound should be repaired following Type 1 abatement procedures;
- Asbestos-containing materials that may be impacted during renovation and/or demolition activities should be removed prior to the renovation and/or demolition activities;

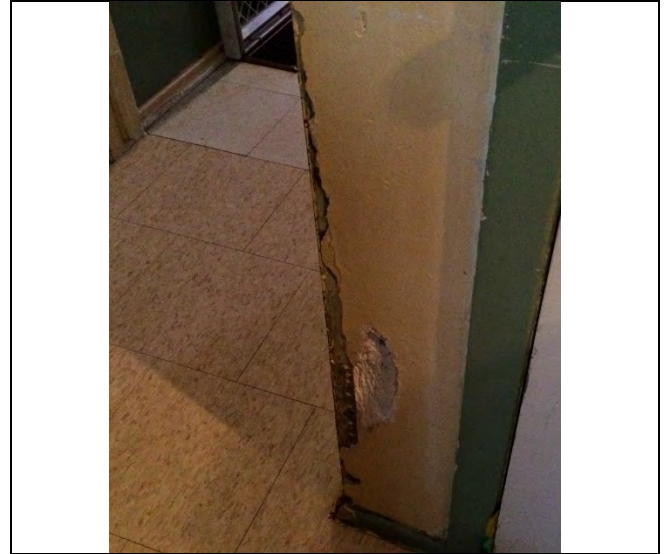
Photo 2: Asbestos-containing drywall joint-fill compound observed to be in poor condition on the kitchen wall at 574 Fort Town Drive.

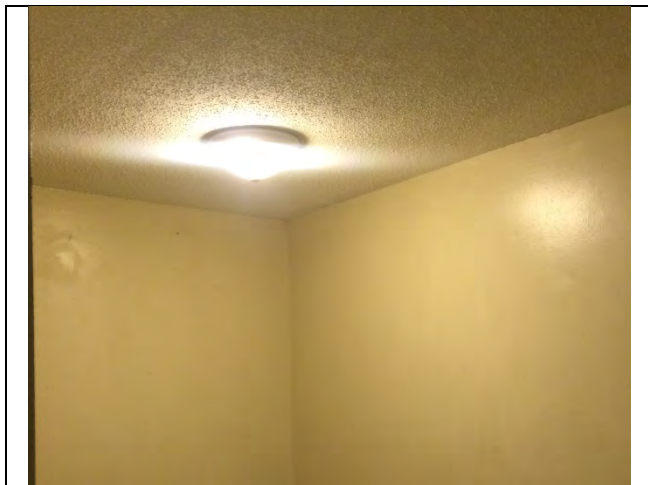
Photo 3: Asbestos-containing drywall joint-fill compound and stucco observed at 550 Fort Town Drive.

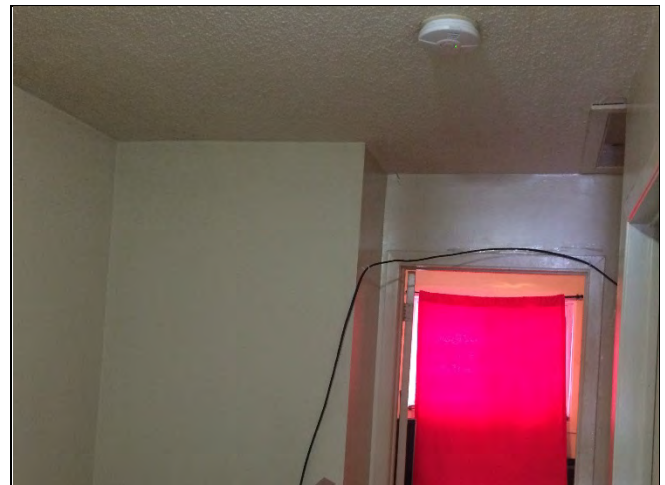
Photo 4: Asbestos-containing drywall joint-fill compound and stucco observed on walls and ceiling at 518 Fort Town Drive.

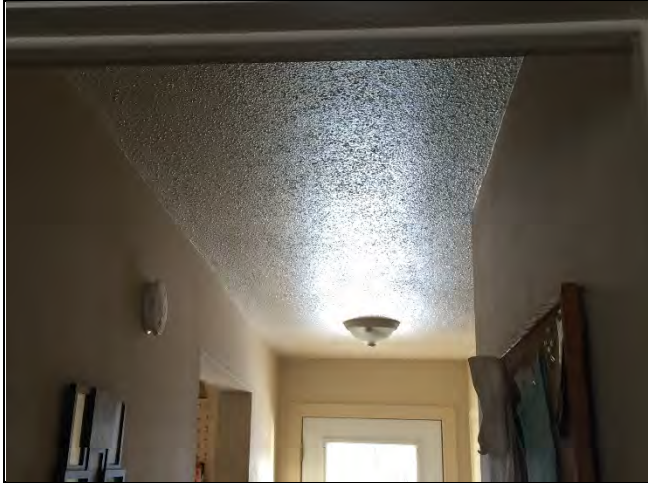
Photo 5: Asbestos-containing stucco and drywall joint-fill compound observed at 563 Fort Town Drive.

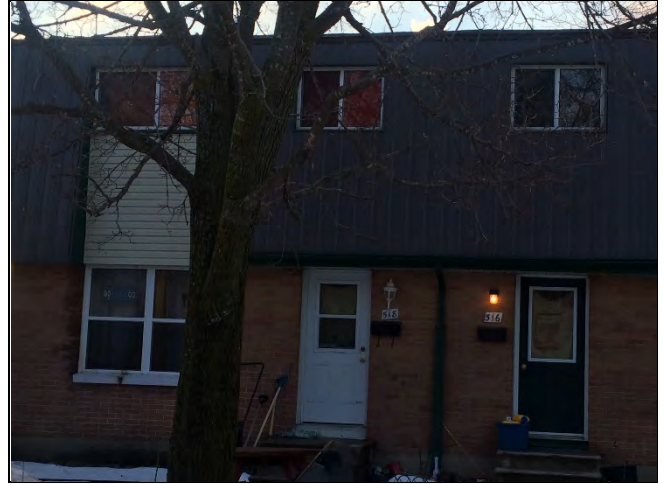
Photo 6: Presumed asbestos-containing brick mortar observed to be present on the exterior walls.

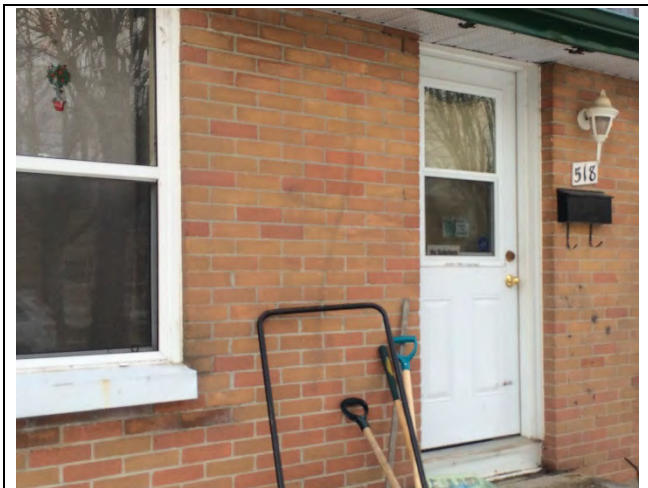
Photo 7: Presumed asbestos-containing exterior caulking – white observed on the exterior windows and doors at 518 Fort Town Drive.
