Asbestos Building Materials Assessment

Multi-Residential Building
43 Centre Street
Lansdowne ON

Project No.: 122150275

February 15, 2017

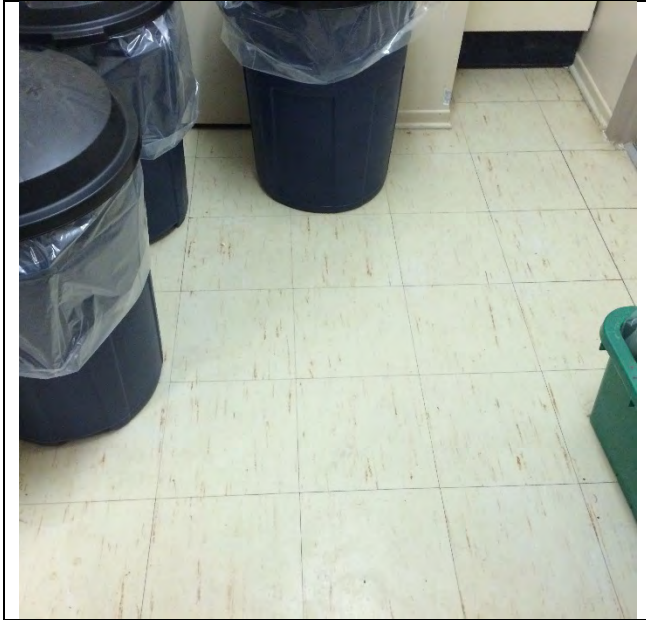
Photo 1: 12"x12" vinyl floor tile – beige with brown streaks identified to be asbestos-containing (2.23% Chrysotile).

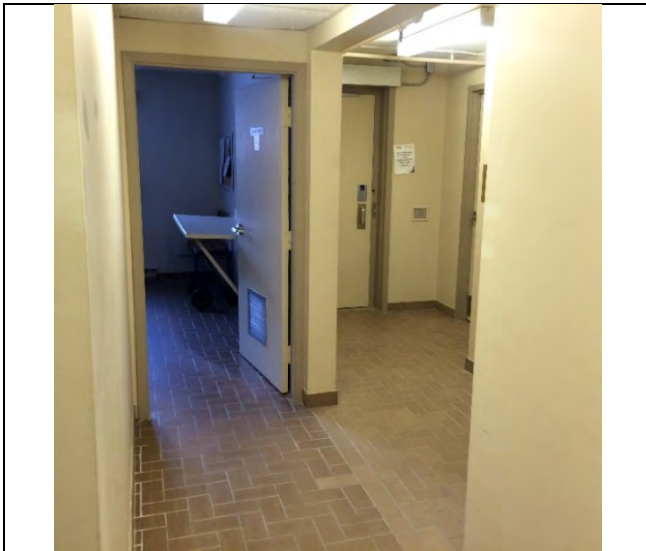
It should be noted that drywall joint-fill compound is considered non-friable in its undisturbed state but can release fibers when damaged.

Photo 3: Drywall joint-fill compound identified to be asbestos-containing in the hallways (1% Chrysotile).

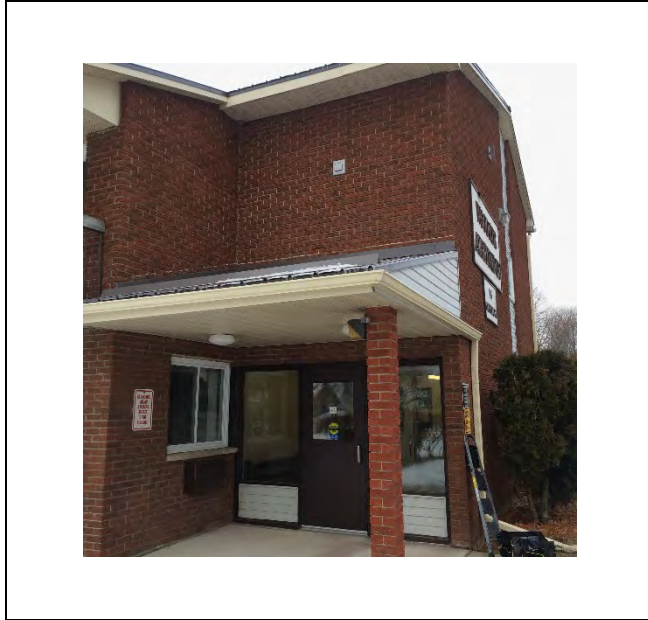
Photo 5: Exterior and interior door caulking is presumed to be asbestos-containing.

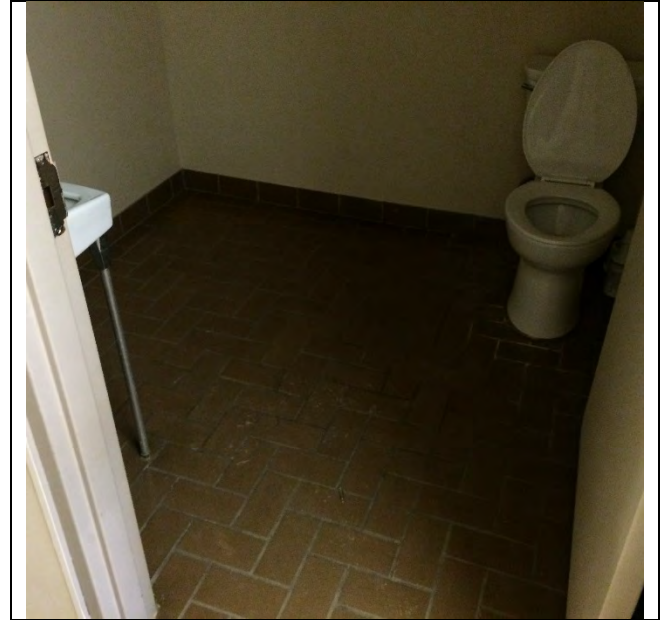
Photo 6: Ceramic tile grout and mortar/adhesive are presumed to be asbestos-containing in the washroom.
