Asbestos Building Materials Assessment

Multi-Unit Residential Building
11 Hastings Drive
Brockville ON

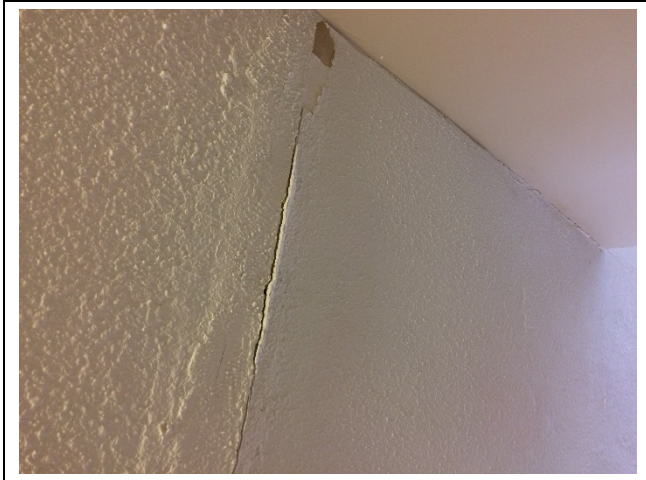
Photo 1: Asbestos-containing texture coat observed to be in poor condition on the ceiling in the lobby area

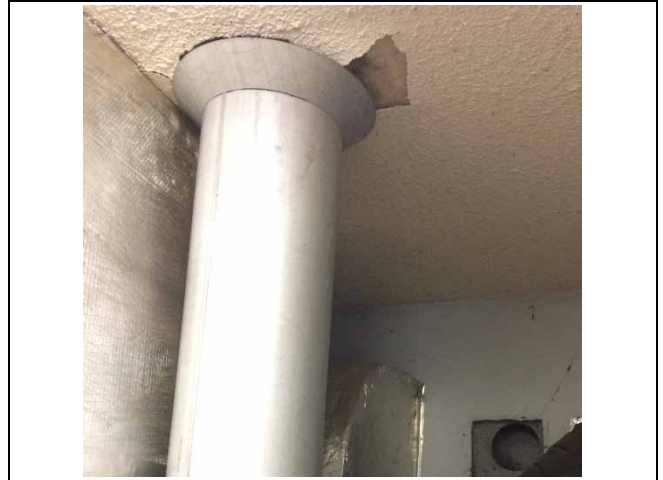
Photo 2: Asbestos-containing texture coat observed to be in poor condition on the ceiling in the storage by unit 214.

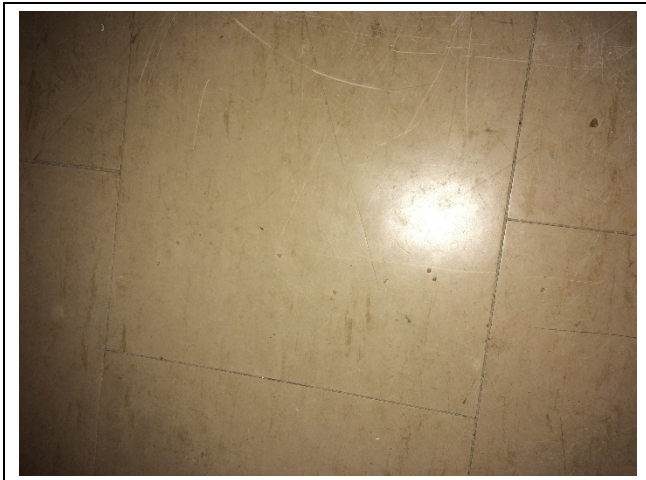
Photo 3: Asbestos-containing 12"x12" vinyl floor tiles – brown with brown streaks observed to be in good condition in unit 103 bedroom.

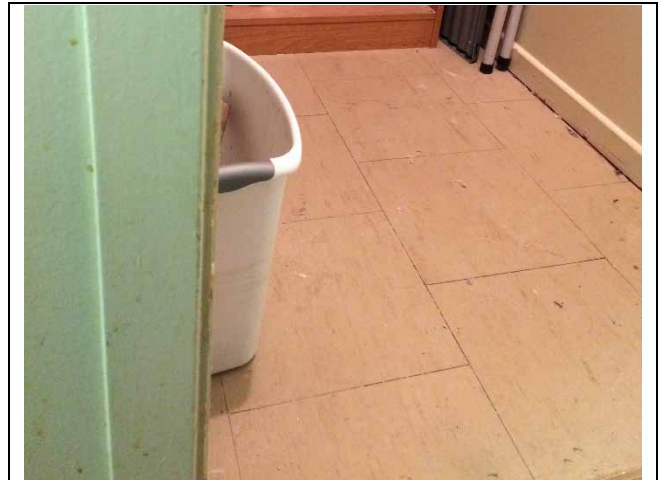
Photo 4: Asbestos-containing 12"x12" vinyl floor tiles – beige with light brown smears observed to be in good condition in unit 213 closet.

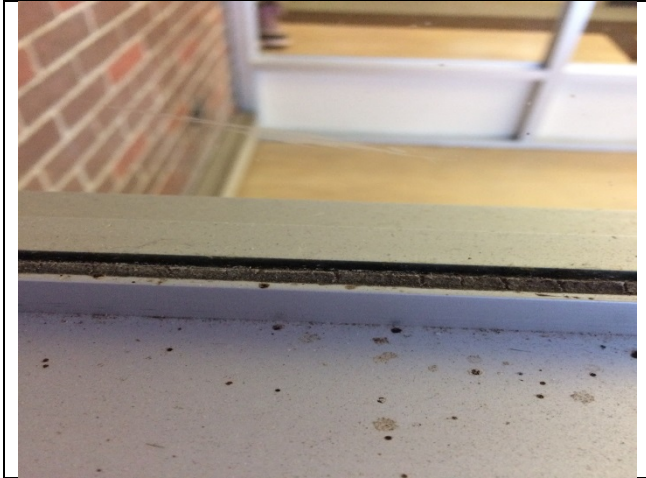
Photo 5: Asbestos-containing exterior window glaze – white observed to be in good condition on the windows at the main entrance doors.

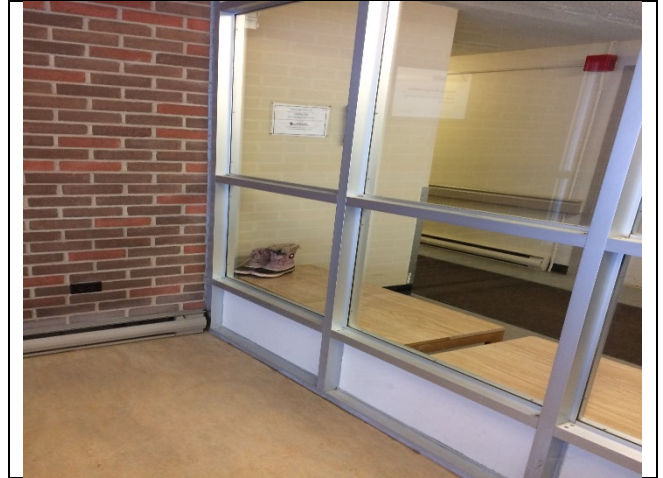
Photo 6: Asbestos-containing interior window glaze – white observed to be in good condition on the windows at the main entrance doors.

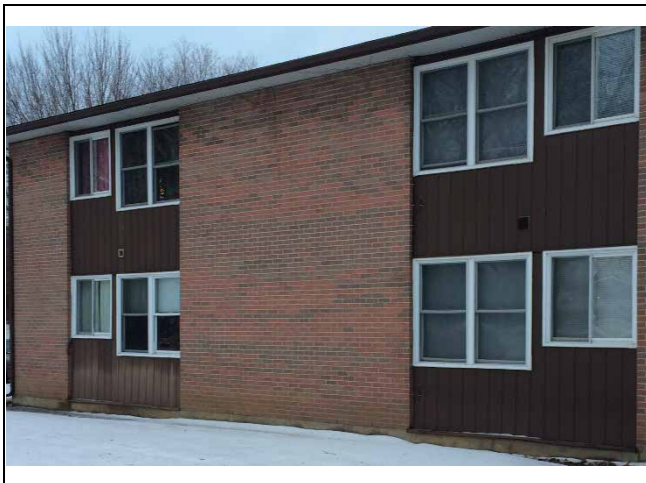
Photo 7: Presumed asbestos-containing brick mortar observed to be in good condition on the North exterior walls.
