## **Asbestos Building Materials Assessment**

Multi-Residential Building  
55 Reynolds Drive  
Brockville ON

Project No.: 122150275

February 15, 2017

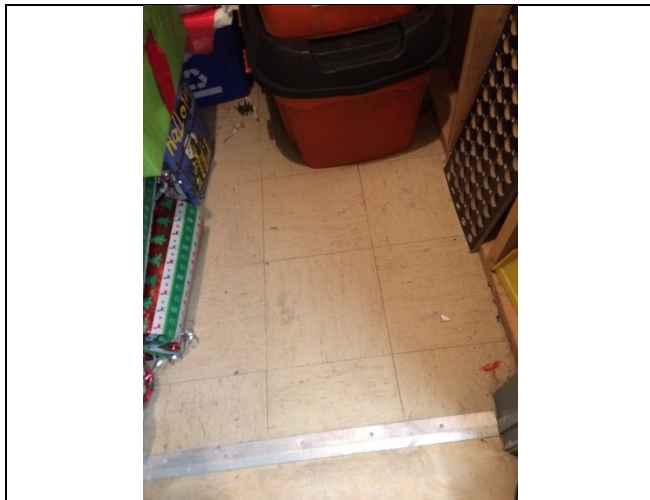
These materials were observed to be in good condition.

Photo 3: Asbestos-containing 12"x12" vinyl floor tiles – beige with brown streaks in the tenant storage under the stairwell.

- Asbestos-containing materials that may be impacted during renovation and/or demolition activities should be removed prior to the renovation and/or demolition activities;

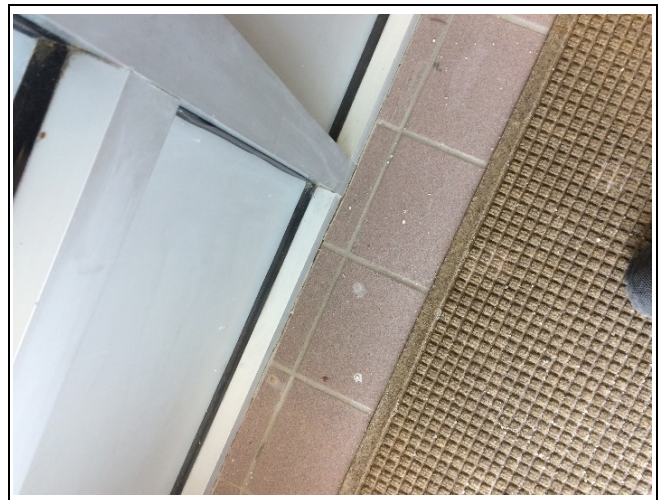
These materials were observed to be in good condition. These materials were not sampled to preserve their integrity. As these materials are known to have been manufactured with asbestos, they should be presumed to be asbestos-containing unless proven otherwise by laboratory analysis.

Photo 4: Presumed asbestos-containing ceramic tile grout and mortar/adhesive at the main entrance.

- Prior to renovation and/or demolition activities that would disturb them, undertake testing of PACMs that may be impacted to determine their asbestos content. Confirmed asbestos materials should be handled accordingly;
