## **Asbestos Building Materials Assessment**

House  
98 Reynolds Drive  
Brockville ON

Project No.: 122150275

February 15, 2017

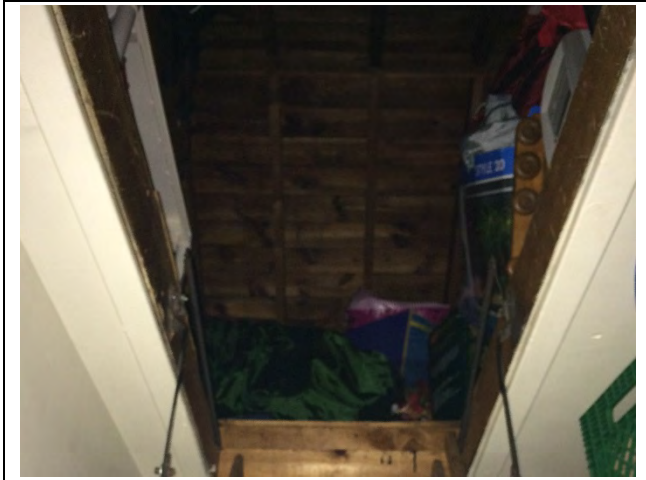
This material was observed to be in good condition.

It should be noted that drywall joint-fill compound is considered non-friable in its undisturbed state but can release fibers when damaged.

Photo 1: Asbestos-containing drywall joint-fill compound was observed to be in good condition on the walls and ceiling in the storage room access to the attic.

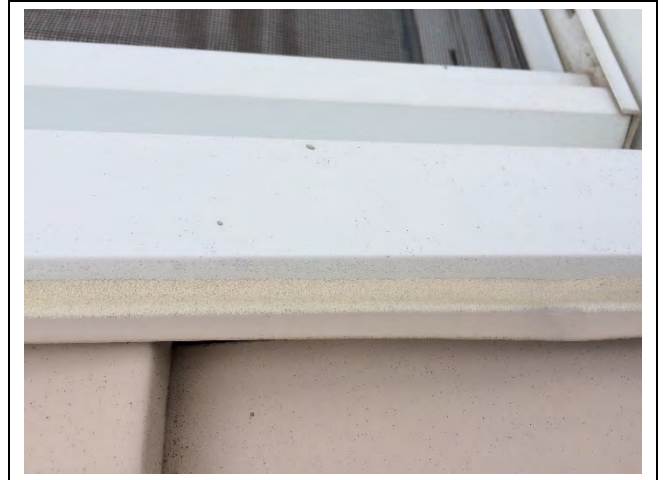
These materials were observed to be in good condition. These materials were not sampled to preserve their integrity. As these materials are known to have been manufactured with asbestos, they should be presumed to be asbestos-containing unless proven otherwise by laboratory analysis.

Photo 2: Presumed asbestos-containing exterior caulking – white on the exterior window.

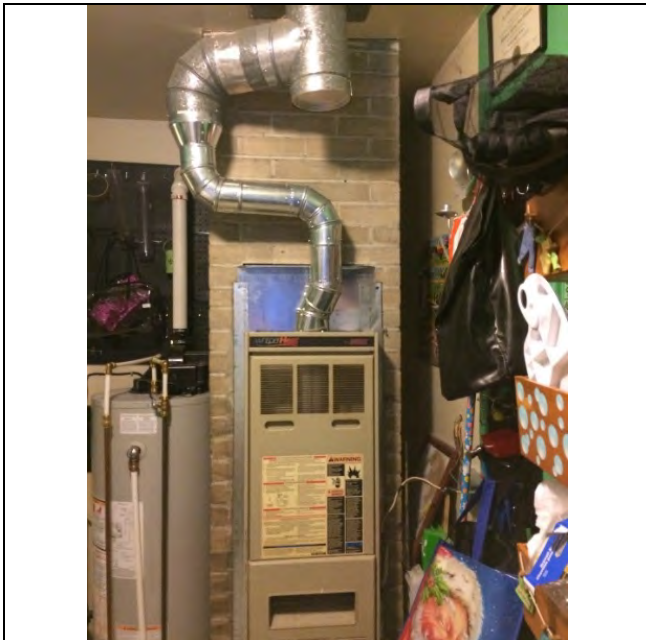
Photo 3: Presumed asbestos-containing brick mortar was observed on a chimney exhaust in the laundry room.

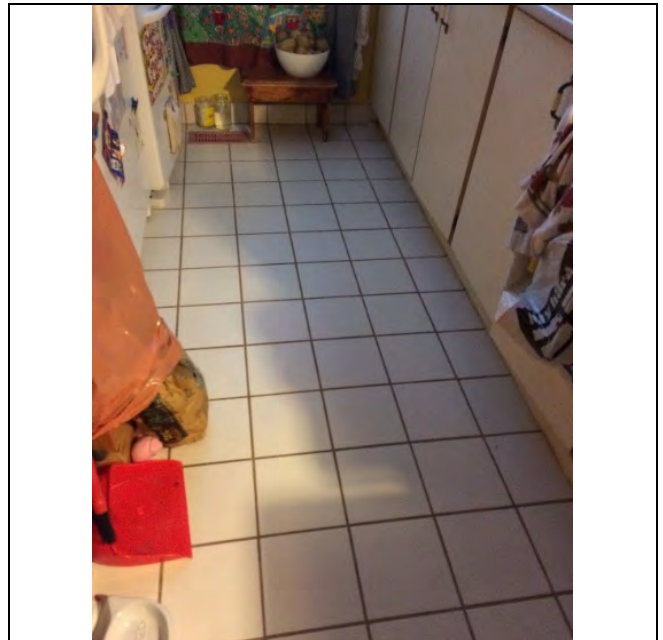
Photo 4: Presumed asbestos-containing ceramic tile grout and mortar / adhesive was observed in the kitchen.
