Asbestos Building Materials Assessment

Residential House
258 Roberta Crescent
Prescott ON

Project No.: 122150275

February 16, 2017

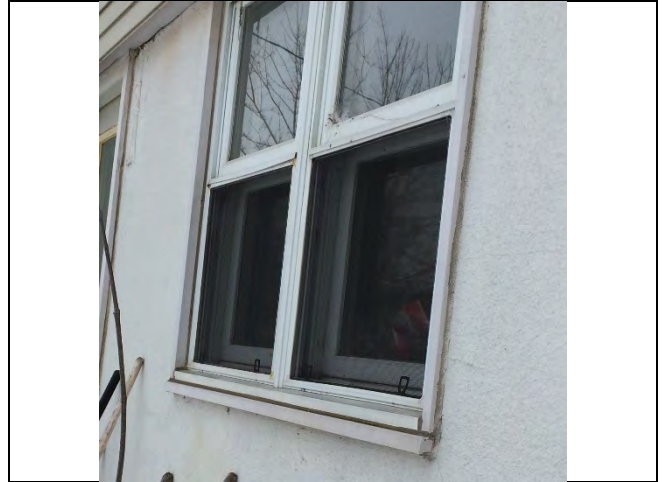
Photo 2: Presumed asbestos-containing exterior window caulking – beige on the exterior back window.
