Asbestos Building Materials Assessment

Multi-Residential Building
318 Brock Street
Merrickville ON

Project No.: 122150275

February 16, 2017

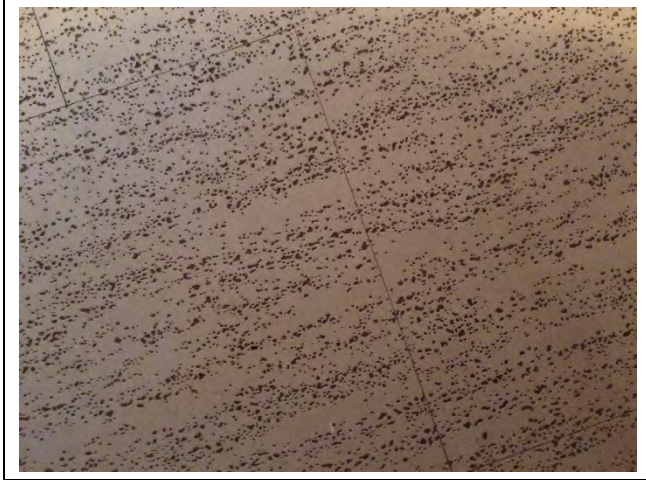
These materials were observed to be in good condition.

Photo 1: Asbestos-containing 12"x12" vinyl floor tiles – beige with dots (2.24% Chrysotile) in unit 103 hallway.

- Asbestos-containing materials that may be impacted during renovation and/or demolition activities should be removed prior to the renovation and/or demolition activities;

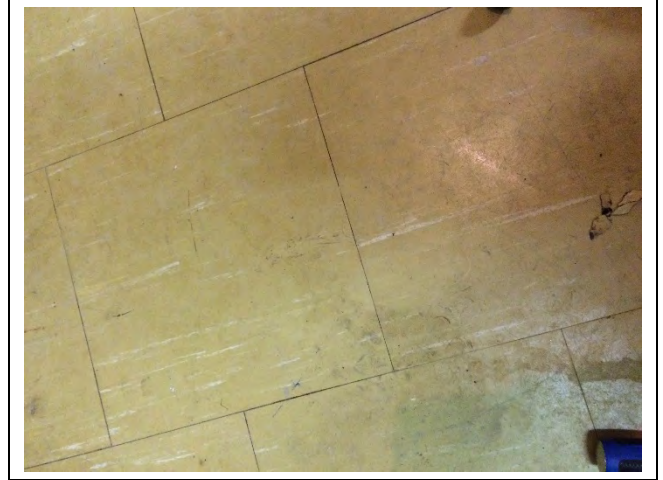
Photo 2: Asbestos-containing 12"x12" vinyl floor tiles – yellow with white streaks (0.75% Chrysotile) in the custodian office.

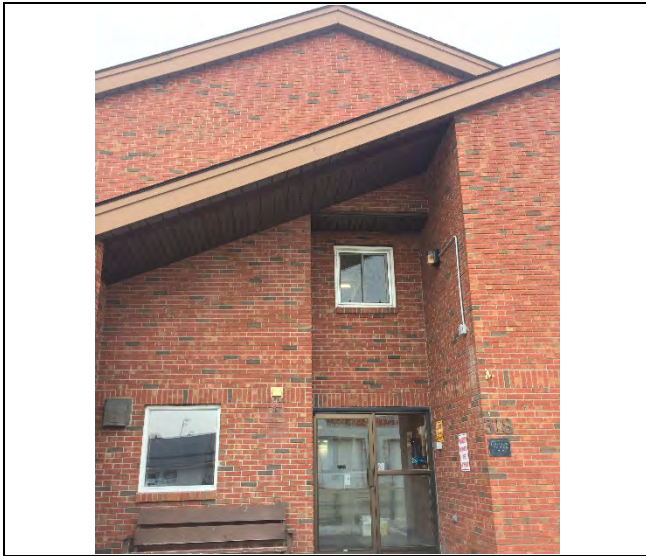
Photo 3: Presumed asbestos-containing brick mortar on the exterior main entrance.

- Prior to renovation and/or demolition activities that would disturb them, undertake testing of PACMs that may be impacted to determine their asbestos content. Confirmed asbestos materials should be handled accordingly;

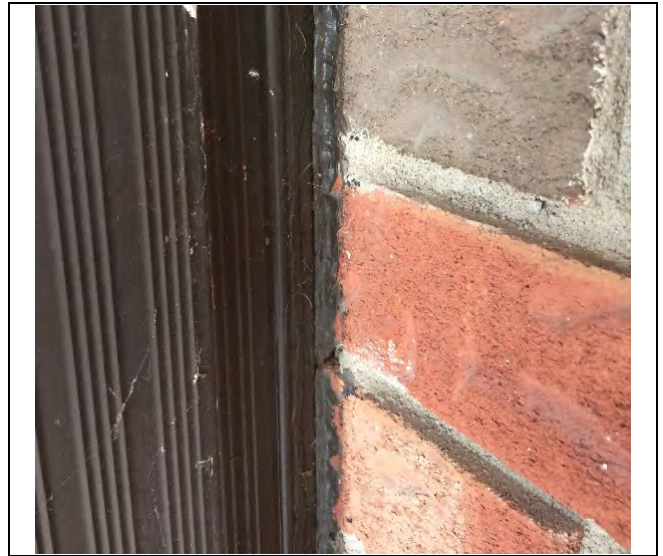
Photo 4: Presumed asbestos-containing exterior door caulking – brown at the exterior door in unit 202.

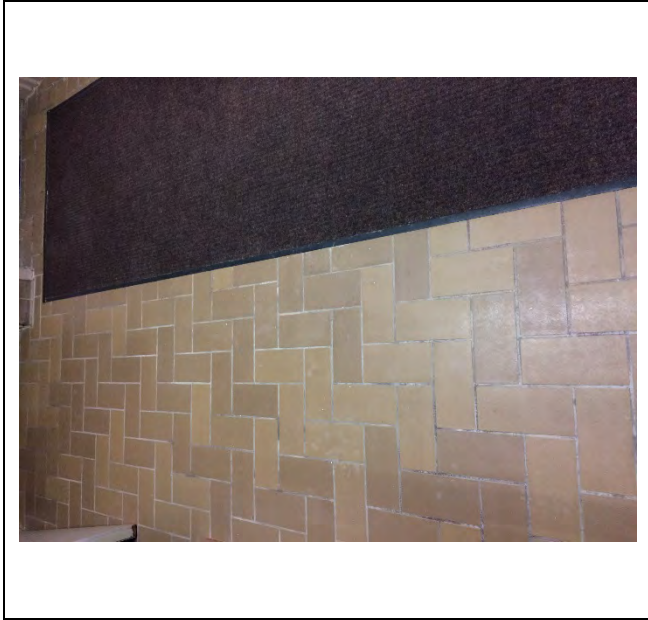
Photo 5: Presumed asbestos-containing ceramic tile grout and mortar/adhesive observed to be in good condition in the lobby.

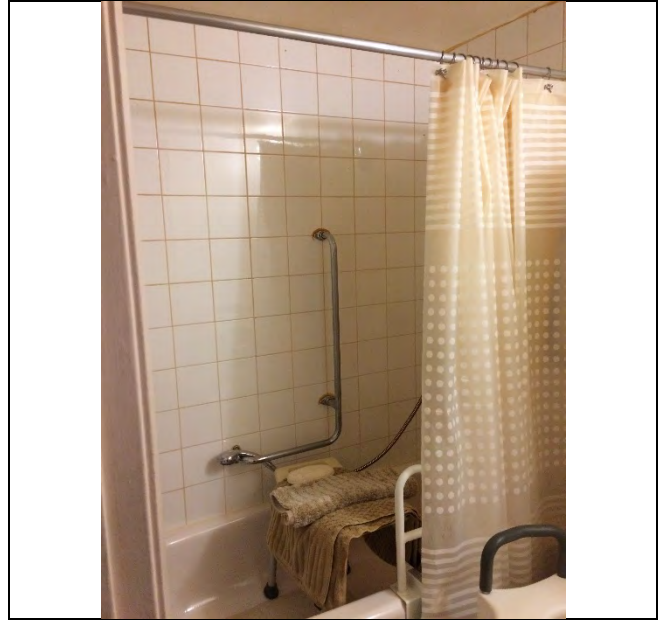
Photo 6: Presumed asbestos-containing ceramic tile grout and mortar/adhesive observed to be in good condition on walls in the washroom at unit 103.
