## **Asbestos Building Materials Assessment**

Residential House  
209 Victor Crescent  
Prescott ON

Project No.: 122150275

February 14, 2017

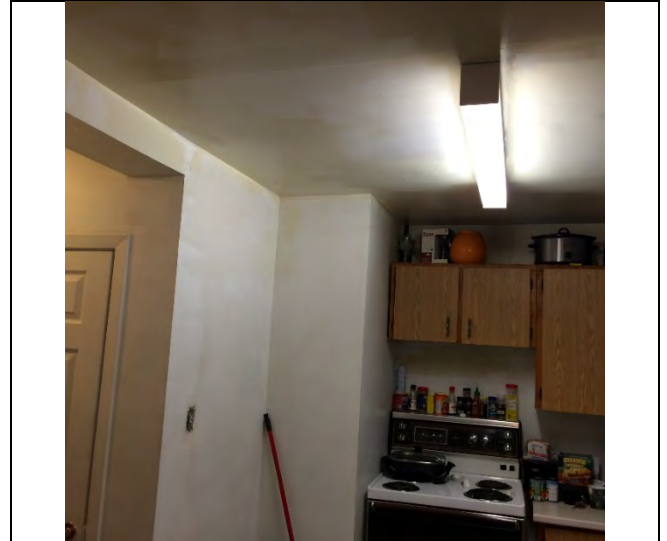
- Drywall joint-fill compound (non-friable).

This material was observed to be in good condition.

It should be noted that drywall joint-fill compound is considered non-friable in its undisturbed state but can release fibers when damaged.

Photo 2: Asbestos-containing drywall joint-fill compound was observed on walls and ceiling.

- Asbestos-containing materials that may be impacted during renovation and/or demolition activities should be removed prior to the renovation and/or demolition activities;
