Asbestos Building Materials Assessment

Multi-Unit Residential Building
33 Bennett Street
Brockville ON

Project No.: 122150275

February 17, 2017

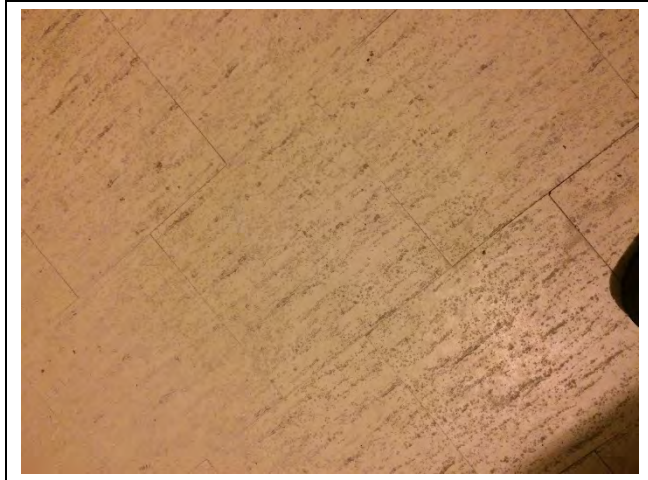
Photo 1: Asbestos-containing 12"x12" vinyl floor tiles – beige with dots observed to be in good condition in the foyer of unit 107.

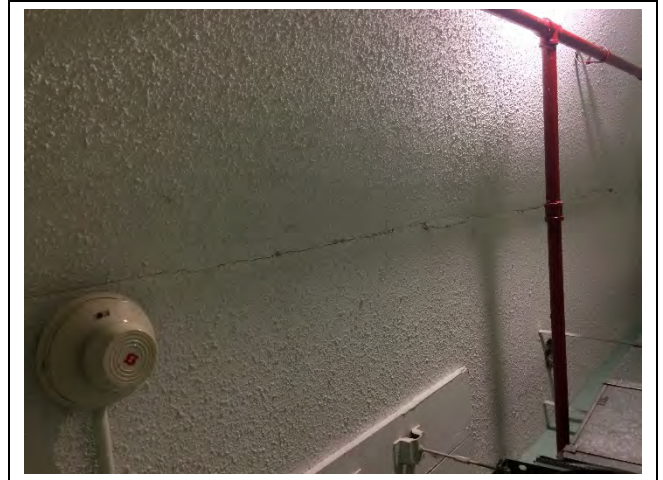
Stucco observed to be in poor condition (cracking, 2 m) in the 2nd floor laundry room.

Photo 2: Asbestos-containing texture material observed to be cracking in the 2nd floor laundry room ceiling.

- Damaged asbestos-containing stucco should be repaired following Type 2 procedures;
- Loose asbestos-containing exterior caulking – brown should be removed and repaired following Type 1 procedures;

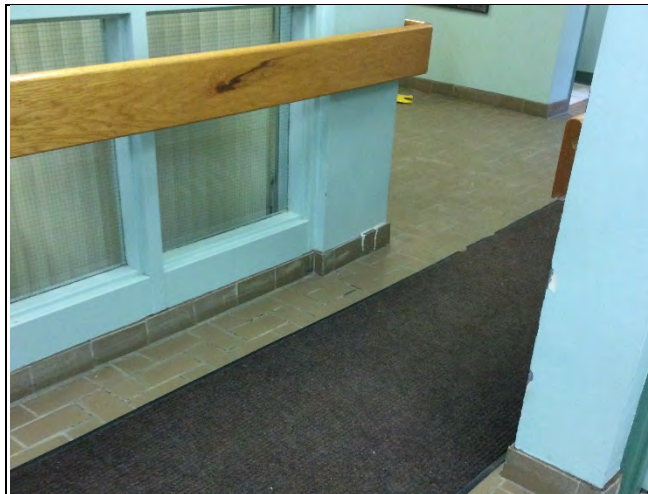
Photo 3: Asbestos-containing drywall joint-fill compound on the walls and presumed asbestos-containing ceramic tile grout and mortar/adhesive on baseboards and floor observed to be in good condition in the 1st floor corridor.

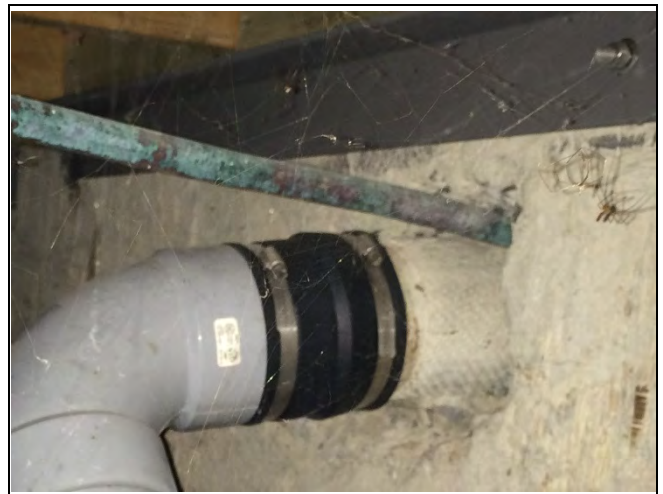
Photo 4: Presumed asbestos-containing cement pipe observed to be in good condition in the crawlspace.
