Asbestos Building Materials Assessment

Multi-Residential Building
56 Bedford Street
Westport ON

Project No.: 122150275

February 17, 2017

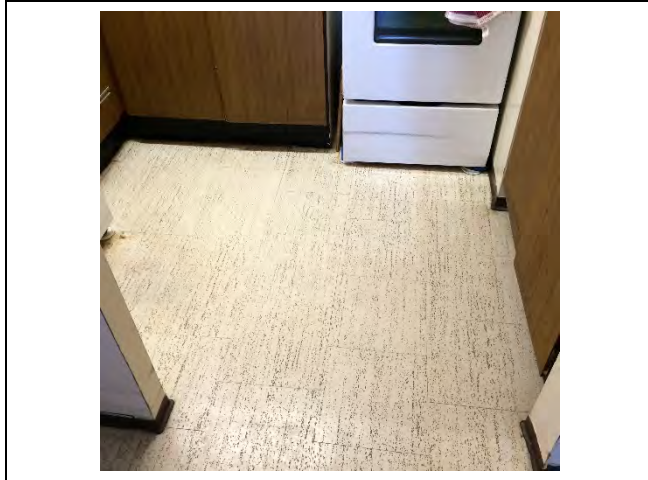
Photo 1: 12"x12" vinyl floor tile – beige with grey specks identified to be asbestos-containing in Unit 101 (1.45% Chrysotile).

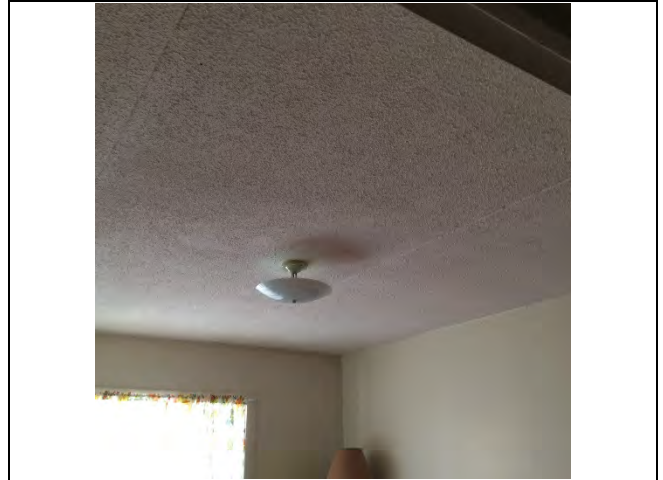
Photo 2: Stucco identified to be asbestos-containing in Unit 210 (3% Chrysotile).

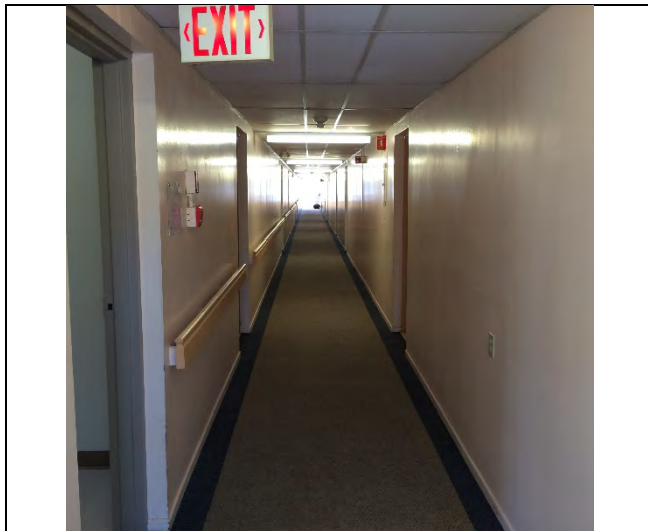
Photo 3: Drywall joint-fill compound identified to be asbestos-containing in the hallways (1% Chrysotile).

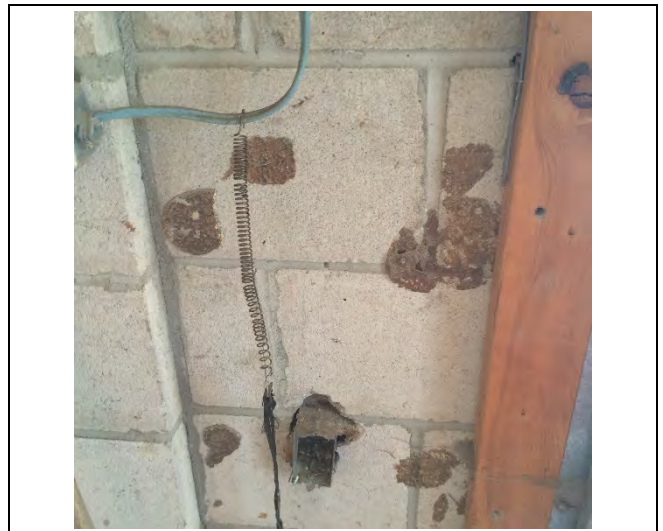
Photo 4: Mastic puck – brown on the block walls in the exterior garage identified to be asbestos-containing (1.2% Chrysotile).

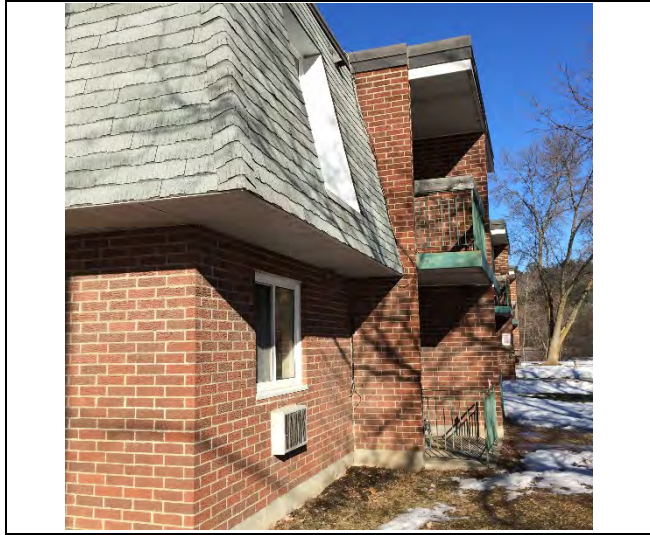
Photo 5: Brick mortar is presumed to be asbestos-containing.

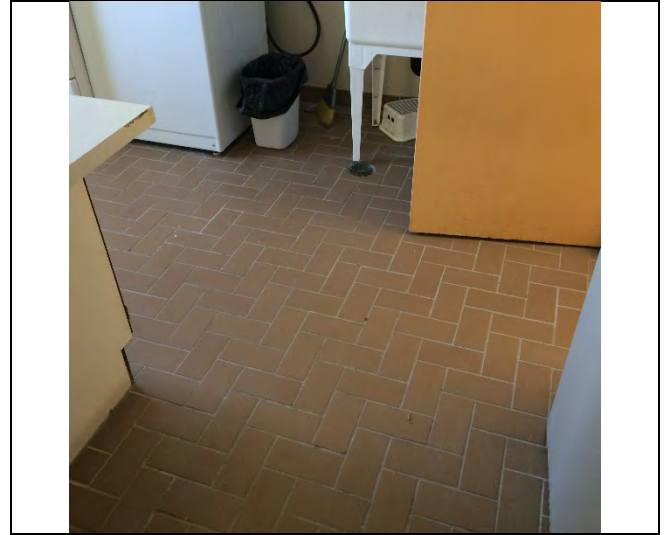
Photo 6: Ceramic tile grout and mortar/adhesive is presumed to be asbestos-containing in the laundry room.

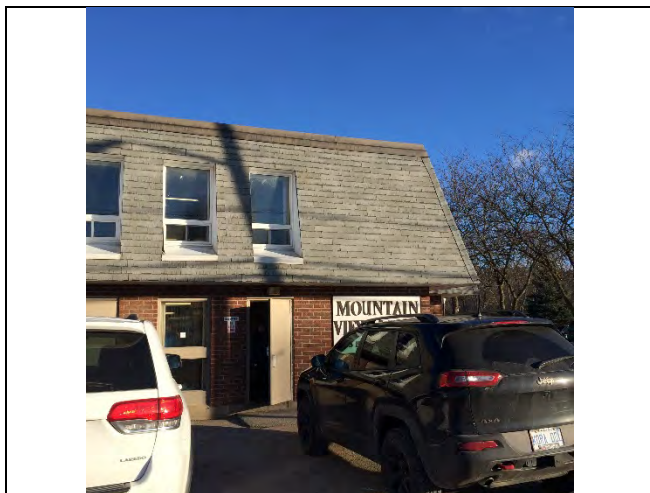
Photo 7: Exterior window and door caulking is presumed to be asbestos-containing.

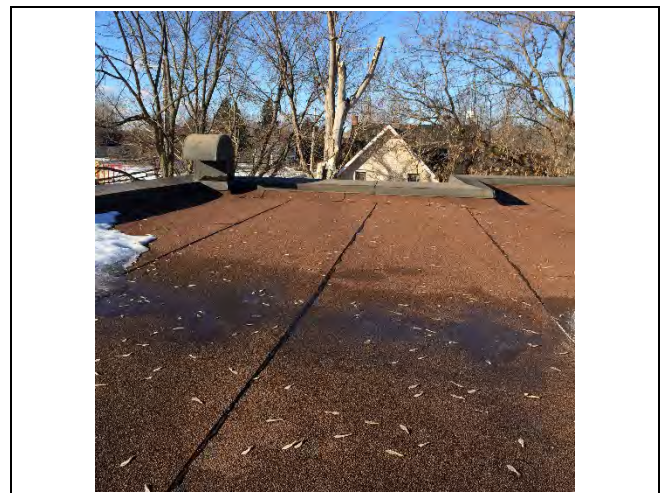
Photo 8: Roof shingles are presumed to be asbestos-containing.
