Asbestos Building Materials Assessment

503 Fort Town Drive
Prescott ON

Project No.: 122150275
February 15, 2017

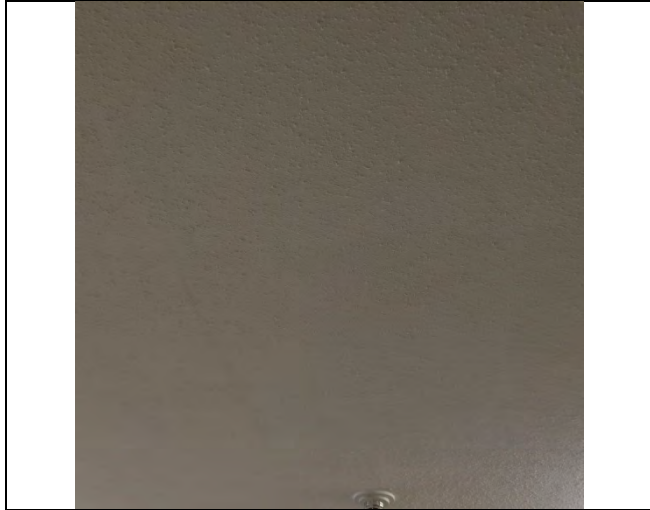
Photo 1: Stucco identified to be asbestos-containing in the hallway (2% Chrysotile).

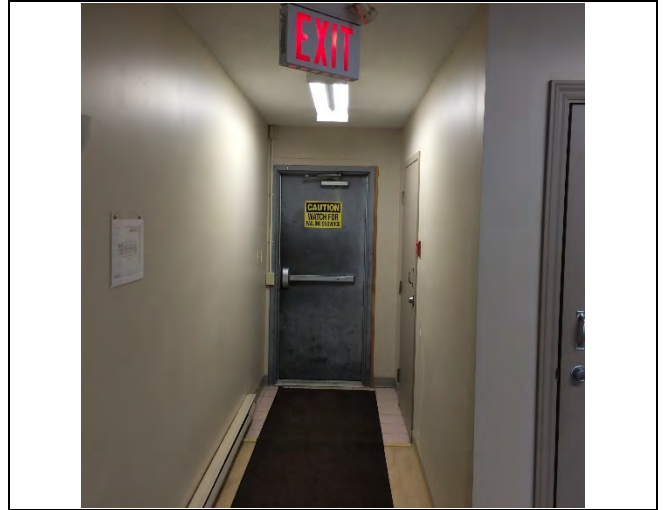
Photo 2: Drywall joint-fill compound identified to be asbestos-containing in the hallway (1% Chrysotile). Fire rated doors is presumed to be asbestos-containing.

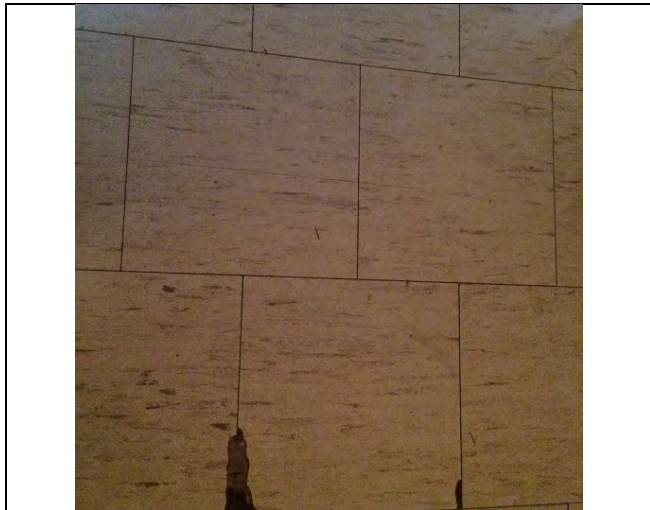
Photo 3: 12"x12" vinyl floor tile – beige with brown streaks identified to be asbestos-containing in Unit 201 (0.77% Chrysotile).

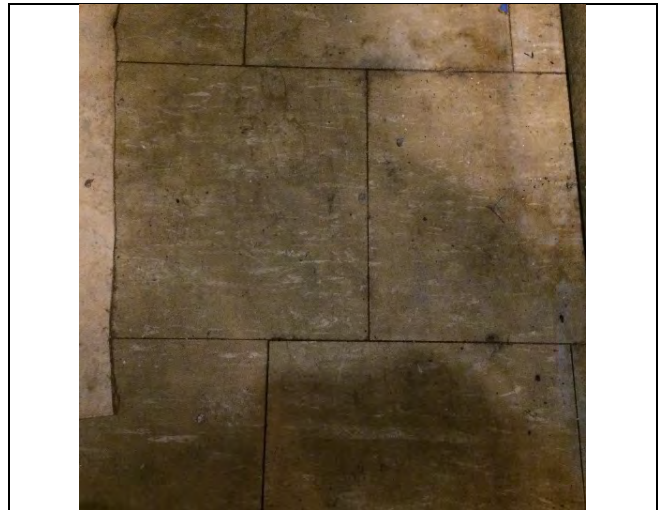
Photo 4: 12"x12" vinyl floor tile – grey with brown streaks identified to be asbestos-containing in Unit 201 (1.44% Chrysotile).

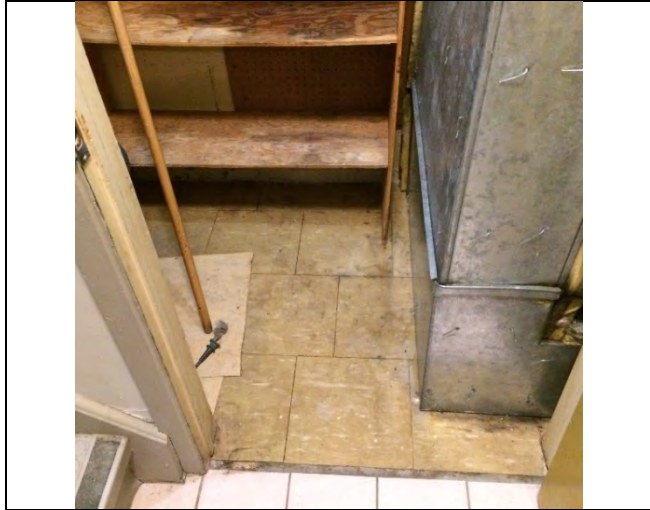
Photo 5: 12"x12" vinyl floor tile – yellow with white streaks identified to be asbestos-containing in the west storage room (0.77% Chrysotile).

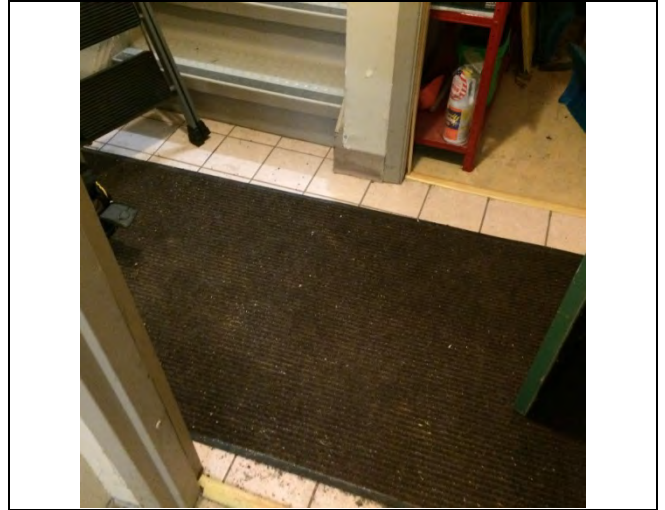
Photo 6: Ceramic tile grout presumed to be asbestos-containing in the back door entrance.

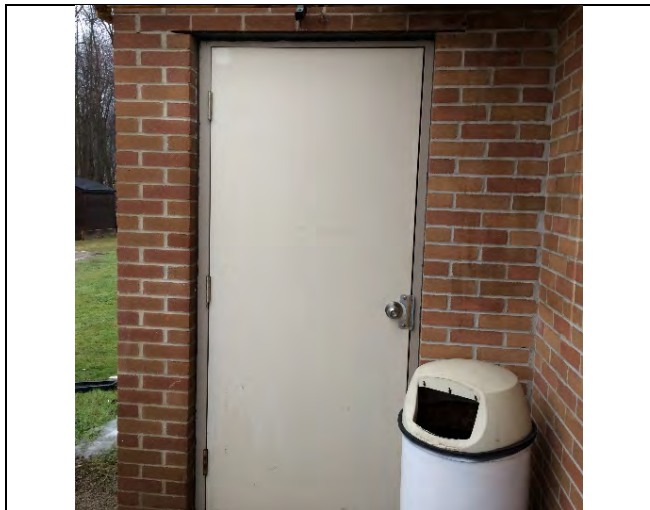
Photo 7: Exterior door caulking and brick mortar presumed to be asbestos-containing.

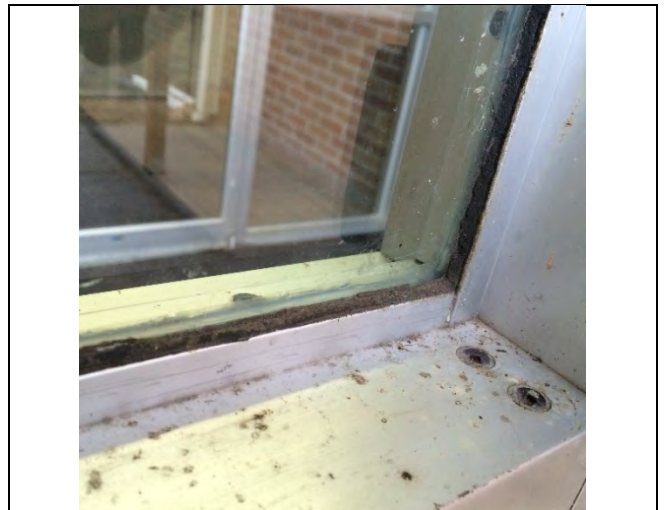
Photo 8: Exterior window glazing compound presumed to be asbestos-containing.
