Asbestos Building Materials Assessment

Row Houses
5 ½ Glengarry Road, Units F and L
Brockville ON

Project No.: 122150275

February 15, 2017

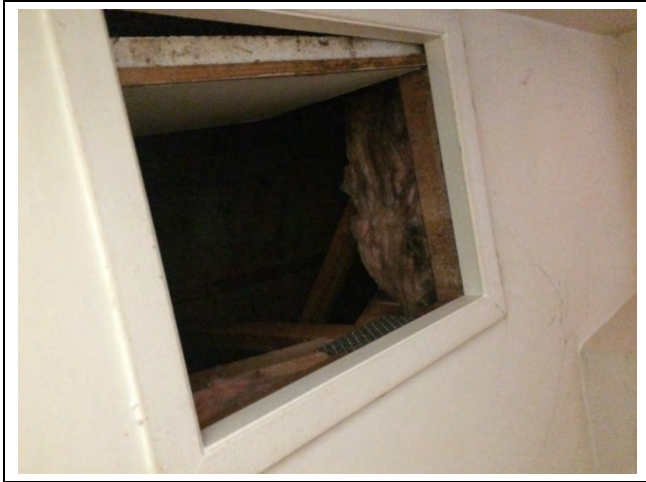
Photo 1: Asbestos-containing drywall joint-fill compound observed on walls and ceilings at Unit F.

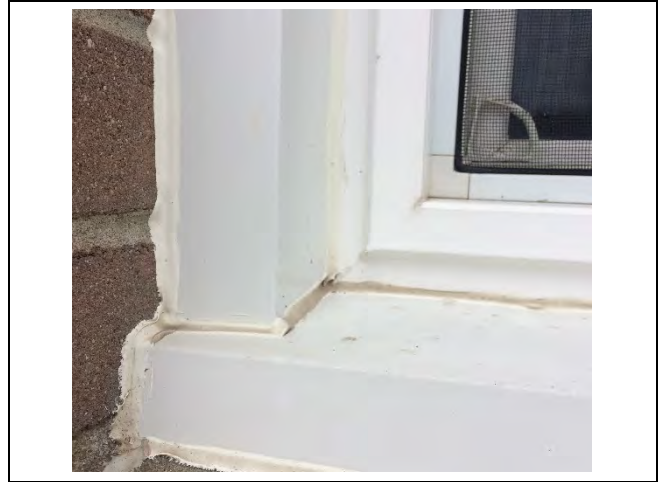
Photo 2: Presumed asbestos-containing exterior window caulking at Unit F.

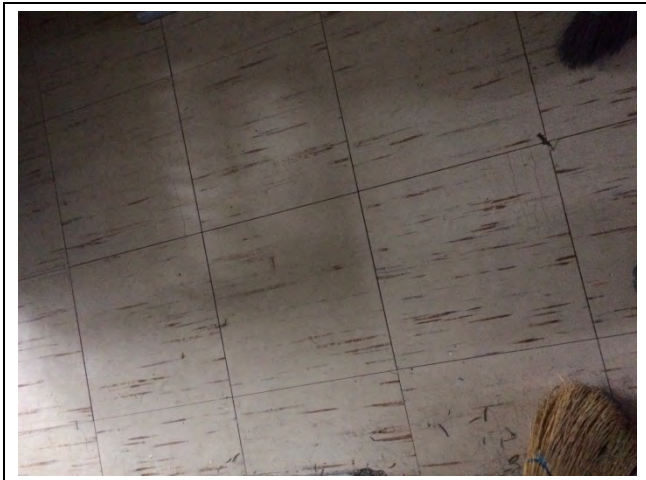
Photo 3: Presumed asbestos-containing mastic associated with 12"x12" vinyl floor tile – beige with brown streaks

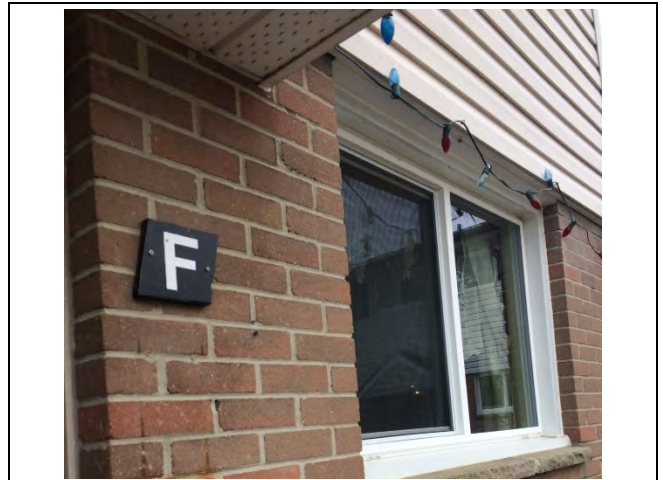
Photo 4: Presumed asbestos-containing brick mortar was observed on exterior walls at Unit F.

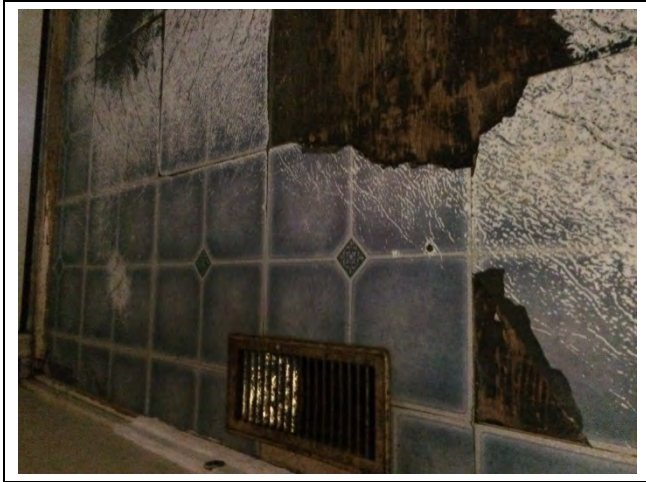
Photo 5: Asbestos-containing 12"x12" vinyl floor tile – beige with brown streaks was observed to be present under peel and stick tiles in the 1st floor hallway in Unit L.
